# Kai Iwi Lakes Security Review

## Kaipara District Council

**September 2020**

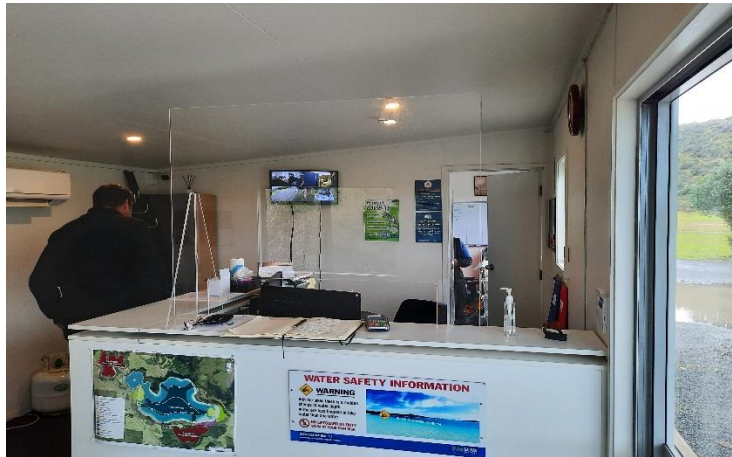
Reception area

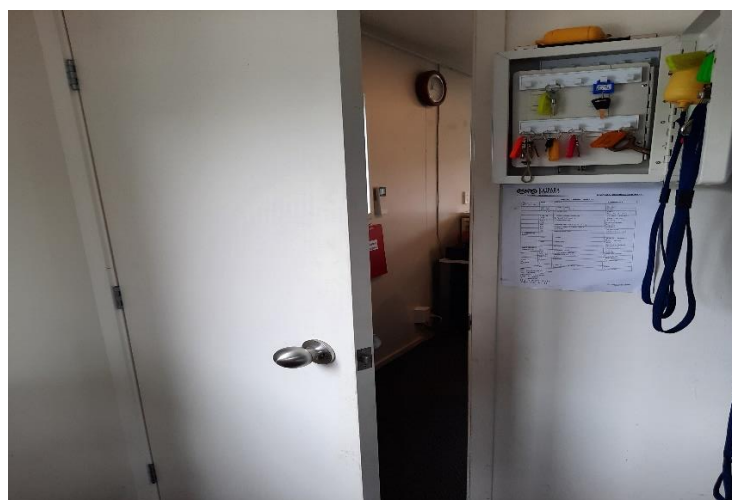
Internal office door

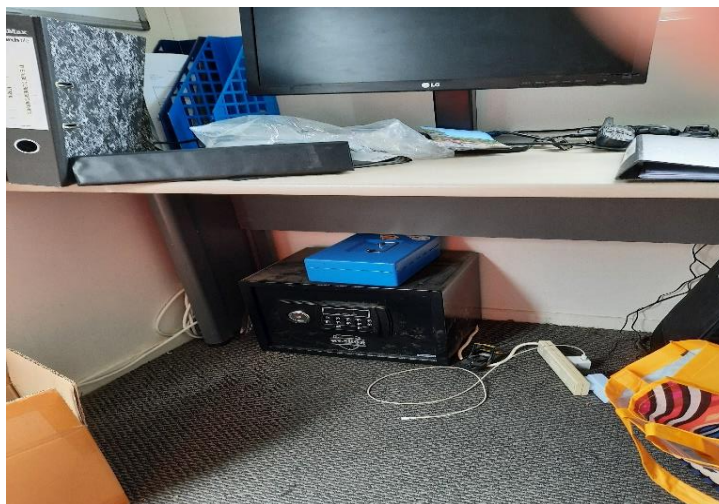
Office floor safe

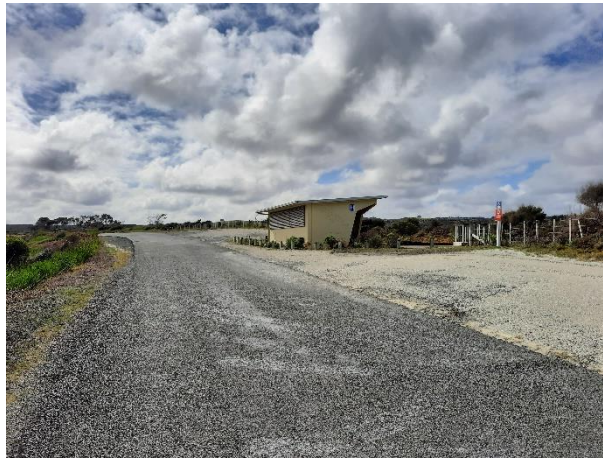
## Kai Iwi Lake Road toilet block

| <b>Findings</b> | <p>The Kai Iwi Lakes road toilet block is located near the entrance of the Promenade campground and is within the Domain confines. The parking area is used by day trippers who park their vehicles and walk or ride along tracks within the Domain including a loop track around lake Taharoa.</p> <p>There have been two reported incidents where multiple vehicles were broken into while parked next to the toilet block with valuables taken.</p> | <b>MEDIUM</b> |

| <b>Advice</b> | <p>As part of an upgraded CCTV system, we advise to install cameras covering the toilet block area on Kai Iwi Lakes road to detect/deter car break-ins, willful damage and disorderly related incidents.</p> <p>Install prominent signs advising of CCTVs and signs warning not to leave valuables due to thieves operating in the area.</p> | |

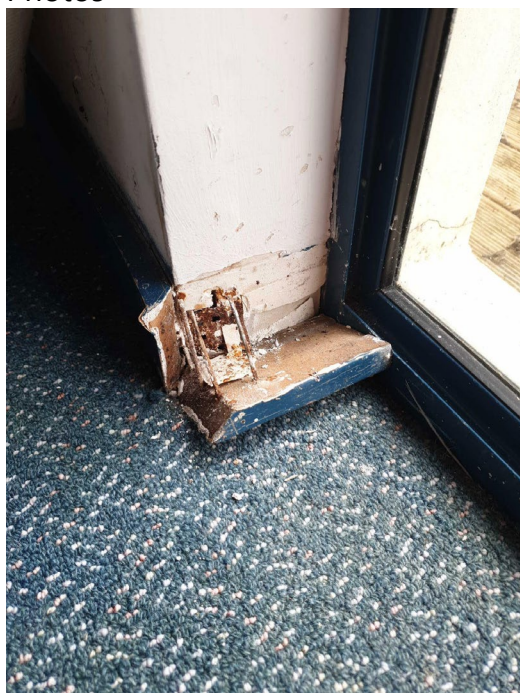
*Figure 1 - Mould and elevated moisture levels on skirting boards, lower wall linings and carpet*

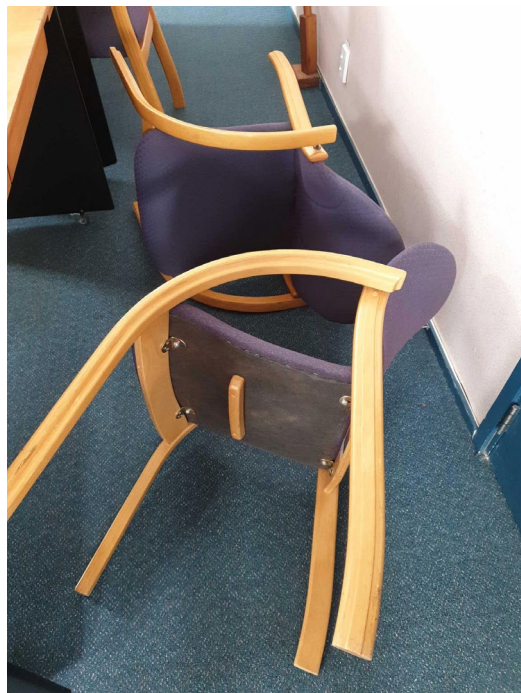
*Figure 2 - Mould on the underside of furniture*

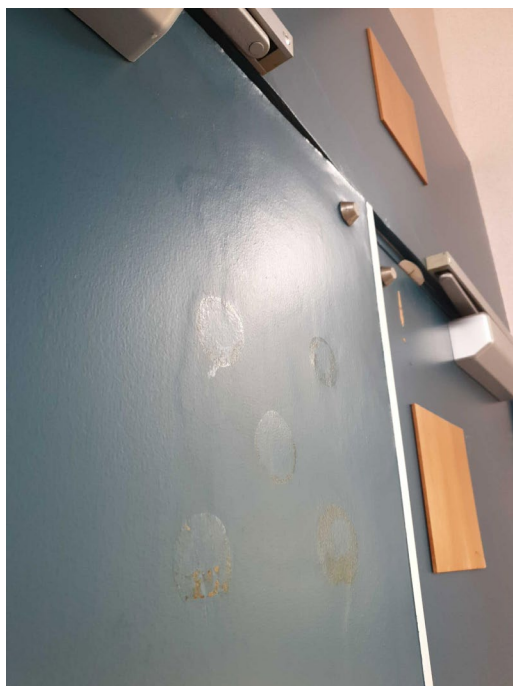
*Figure 3 - Water damage to doors*

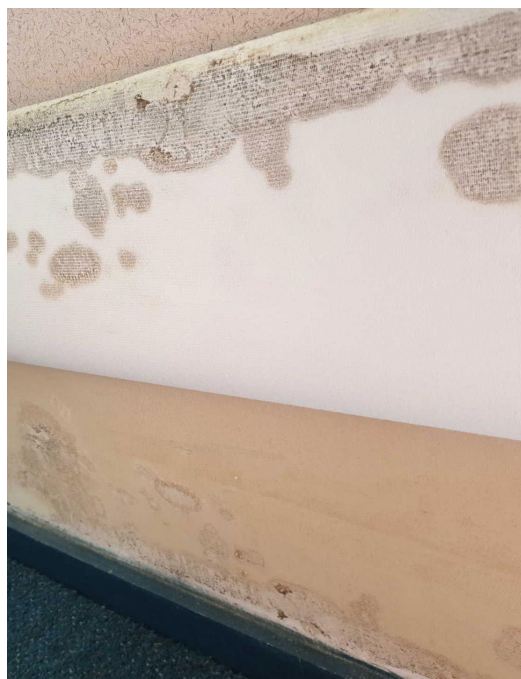
*Figure 4 - Water damage and mould to the backside of vinyl paper and plasterboard*

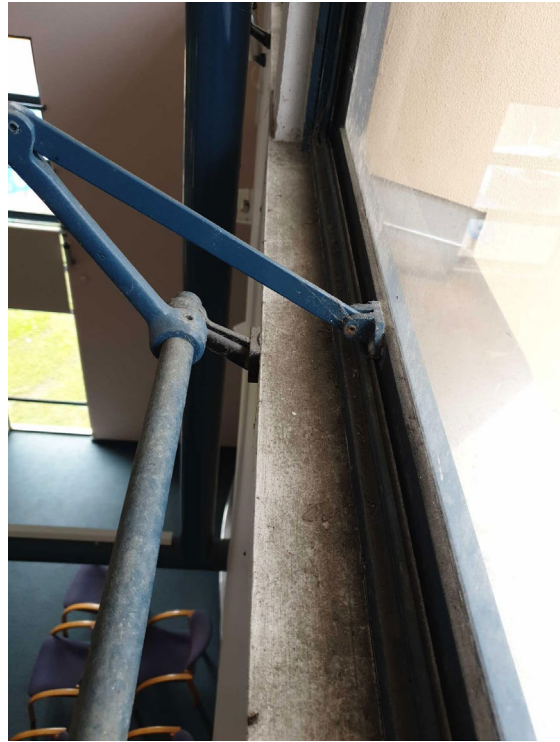
Figure 5 - Superficial mould to the window sills

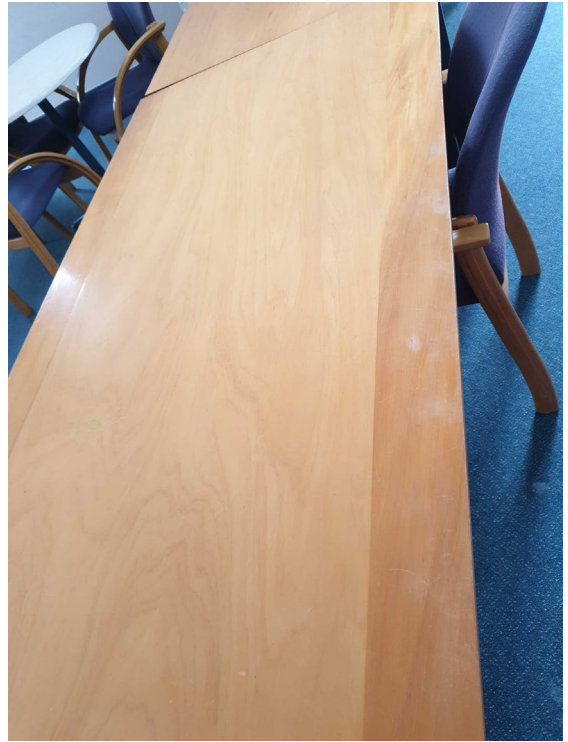
Figure 6 - Superficial growth to the hard surfaces of contents

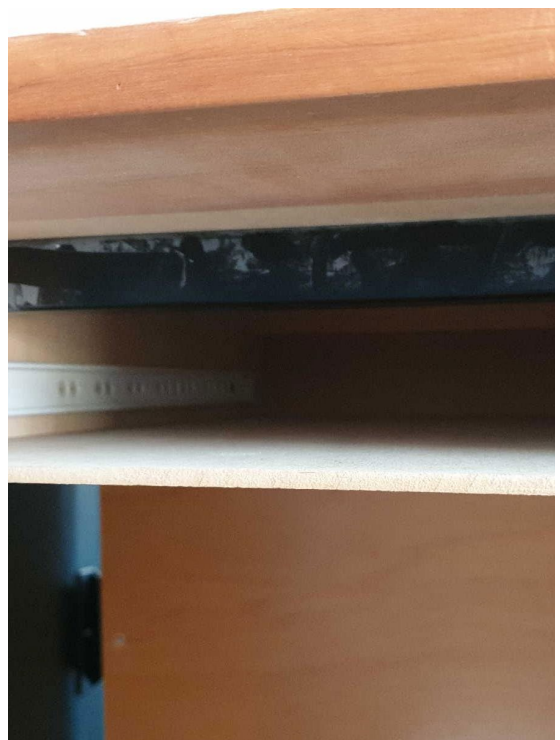
Figure 7 - Mould growth on the unprotected semi-porous services of contents

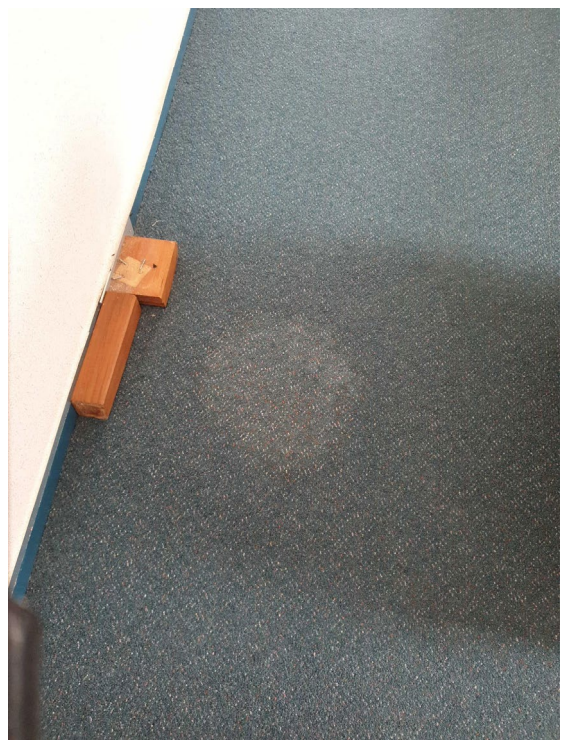
Figure 8 - Spots of visible mould on the carpet

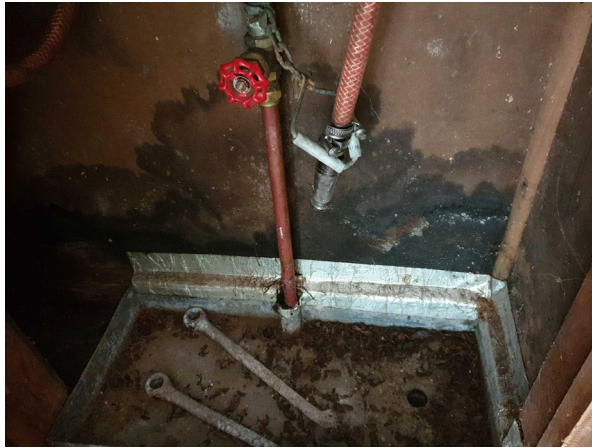
Figure 9 - Mould was discovered in the firehose cupboard

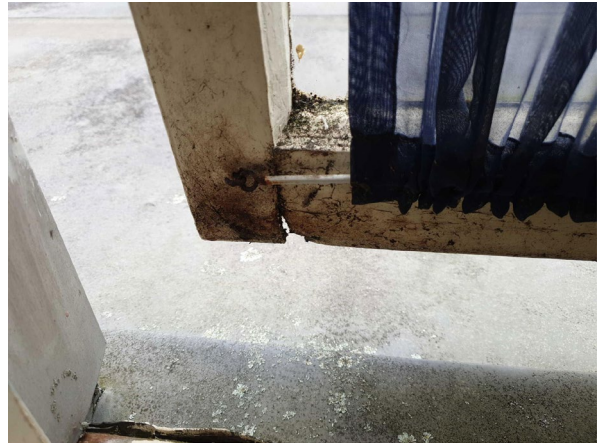
Figure 10 - The joinery has significance fungal deterioration and mould growth

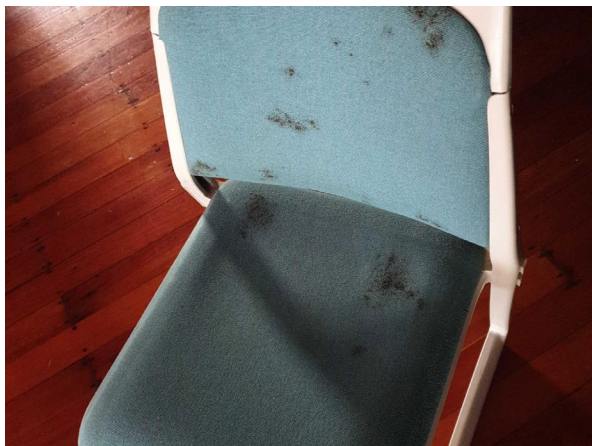
Figure 11 - Some of the soft furnishings were found to be significantly damaged by mould

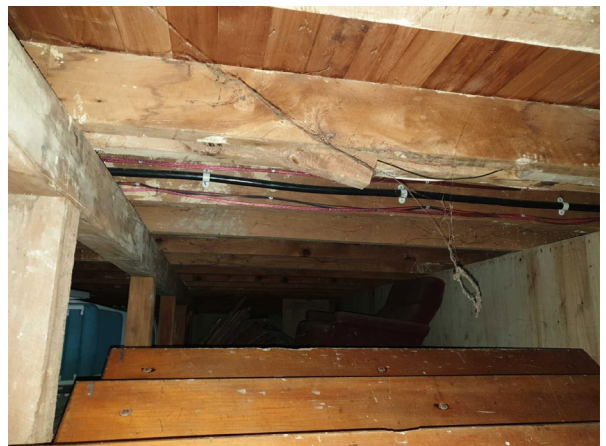
Figure 12 - The underside of the stage showed signs of water staining and topical fungal growth

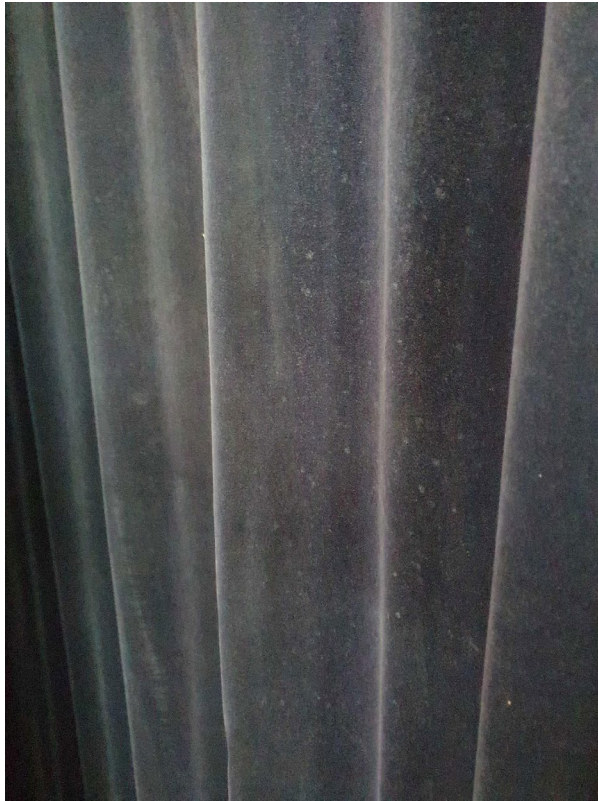
Figure 13 - The heavy curtains had significant spotty growth

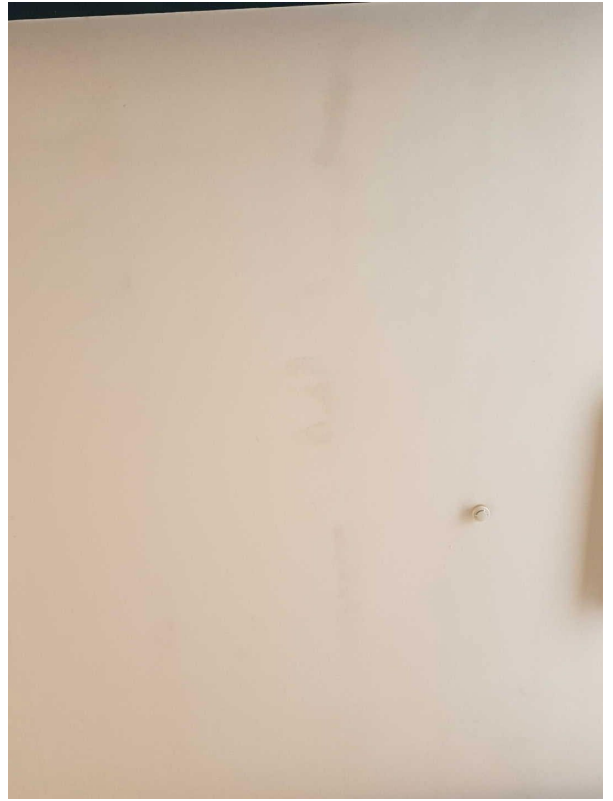
Figure 14 - Parts of the ceiling showed water damage and mould growth

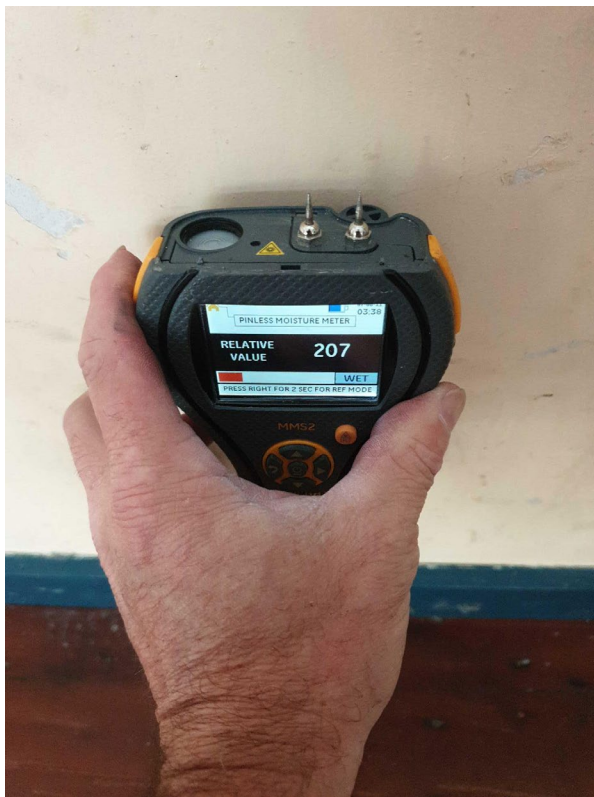
Figure 15 - Much of the lower wall presented high moisture readings

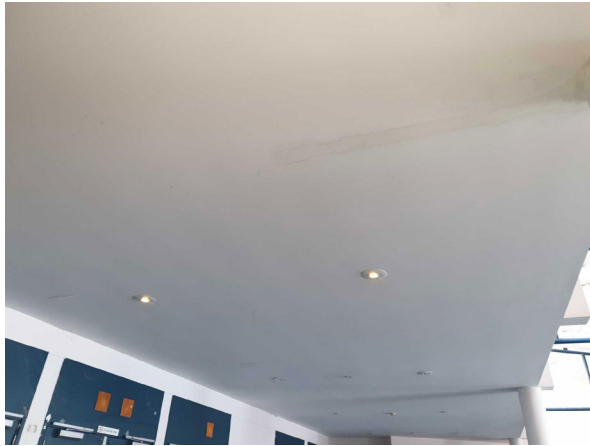
*Figure 17 - Water damage to some of the ceiling plasterboard*

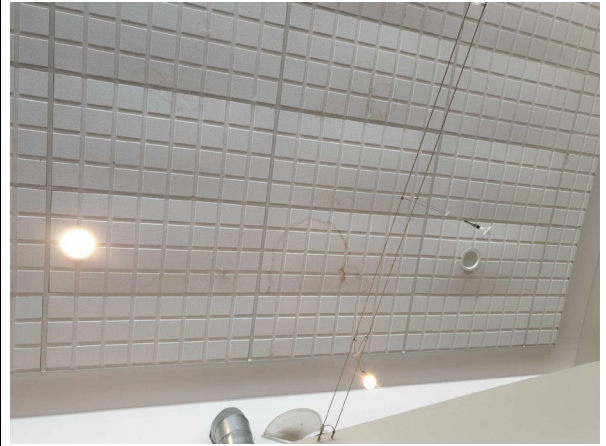
*Figure 18 - Water damage to some of the ceiling tiles*

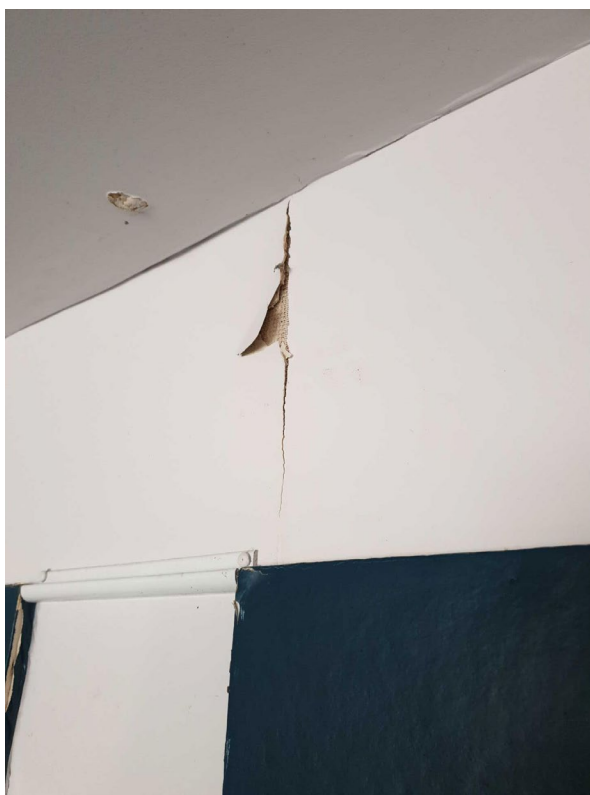
*Figure 19 - Water damage to some of the wall plasterboard*

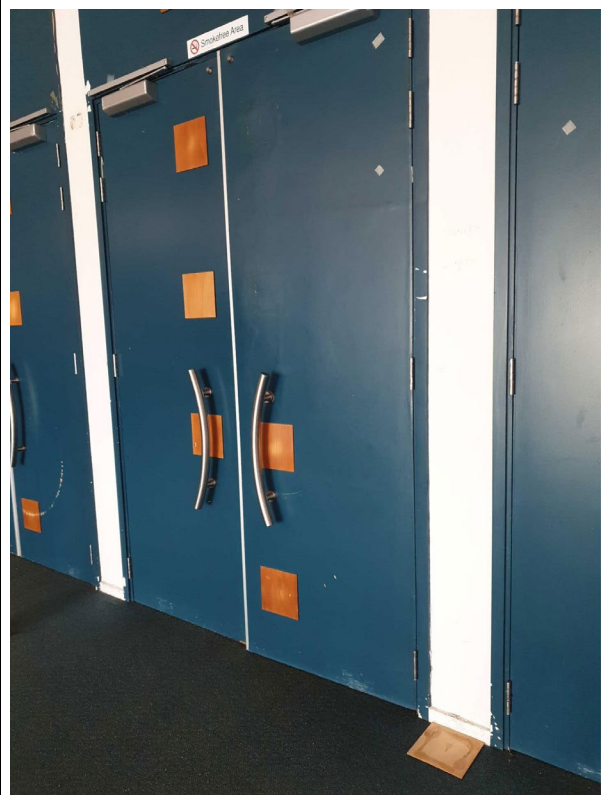
*Figure 20 - Water damage to the doors resulting in swelling*

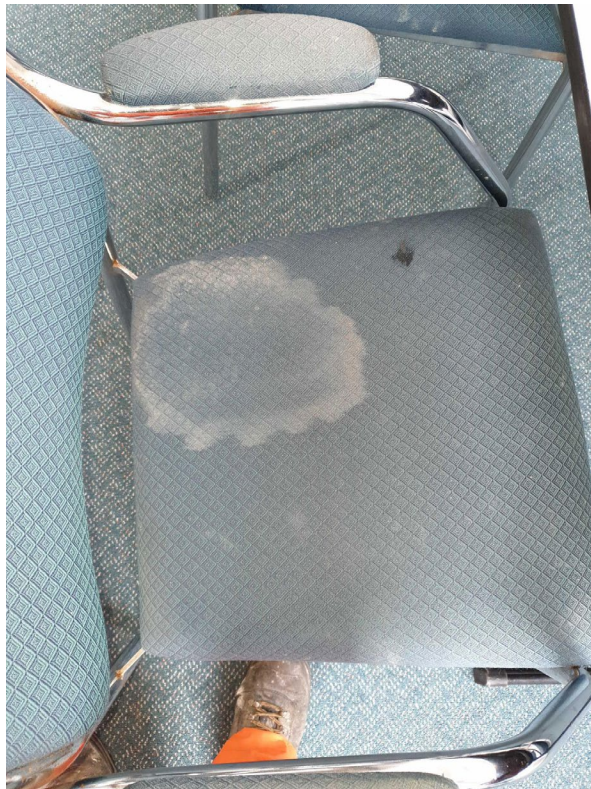
Figure 21 - Visible mould growth on some of the chairs

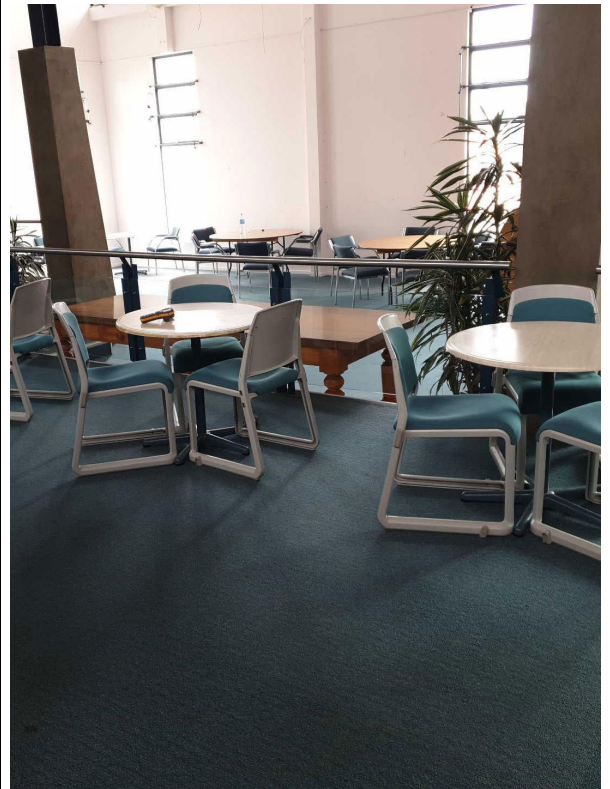
Figure 22 - All chairs and furniture will require individual assessment for suitability to salvage

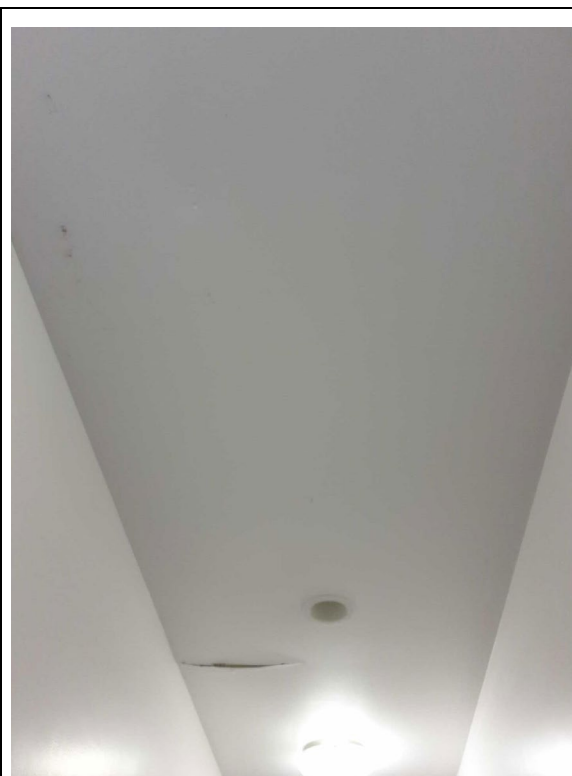
Figure 23 - Water damage to ceiling

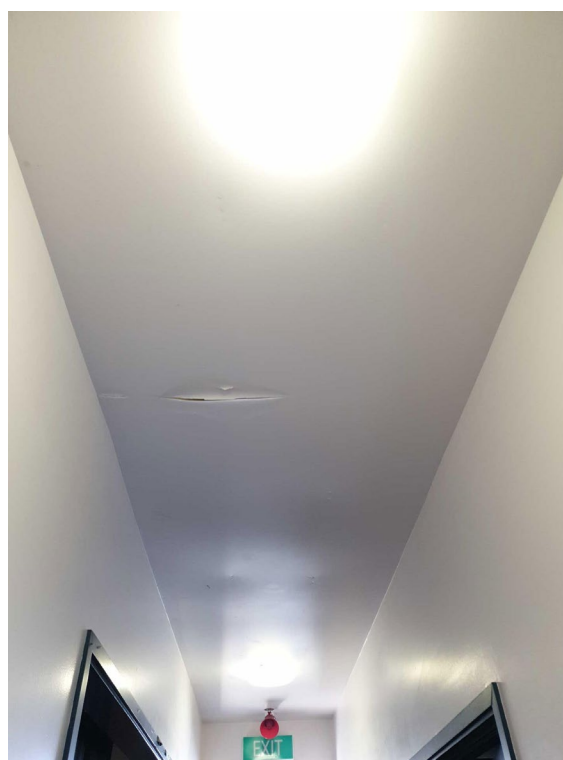
Figure 24 - Water damage to ceiling

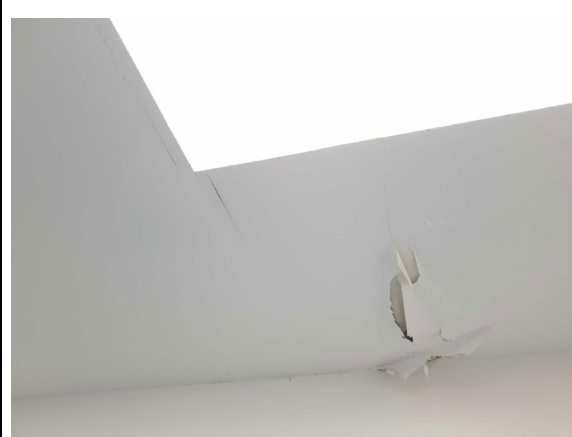
Figure 25 - Water damage to ceiling

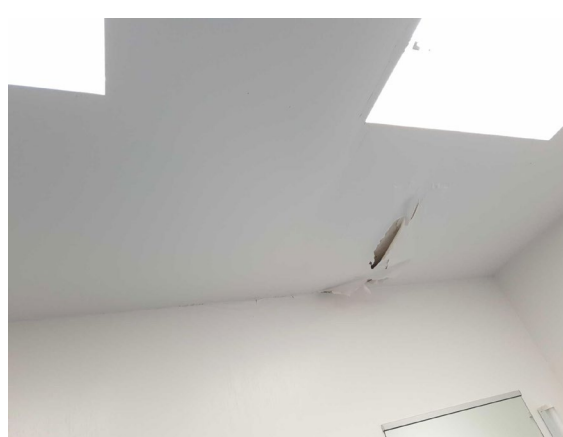
Figure 26 - Water damage to ceiling and wall

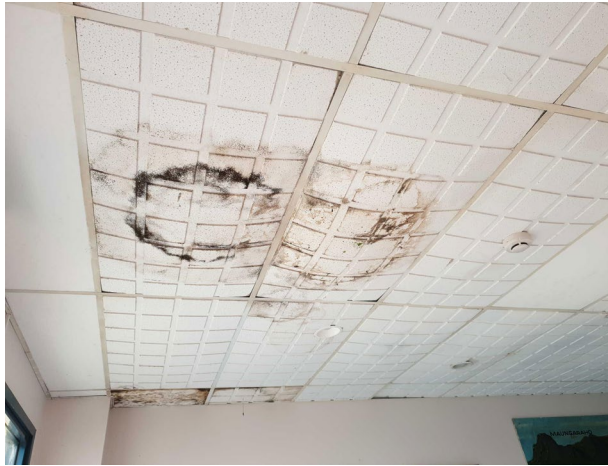
Figure 27 - Heavy growth on some of the ceiling tiles

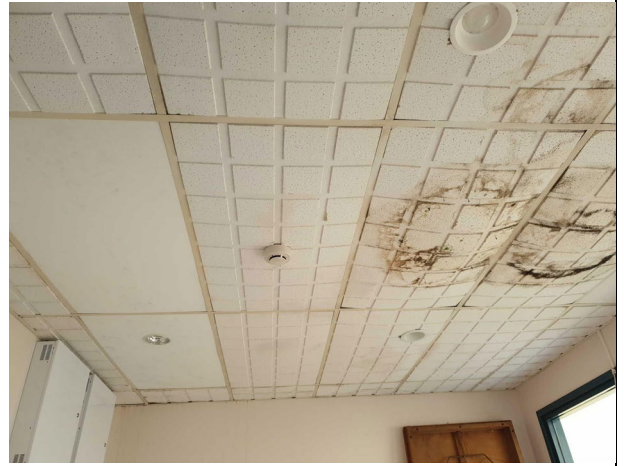
Figure 28 - Heavy growth on some of the ceiling tiles

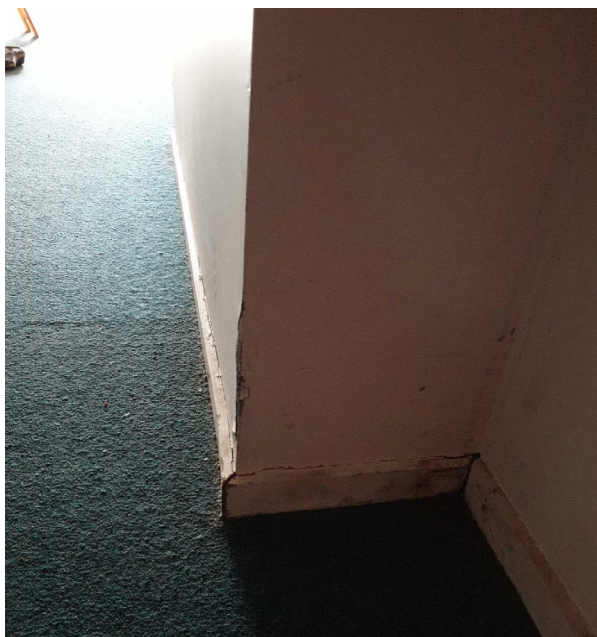
Figure 31 - There is visible growth on the lower walls and skirting boards

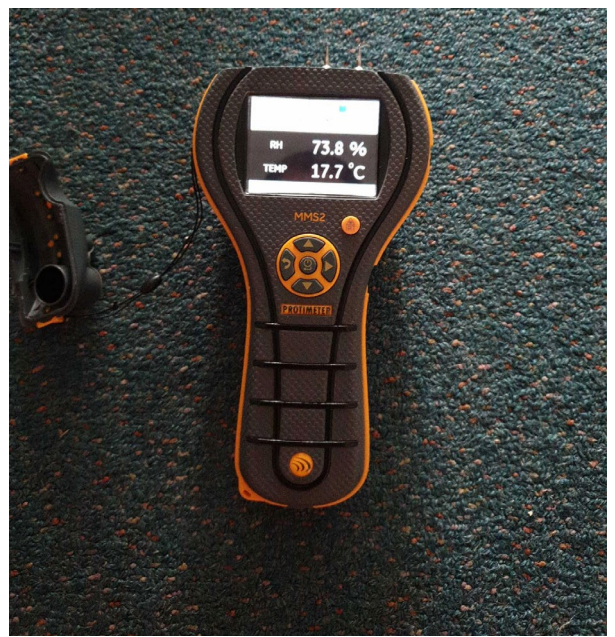
Figure 32 - A sustained relative humidity of more than 60% can promote ubiquitous mould proliferation

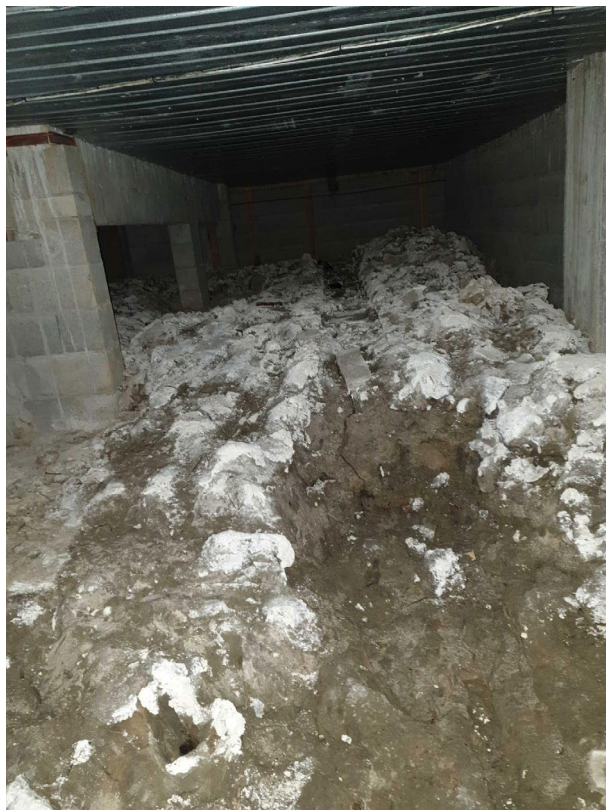
Figure 33 - Efflorescence is present indicating dampness from a subterranean source is evaporating into the subfloor space

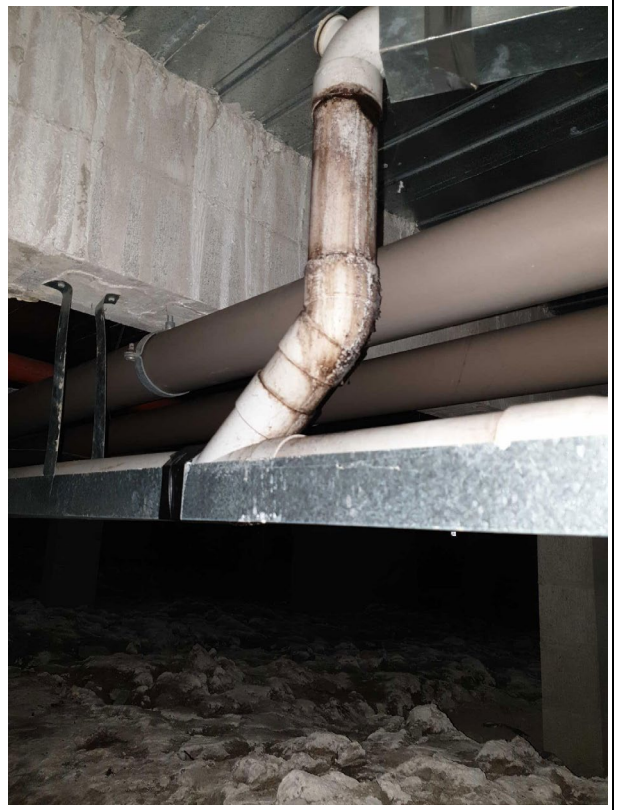
Figure 34 - The sewerage riser is leaking and should be attended to urgently

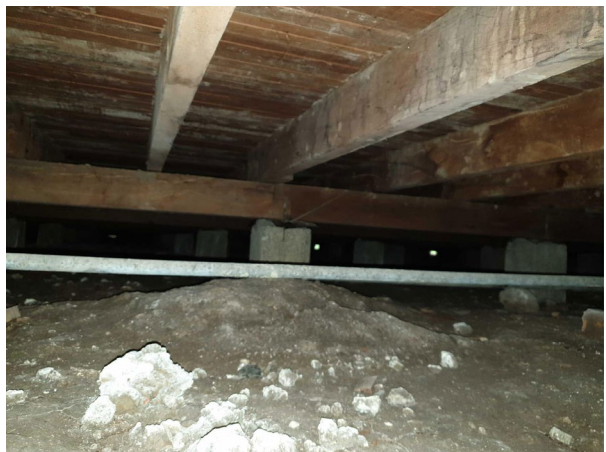
Figure 35 - The bottom side of the floor boards and some isolated areas showing signs of visible mould growth

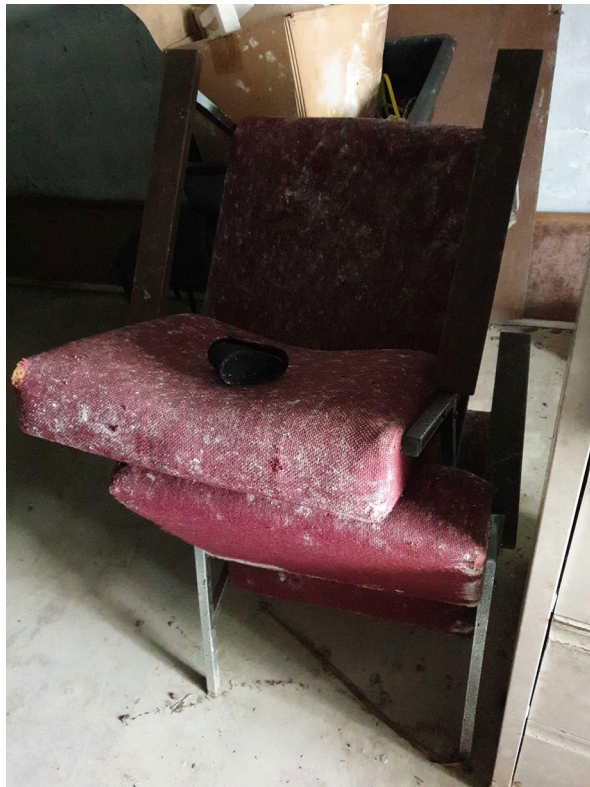
Figure 37 - Some of the contents have significant mould growth

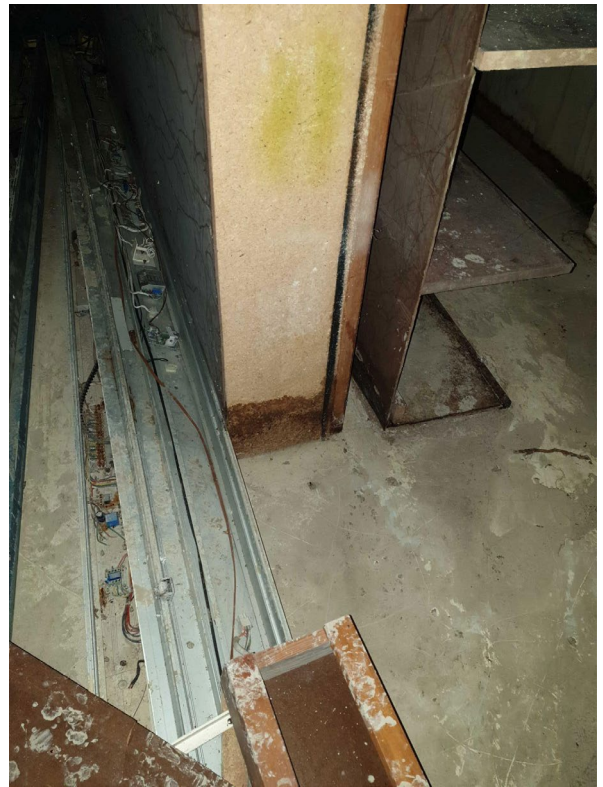
Figure 38 - More contents with visible mould growth

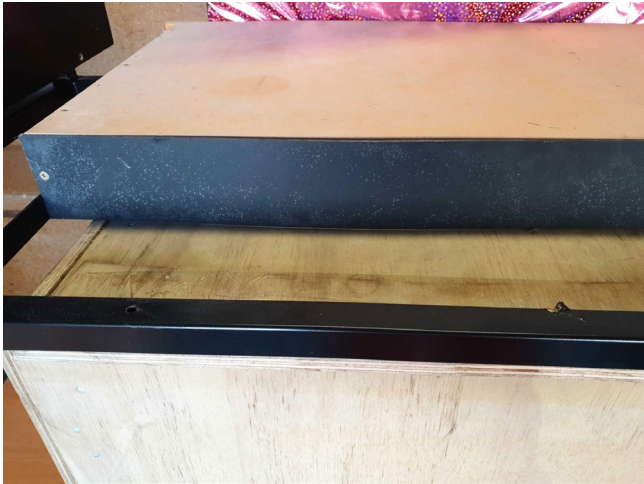
Figure 39 - Many of the contents exhibited superficial mould growth, some of which can be cleaned

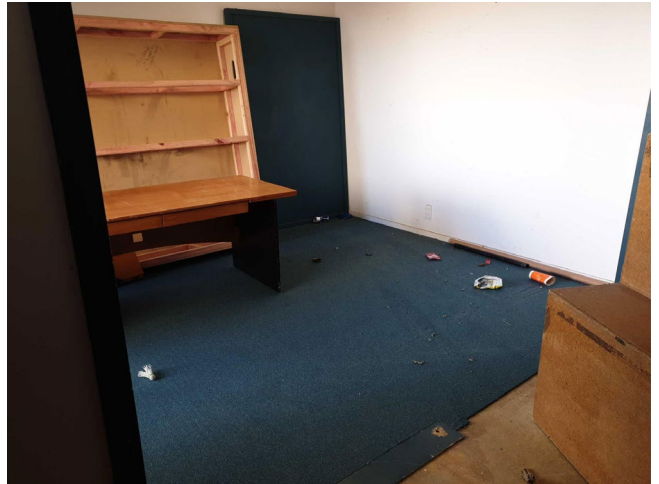
Figure 40 - There is contaminated carpet in part of the storage area

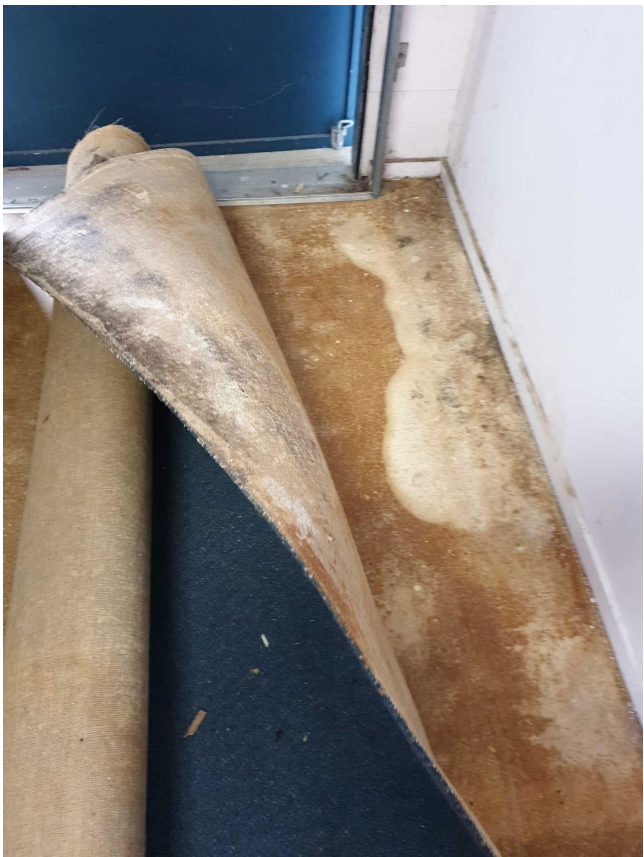
Figure 41 - Visible water damage and mould growth to the top and bottom of some of the carpet storage

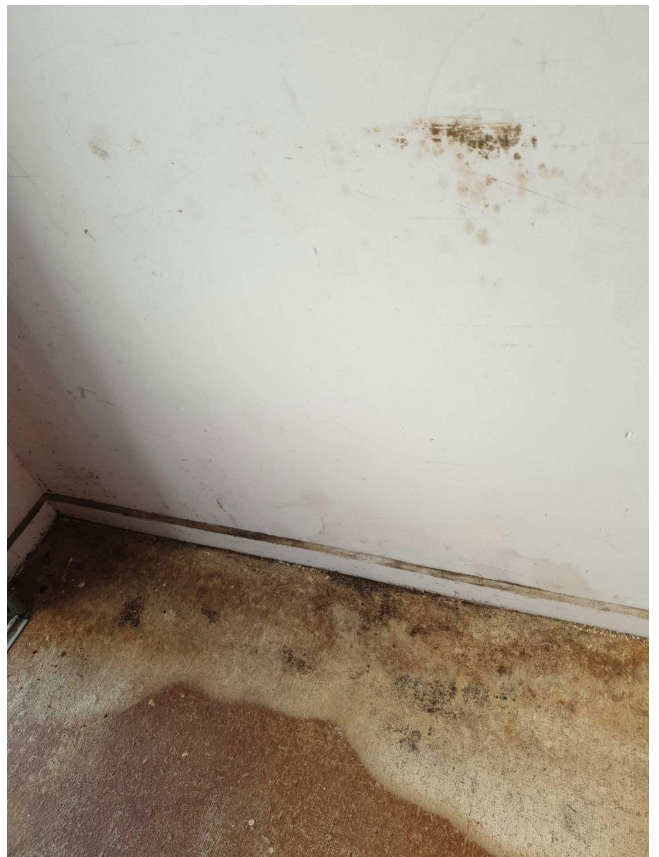
Figure 42 - The growth has affected skirting boards, lower wall boards and the floor in some areas

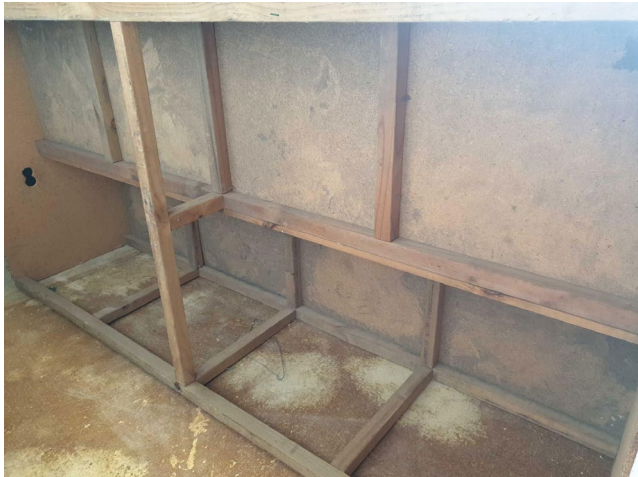
Figure 43 - Some staging that is kept in the storage is unsalvageable and will require disposal

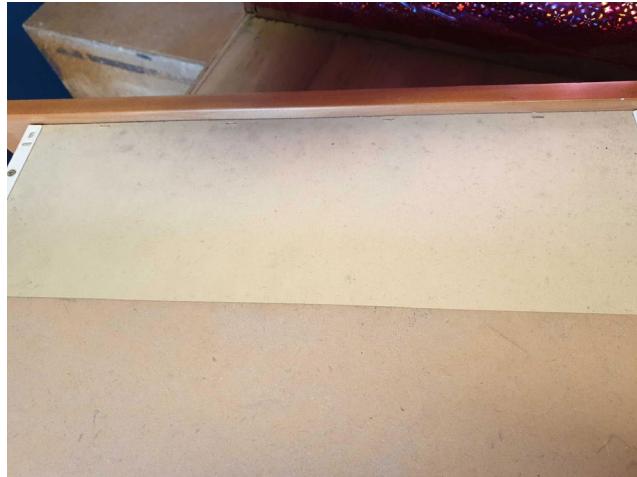
Figure 44 - Some unfinished timbers such as the bottoms of draws on desks in the storage area are deemed to be unsalvageable

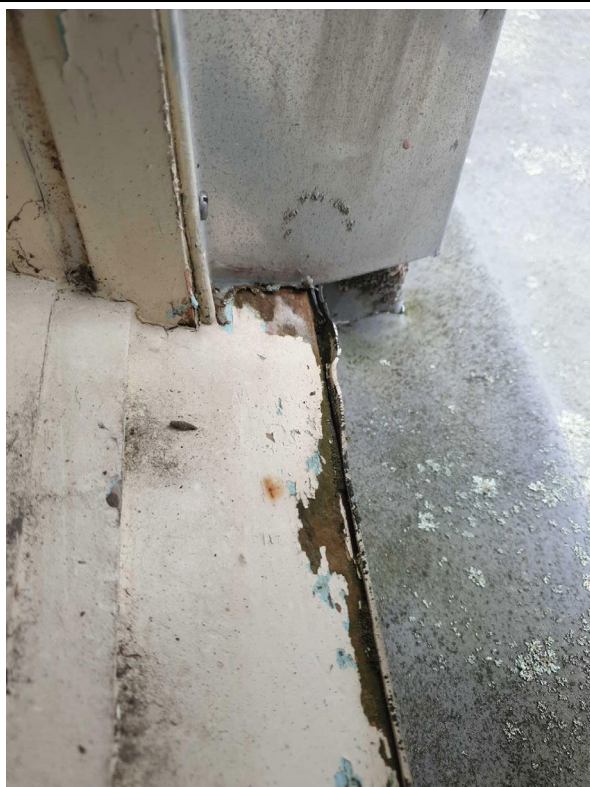
Figure 45 - there are no sill flashings along the top of the gymnasium

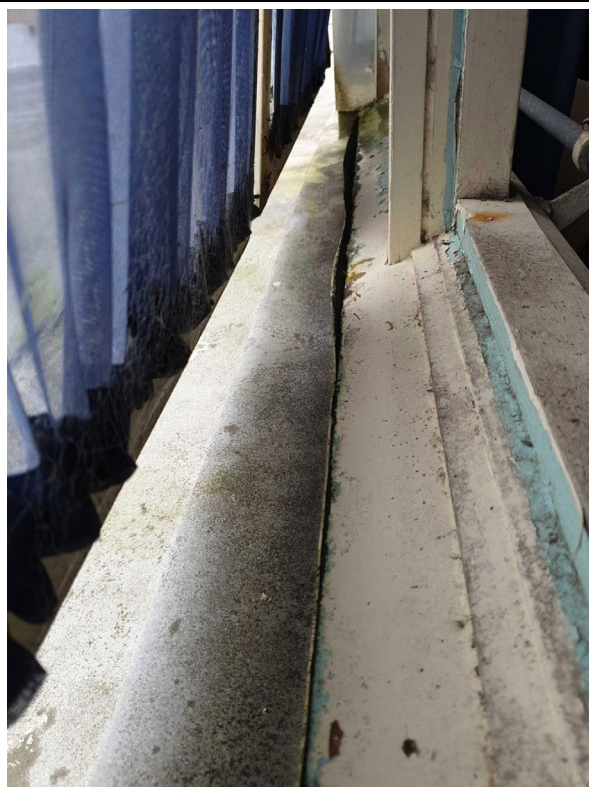
Figure 46 - the water proofing membrane does not turn up behind a wet or dry flashing

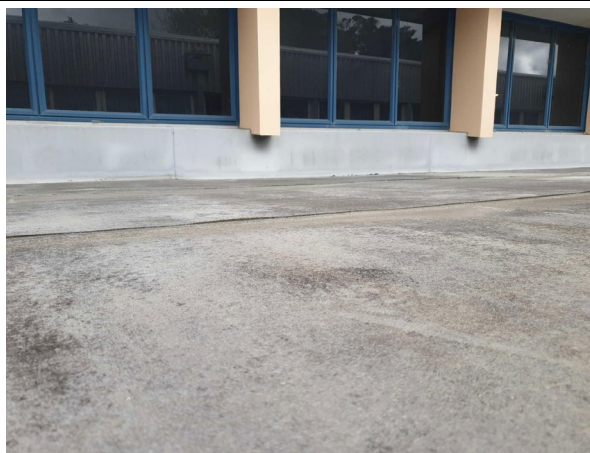
Figure 47 - there is inadequate fall

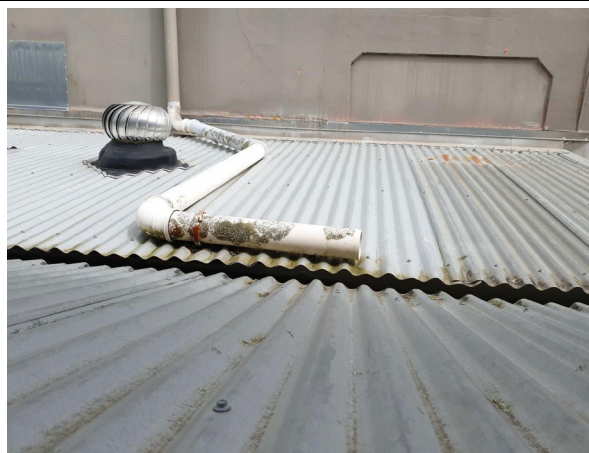
Figure 48 - the discharge from the upper roof does not disperse well

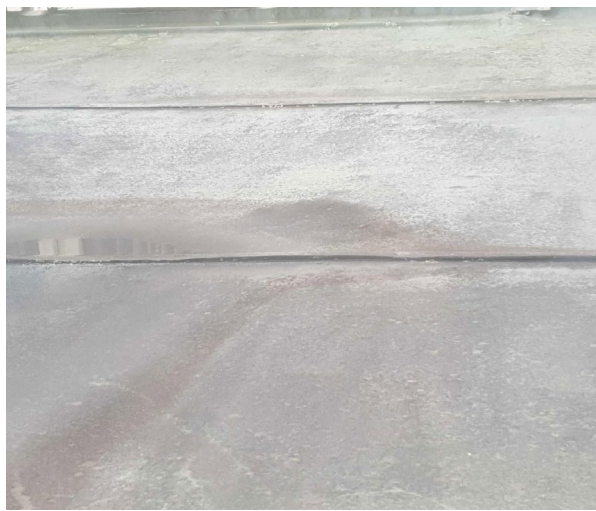
*Figure 50 - the laps of the waterproofing membrane are counter to the rake and water is able to push into the joint.*

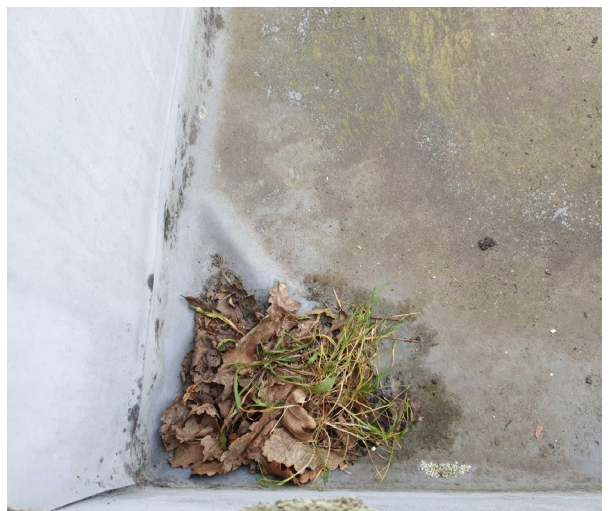
*Figure 51- organic debris is blocking some drains*

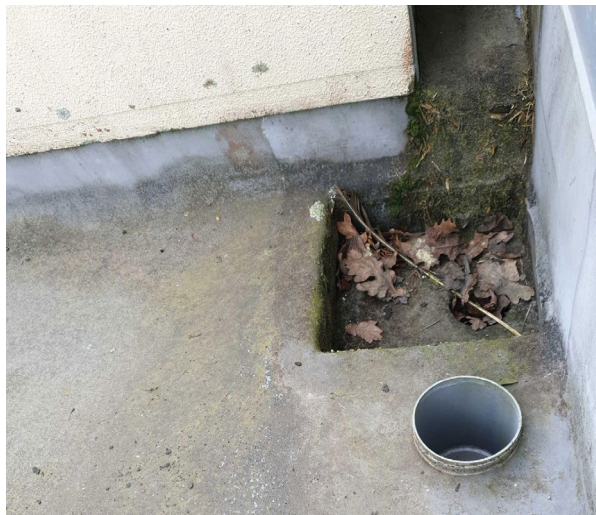
*Figure 52 - organic debris in the rain head*

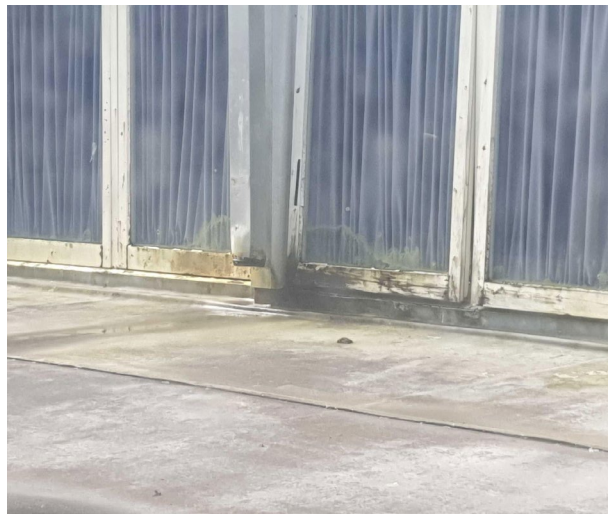
*Figure 53 - some window joinery has signs of serious deterioration and cannot close.*

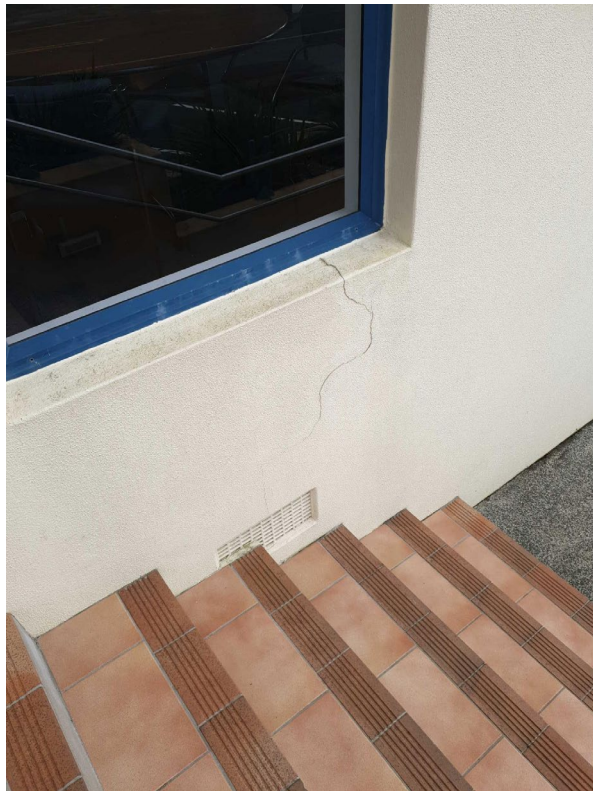
*Figure 54 - step cracking in the render*

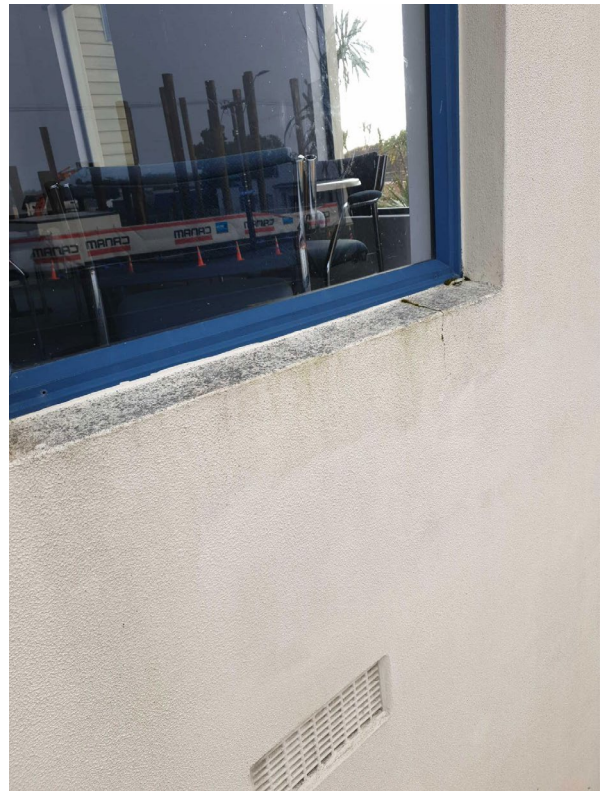
*Figure 55 - no sill flashing*

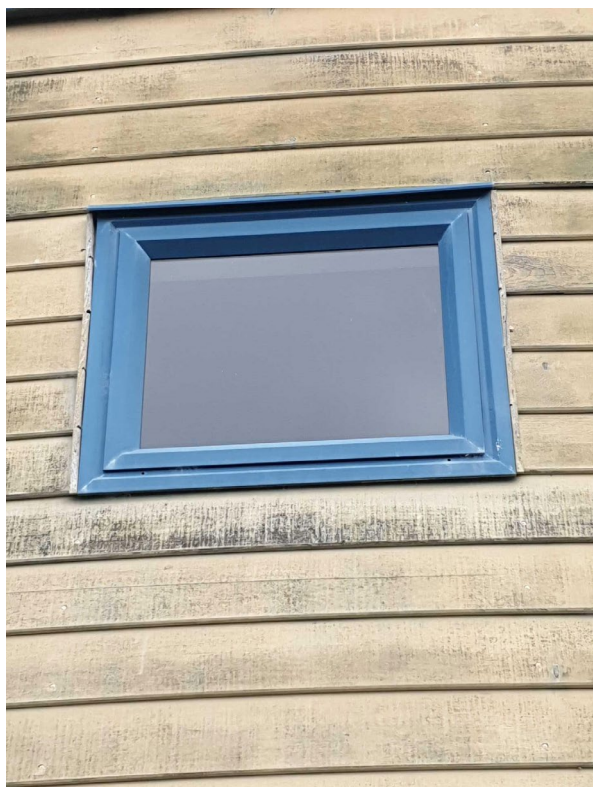
*Figure 56 - the weatherboards require treatment with wood preservative*

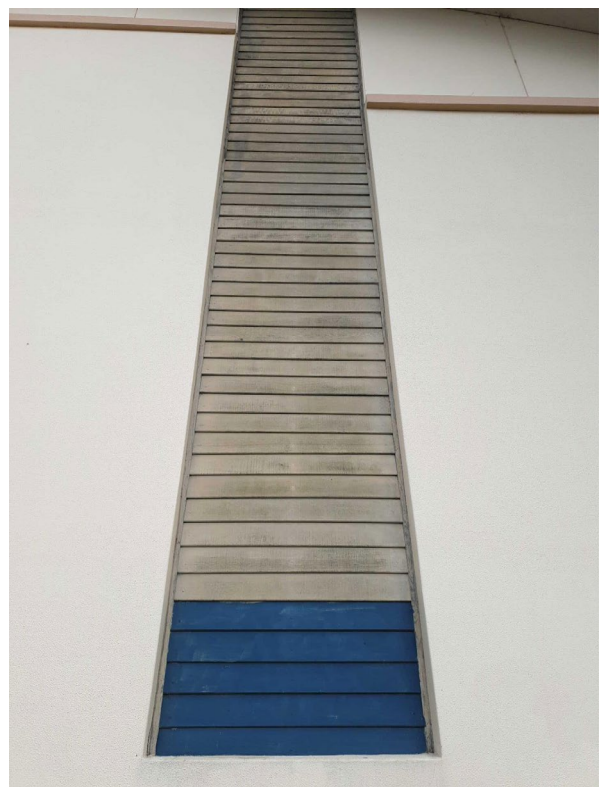
*Figure 57 - the weatherboards require treatment with wood preservative*

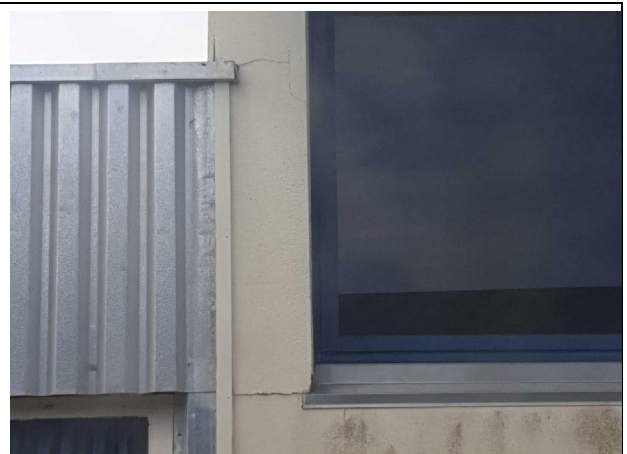
Figure 59 - cracking in the render
