## Review of Road Maintenance Delivery by NTA and Ventia for Kaipara District Council

### Part of Section 17A Review on Road Maintenance Delivery

*Prepared for:* Kaipara District Council

*Prepared by:* Kingston Infrastructure Ltd

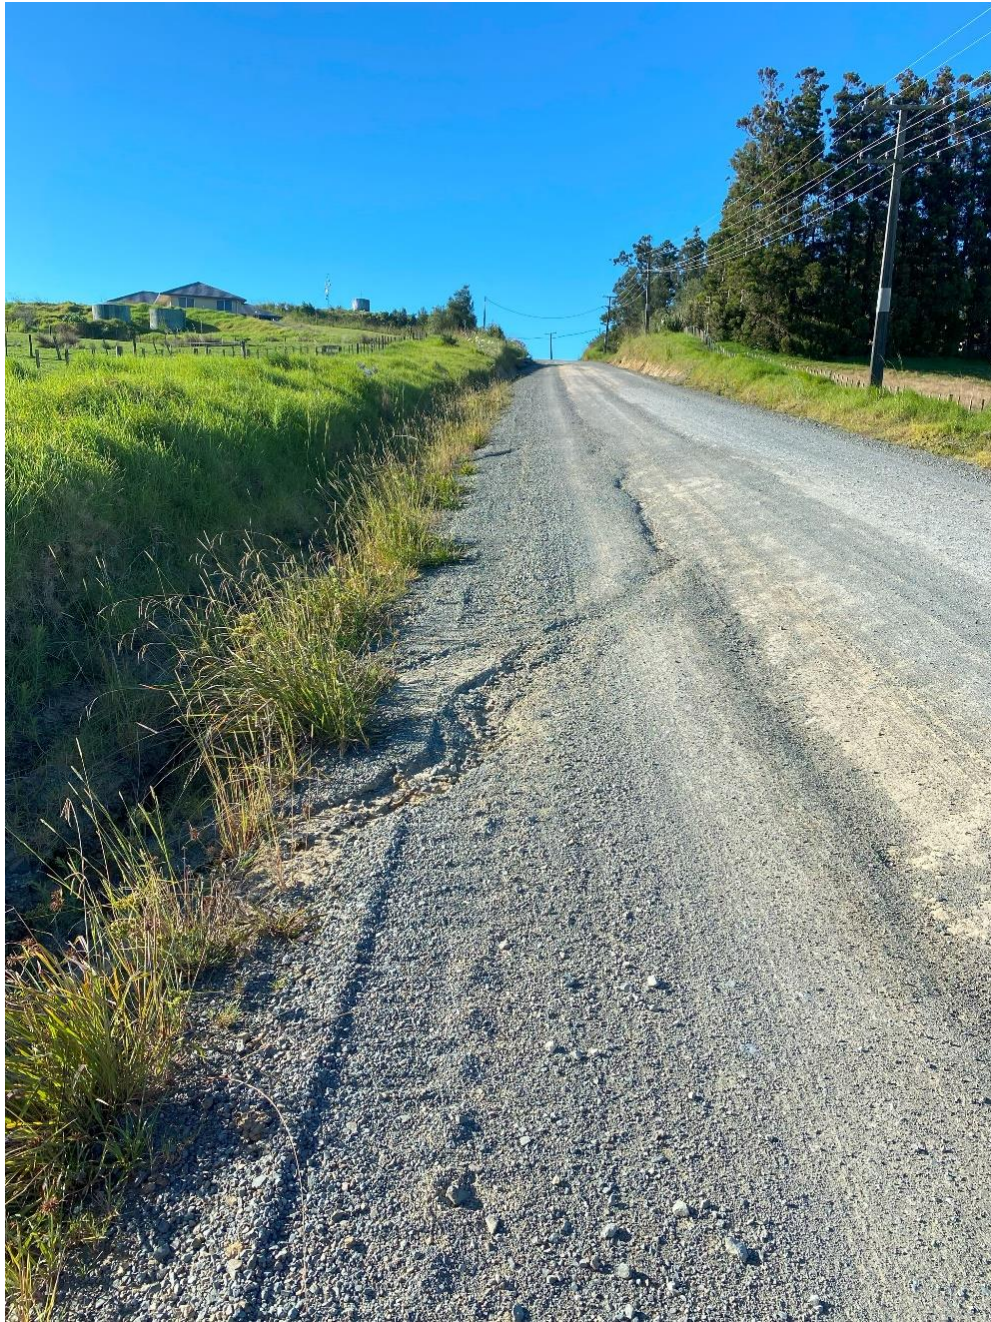
**Photo 1: Lawrence Road:** Site of proposed heavy metal overlay. Underlying drainage faults not addressed as priority actions beforehand. Driveway at top of hill needs \$8000 (of which nearly \$4000 is traffic control cost) to add culvert/headwalls which is outside of the scope of Part 2 of the Consolidated Bylaw.

It is recommended that *Council reprioritise funding in discussion with NZTA to create a clear programme of culvert and water table maintenance/clearance on unsealed roads prior to winter 2024 (Recommendation 1).*

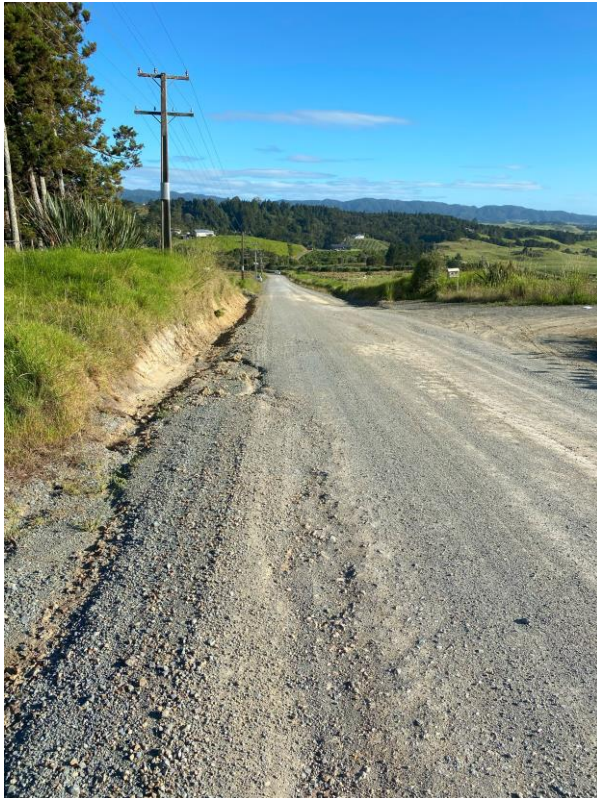
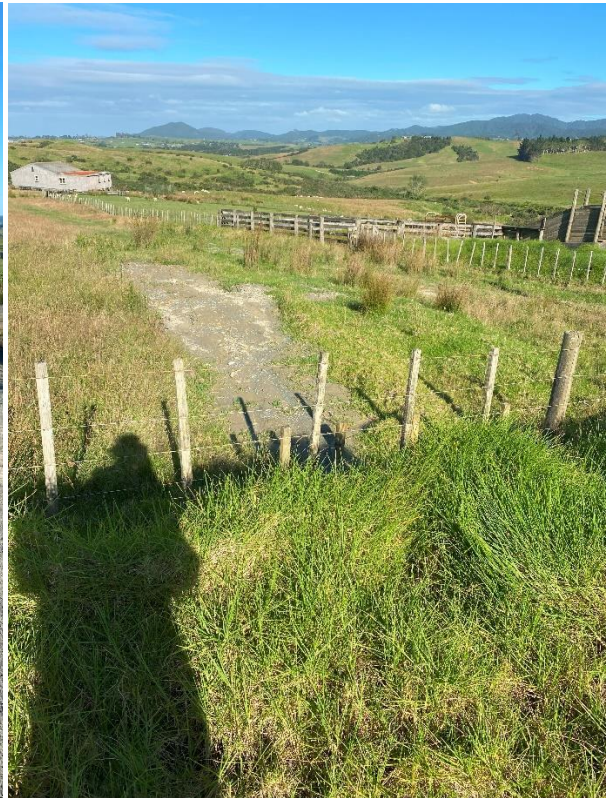
**Photo 2:** *Lawrence Road* looking downhill at site of proposed heavy metal overlay, scour from LHS creating trail of sediment and aggregate in paddock, and removing support for powerpole

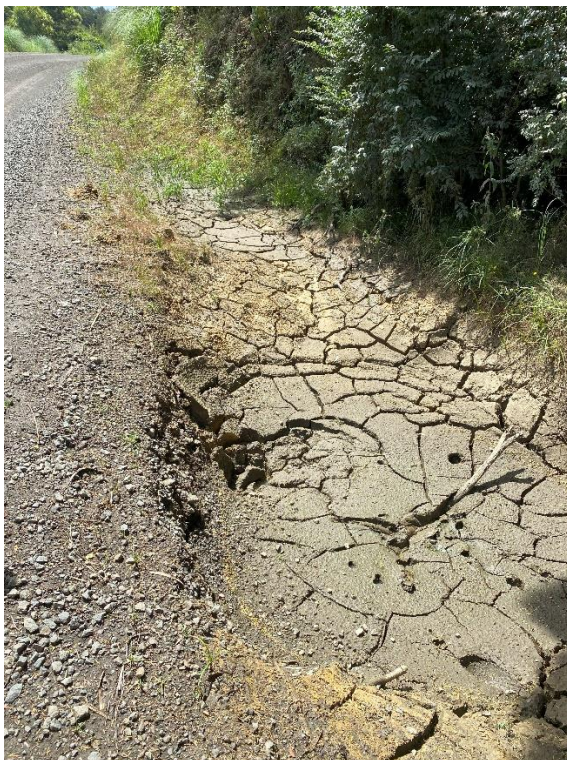
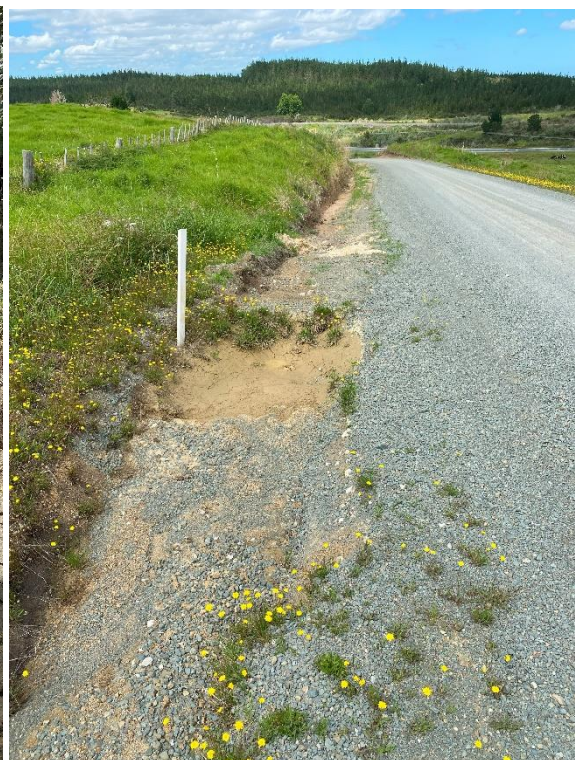
**Photo 3:** *Examples of recently blocked culvert inlets from silt (Pukehuia and Otioro Roads)*

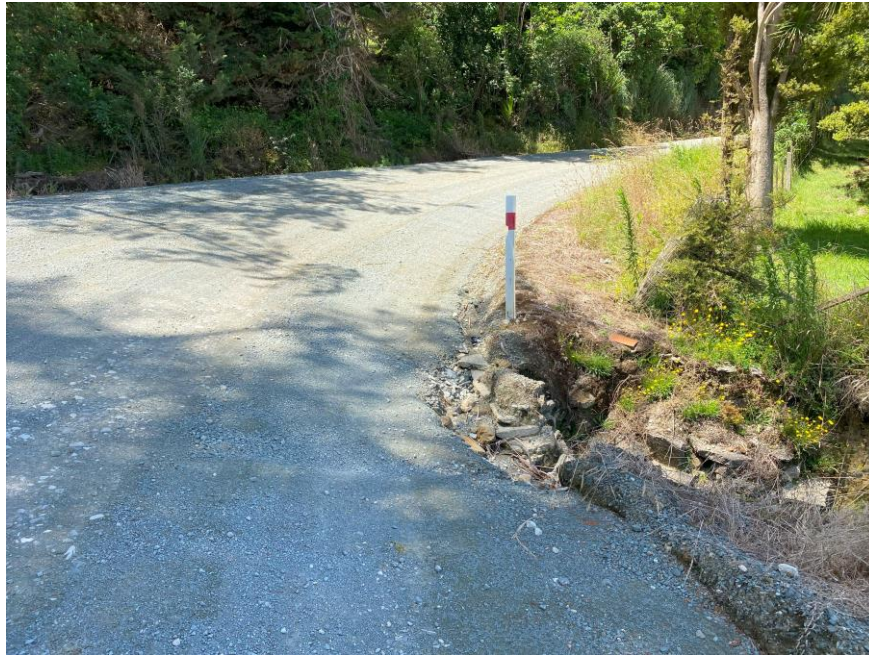
***Photo 4: Lack of maintained upstream water table & cutoffs leading to scour and loss of culvert headwall.***

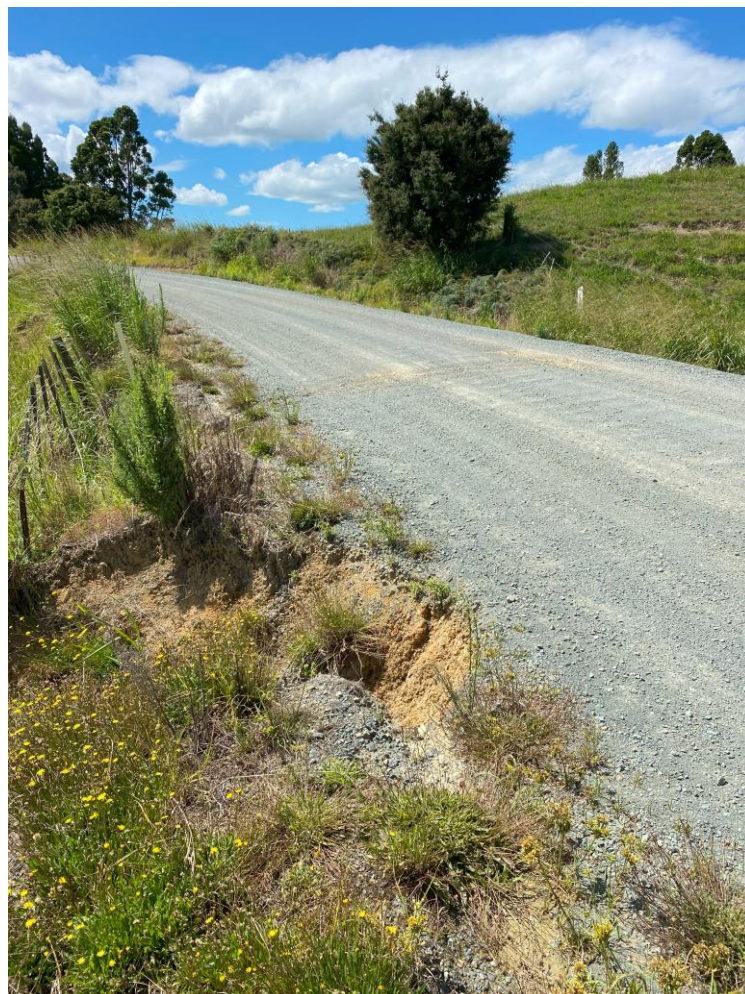
***Photo 5: Lawrence Road – lack of upstream water table maintenance scouring into dropout.***

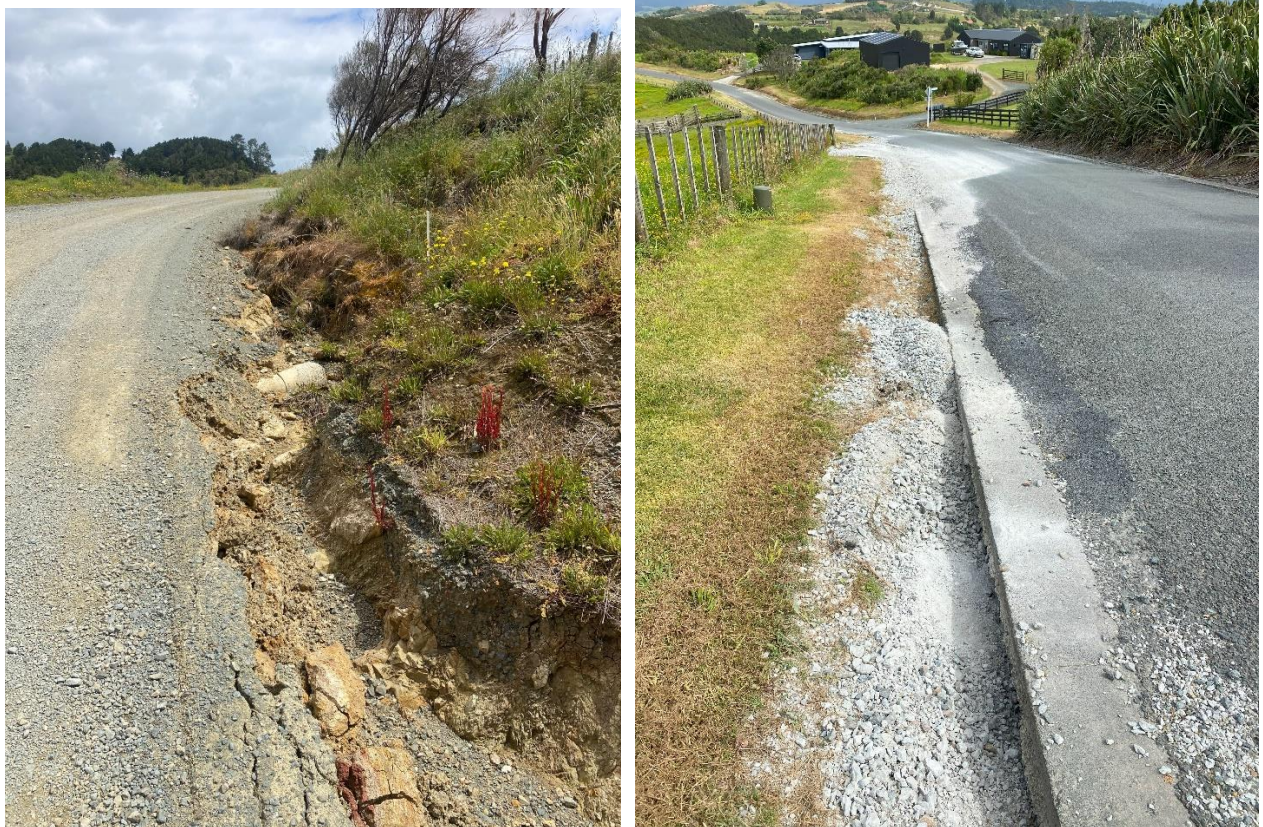
Multiple reasons were given as to why examples on Otioro Road by Kaiwaka could not be repaired, such as the grader would hook this gabion rock out when wide grading or budget isn't available. A subsequent site visit identified along the first 1km of road, the water table had been "grader infilled", however this loose clay material, as expected, washed down the waterway and blocked the culverts in subsequent heavy rain. Details have been sought on what the instruction to contractor was along with cost, and a similar case is evident in Cames Road. In response to a complaint lodged in May about the scour undermining the concrete dish-channel and sealed pavement, a contractor has infilled the scour with limestone in late 2023, which unsurprisingly subsequently washed out into a farm paddock. Refer Photograph 6 below.

**Photo 6: Watertable scouring** leading to pavement collapse. Right hand is Cames Road infilled with limestone.

It is recommended *Council agree to prioritise a programme of work to repair deeply scoured water tables to rebuild resilience in the unsealed network, by deferring part of the heavy metal overlays programme (Recommendation 2).*

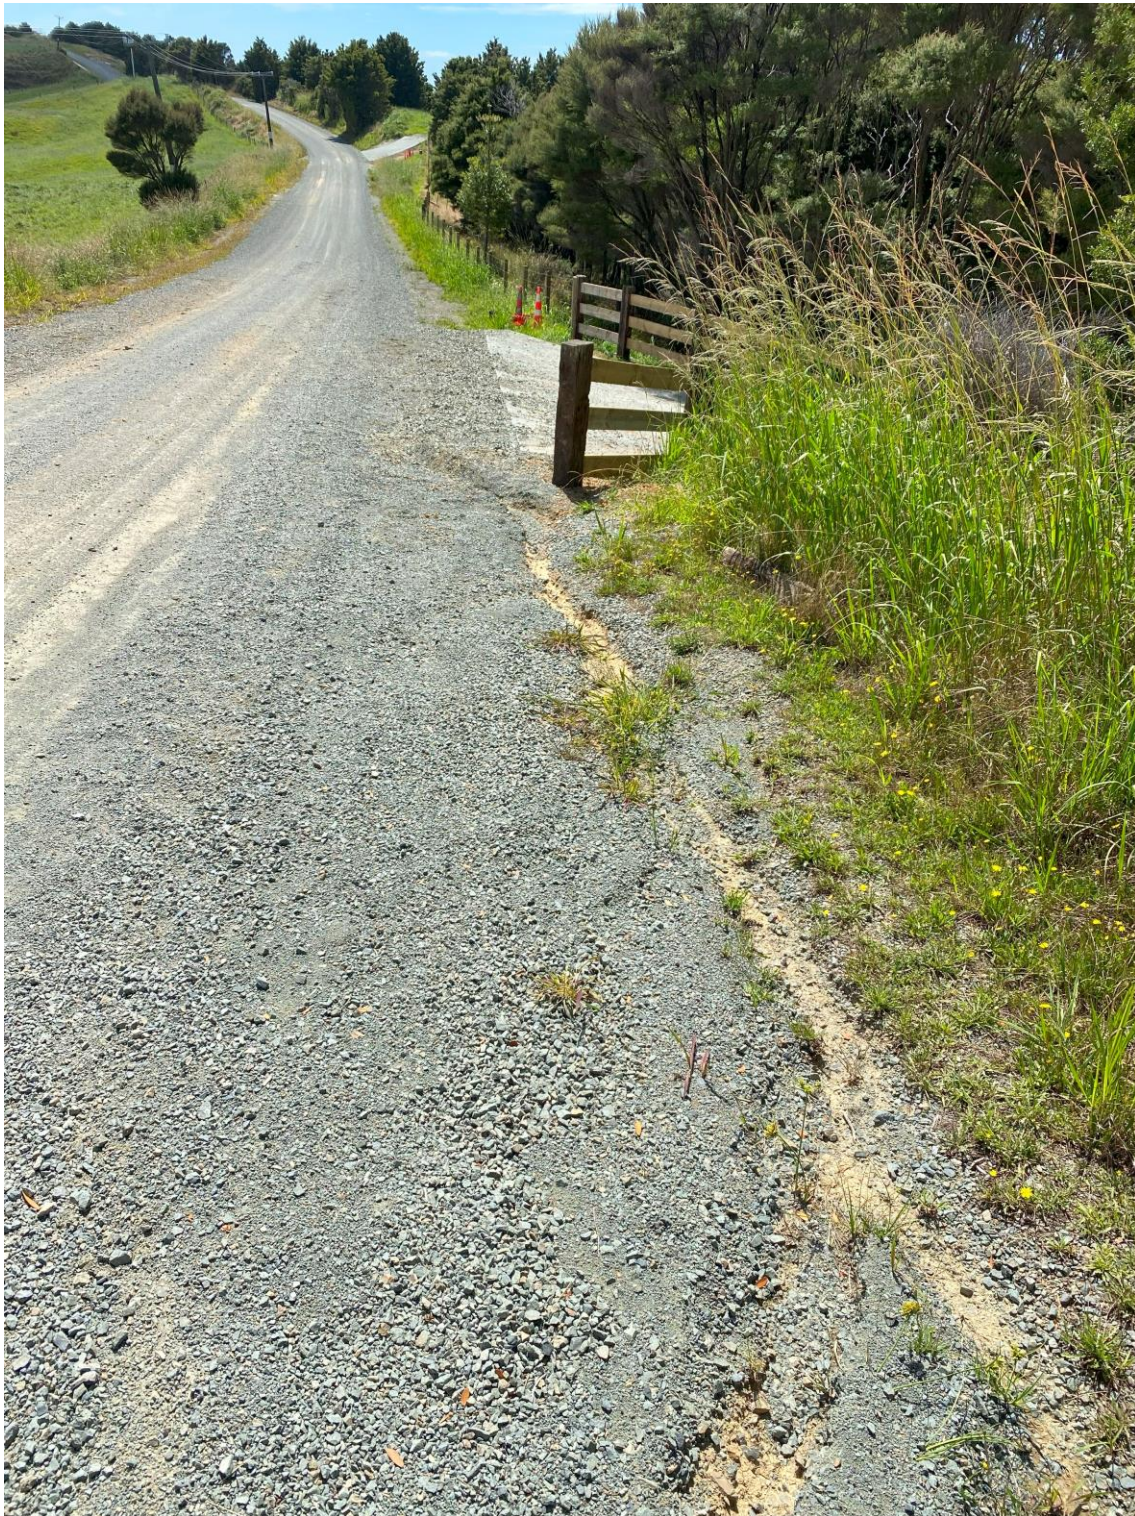
Multiple new concrete driveways such as on Pukehuia Road and Lawrence/Cames/Devich Roads have been installed without a maintainable stormwater path for the contractor. Already water is scouring across the concrete frontage, and the risk of a grader breaking these concrete aprons is high. Refer Photograph 7 below.

**Photograph 7: Lawrence Road where new driveways built but water scouring past.** This needs coordination between development engineers and asset maintenance teams as part of design/construction signoff.

It is recommended that Council *provide better guidance and requirements for new vehicle crossings to ensure the on-going maintenance needs for roadside drainage and pavements are low cost to ratepayers (Recommendation 3).*

Where the driveway is not at a level of deterioration that would enable Council to require the owner to rebuild as per Section 11.7 of Part 2 in the Council Consolidated Bylaw, but there is a lack of appropriate culverts (to effectively channel stormwater from the pavement) that is already causing significant road damage, it is recommended Council *require a 50% cost share with private landowners to remediate existing crossing/culverts that are creating significant scour in pavements up to \$6,000 per crossing (Recommendation 4).*

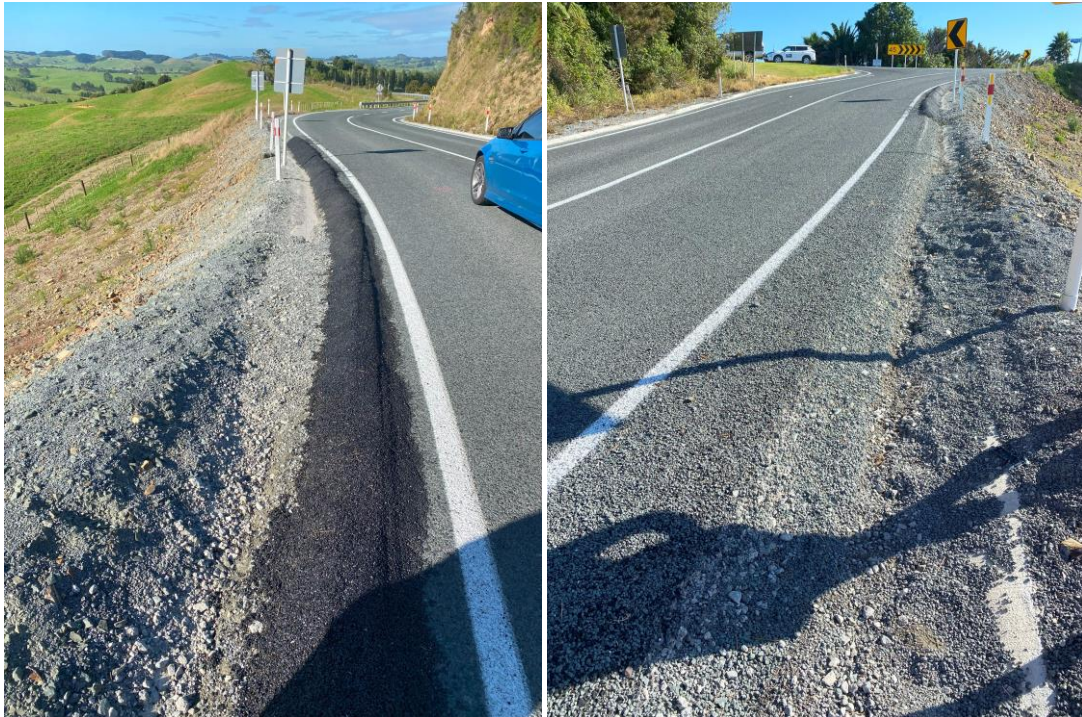
Photo 8 at Mangawhai-Kaiwaka Road by Hilltop Road is an example of the “design intent” for the road reinstatement being lost in communication between parties. Although the slip repair was deemed complete, the new concrete dish channel to transport stormwater across the slip, was infilled during pavement construction. This resulted in scour down the slip face by stormwater, and a subsequent visit has confirmed kerb and channel will need to be installed.

**Photograph 8: Mangawhai Road at Hilltop Road:** Slip repair had new concrete dish-channel installed, this has been then infilled by the pavement construction, allowing stormwater to overtop and scour the repaired slip face. Solution is a new kerb and channel. Consideration should also be given to a guardrail extension treatment due to steep land drop-off.

It is recommended that NTA address the stormwater remedies for Mangawhai Road (at Hilltop Road) slip repair and consider guardrail extension treatment due to steep drop off (Recommendation 6).

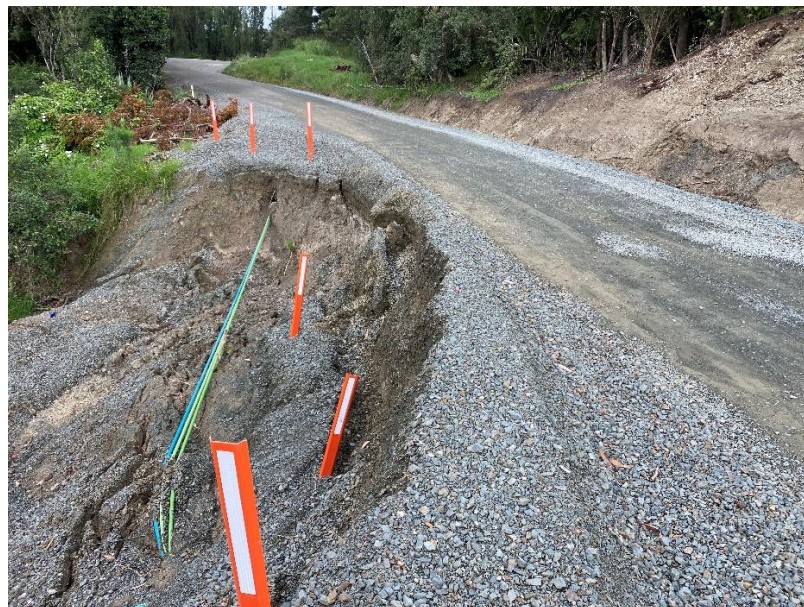
Photo 9 at Mountain Road shows a “retreat” constructed in the bank behind a major slip. The marker pegs below the road show this slip face still moving. It would be prudent to have regular surveys of these repairs to assess ground movement and determine whether remedial work to stabilise the toe of the slip is warranted.

**Photograph 9: Mountain Road slip repair:** Slip front still moving, creating tension on fibre optic, no Slip Intervention Strategy supplied from NTA advising what are the trigger points for intervention.

It is recommended that the NTA cross-check unrepaired underslips in RAMM for date of identification to see if they can be claimed as part of the Cyclone Gabrielle, and the Table of Slips is updated to include the above Slip Intervention Strategy (Recommendation 5).

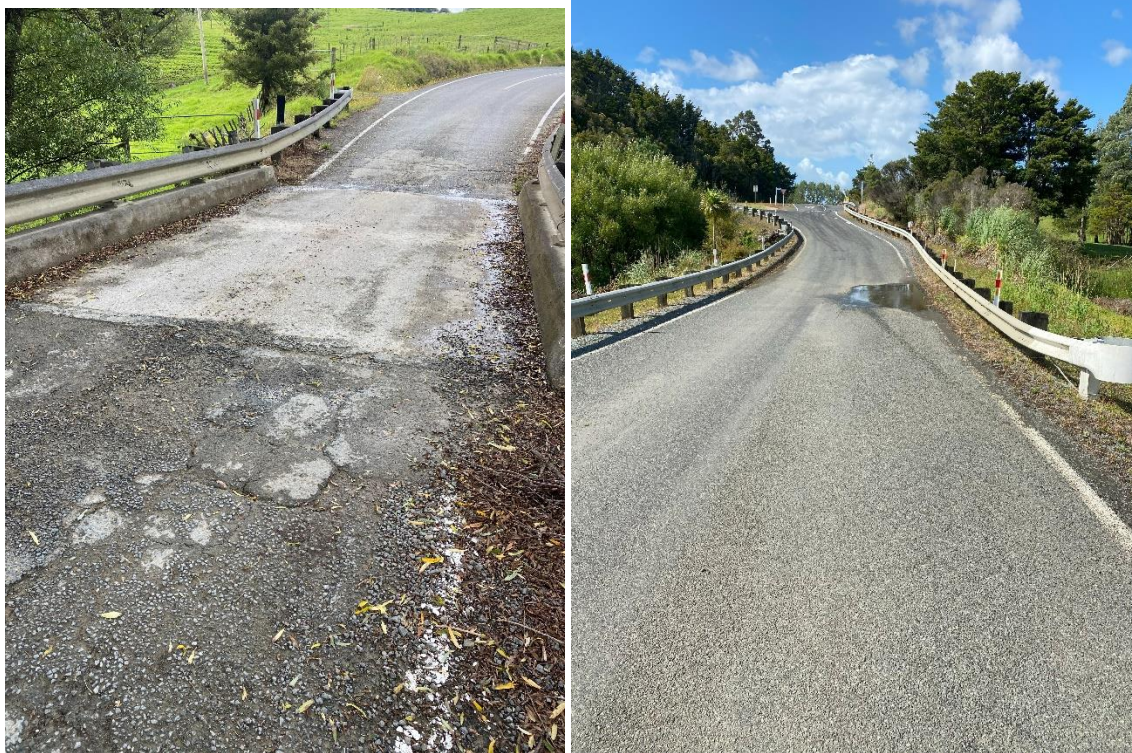
Examples pointed out in discussions with farmers as shown in Photographs 9 & 10 below on Paradise Valley, Tangowahine Valley/Murrays Road, Mountain Road suggest improving these will help Councils credibility with road users. Ventia as noted in their January 2024 report intending fixing the sunken approaches to the bridge at the Murrays Road/Tangowahine Valley Road intersection.

**Photograph 9: Mountain Road and Paradise Valley Road.** Single lane bridges with obvious defects that are low cost to remedy.

It is recommended Council *receive information on the level of defects that exist at the approaches to single lane bridges along with the cost to remediate so it can make an informed decision on priorities (Recommendation 7).*

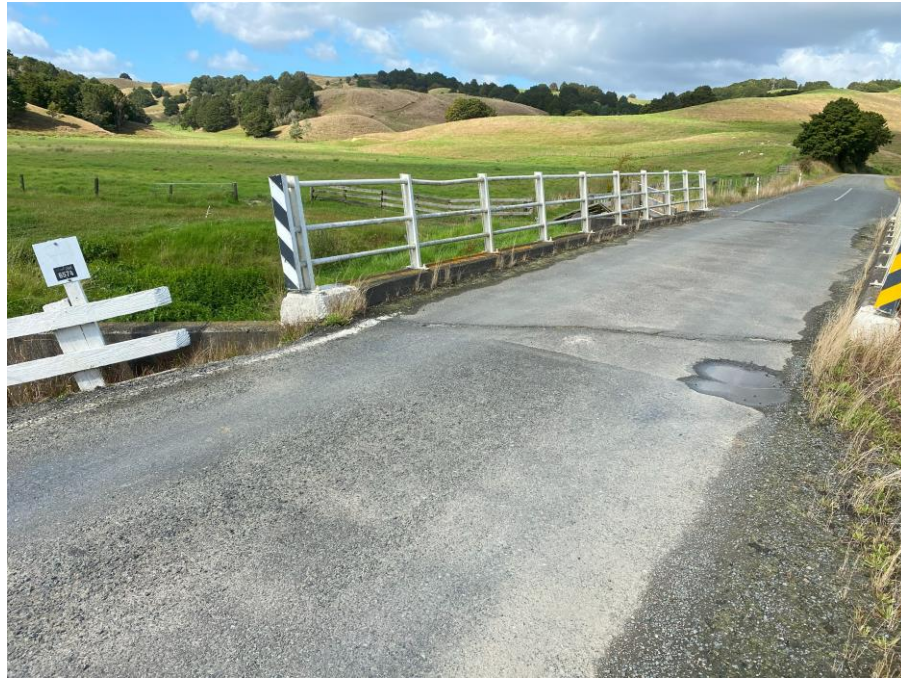
**Photograph 10: Single Lane Bridge Paradise Valley Road.** Slump and water ponding on approach.

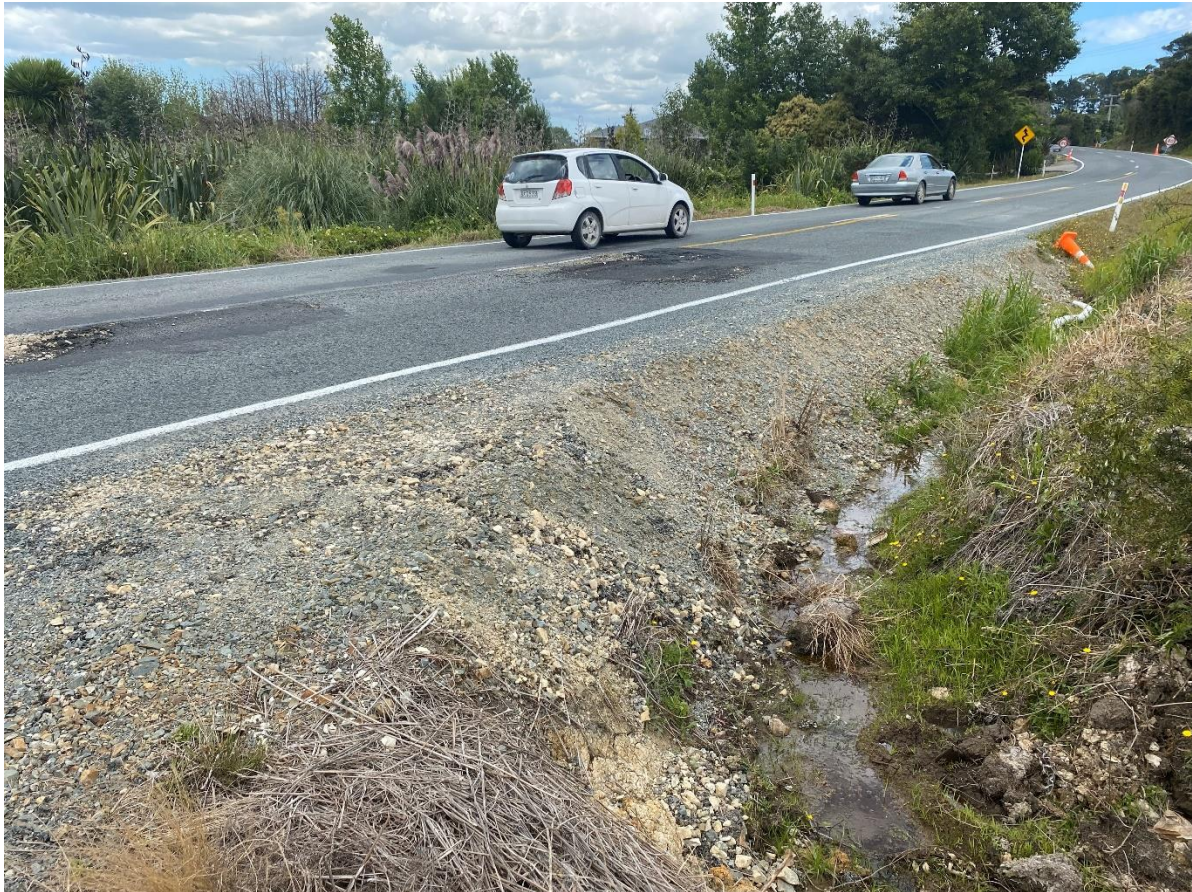
Reviews of digout or stabilised pavement failures such as Cove Road and Lawrence/Valley Roads indicate a period where there has been little “engineering” for solutions, as opposed to doing what has been done in the past. Information was sought from the NTA and Ventia to confirm the aggregates and proposed stabilised mixture are appropriate and will give the required pavement residual life. No lab testing results have been supplied that would show for example whether the percentage of lime or cement being added into the stabilised mix is optimal. No QA information was provided showing that checks occurred to verify the material has been well compacted into a mosaic before sealing. These are low-cost improvements and covered in recommendation 8 below.

**Photograph 11: Cove Road failure:** No pavement compaction QA results, no aggregate lab testing results, no as built confirming the location of positive drainage from digouts (potentially the white novaflow by cone)

It is recommended a Notice to Contractor (NTC) be issued noting improvements are also required in the supply and storage of Quality Assurance records for every pavement repair, including photographic evidence of as-builts, Inspection Test Plans (ITPs), check sheets, materials testing results, compaction, and positive drainage confirmation (Recommendation 8).
