Kai Iwi Lakes Security Review Kaipara District Council

September 2020

This report presents the findings of a security review requested by the Kaipara District Council (KDC) for Kai Iwi Lakes, Taharoa Domain, located 35kms north of Dargaville. An onsite assessment was conducted on 2nd September 2020 by Craig Bidois and Greg Bolton from Security Consultants, FearFree Ltd.

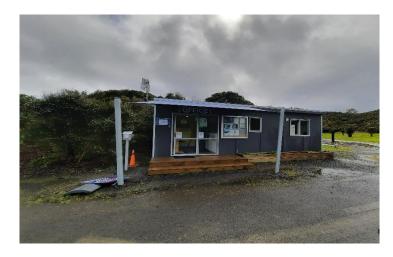
Pine Beach campground reception office

The reception office is well situated just inside the entrance to the Pine Beach camping ground area and consists of two rooms, a reception area and office connected by an internal door. There are 2 CCTV cameras attached to the exterior walls covering the front entrance area and side/rear of the building and another 2 cameras positioned inside the reception area.

The building is fitted with an internal sensor activated audio alarm system. Entry into the reception area consists of a ranch slider fitted with a standard lock.

The reception counter is 'L' shaped, 1100mm high although has no door/gate preventing unauthorised persons from walking around the counter to where a staff member usually sits.

Install dead locks to the internal and external office doors creating a safe haven for staff allowing time to retreat to and call for help.	
	Apply frosting to the reception and office windows to prevent someone observing cash handling as large amounts of cash can be received per day during peak season.	
	Bolt safe to floor.	
Risk	Inadequate internal physical security exposes staff to assault, aggressiveness/threatening behaviour, robbery and theft.

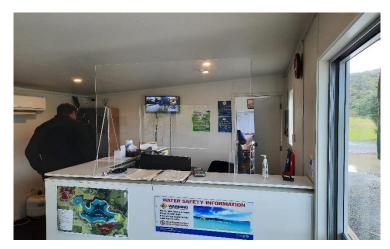
Reception area

The reception area counter is well positioned allowing staff to observe people and vehicles entering the camp area and people approaching/entering the reception area.

Currently there is no gate or door preventing anyone walking around the side of the counter to the staff area and office.

Although the counter is an adequate height, we recommend it is fixed to the counter to prevent it being used as a weapon or pushed onto staff with consideration of extending it along the counter.

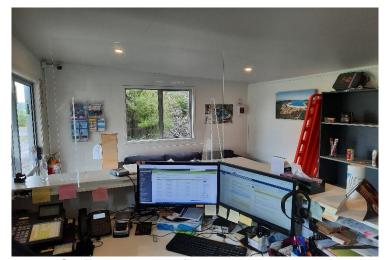
Staff desk space facing reception area

A cash register and computer are positioned on the desk with the staff member facing towards the entrance door with a good line of site towards the entry door and campground entrance.

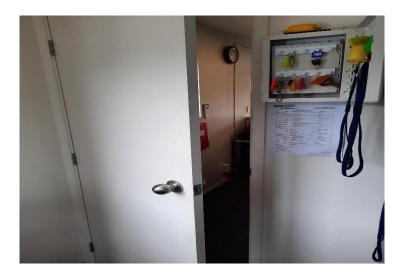
Internal office door

An internal door with no lock connecting the reception area with the office is located to the rear of the counter area. A staff-only office entry door is located off the side of the building and fitted with a standard manual key entry lock.

The internal door to the office area is ideally located behind the reception area allowing an escape route although currently has no lock.	
	The office would serve as an ideal safe haven for staff to retreat to incase of an aggressive/violent person.	
	The window located next to the reception desk and windows along with glass entry door allows a person outside to observe cash handling.	
	The CCTV system monitor is located on the wall in the reception providing a good visual deterrent while able to be observed by staff. The cameras have reasonable coverage although video digital footage can only be saved up to 7 days and the cameras can only be monitored from within the office and not remotely.	
Advice	Fix Perspex screen to counter to prevent it being pushed onto staff or used as a weapon.	
	Install a gate or door between the end of the counter and internal wall to slow down an attacker allowing time for staff to retreat to the office.

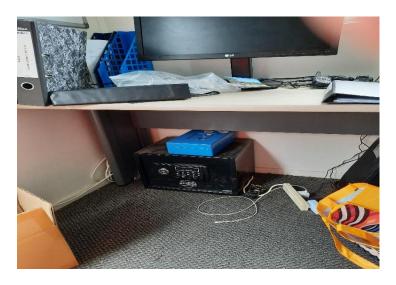
Office floor safe

A small floor safe is located under a desk in the office although is currently not bolted to the floor.
