Kaiwaka Domain Kauri Walk - Risk Assessment and Recommendations

For Kaipara District Council

June 2019

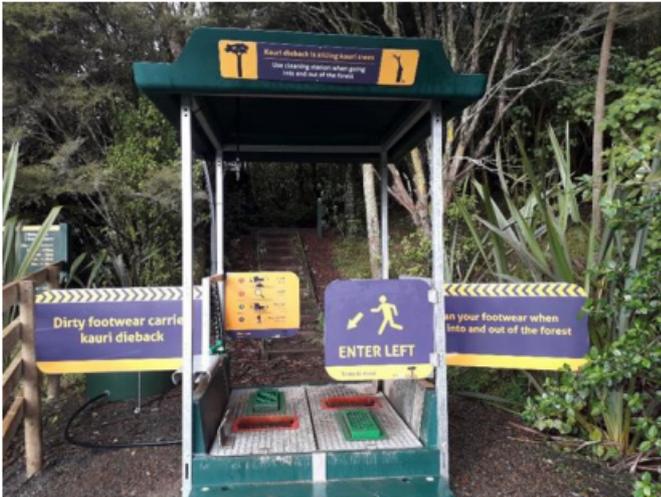
The Department of Conservation (DOC) have tested a number of products to determine which disinfectant can be used in the forest, which is not only effective against the pathogen but is also safe to use by the public and environmentally friendly. Although there are other products available that are likely to be more effective against the pathogen, sterigene was found to have a better all-round profile in terms of having less of an impact on the environment and is safe to use compared to other disinfectants tested.

Figure 1 - Photo showing example hygiene station at track entries with associated signage.

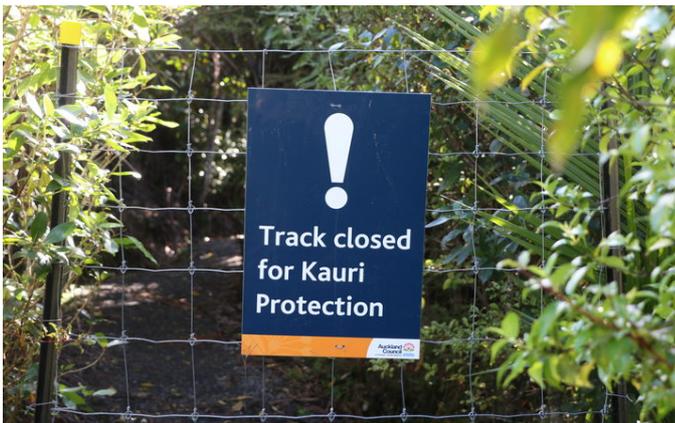
Figure 2 - Photo showing example of track closure signage and barrier.

This would involve closing a track and in this instance this would likely be a permanent closure until such time as the risk of PA is eliminated. The track would require fencing across entry points to prevent access and signage to explain the importance of the track closure. It is recommended that some planting could occur to assist with preventing people walking through the adjacent forest to get back onto the track and the track would be allowed to naturally regenerate with no maintenance to keep it accessible.

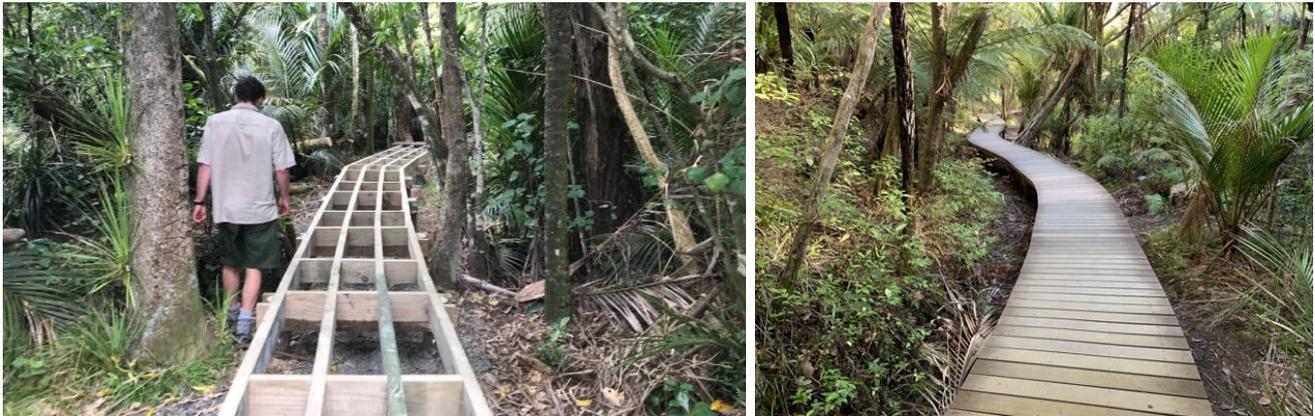
In some instances the installation of boardwalks to prevent direct access of walkers' shoes to kauri roots has been implemented. This response reduces risk but does not remove it as soil from shoes can still fall through the boardwalks and associated hygiene methods should be used.

Figure 3 - Photographs showing construction of and finished boardwalk at Kitekite Falls, Piha - design specifically for PA.

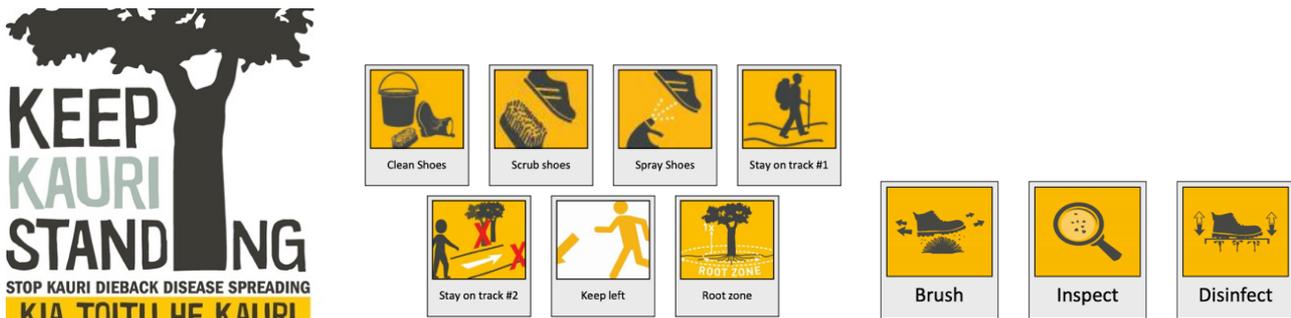
Figure 4 - Examples of signage for PA.

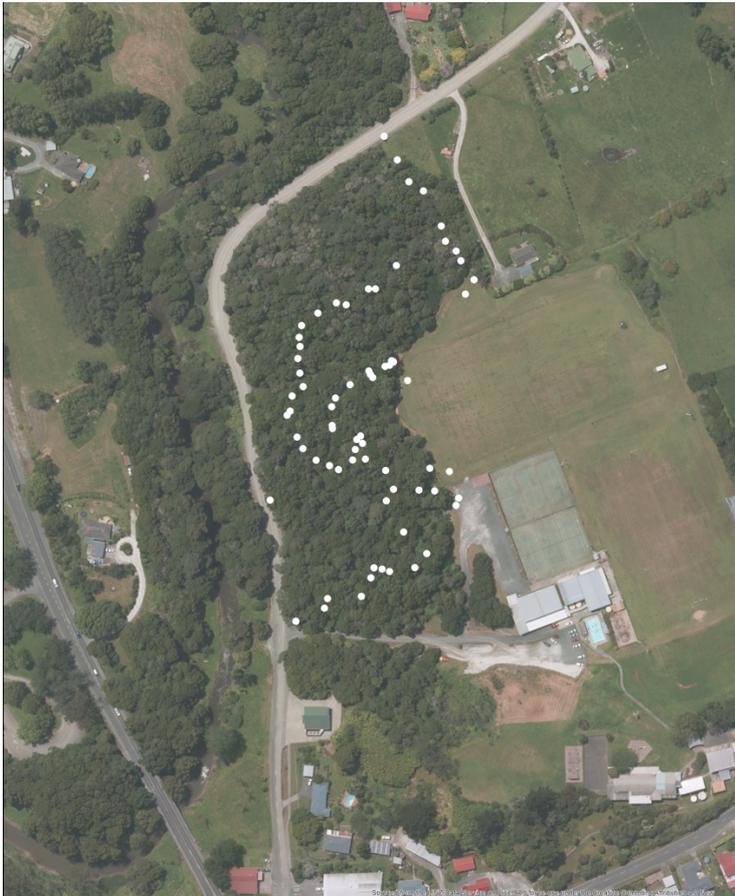
The site visit included GPS mapping of all the tracks and GPS location of the main kauri or stands of kauri along the tracks. In addition the current track alignment and condition was assessed. The site visit also mapped with GPS co-ordinates the possible relocation option/s for the track to avoid the kauri trees and/or identification of particular approaches to the track to mitigate potential kauri infection.

Figure 5 - Aerial photograph showing the GPS co-ordinates of track alignments and associated kauri tree locations. Refer to **Appendix C** for full numbered list.

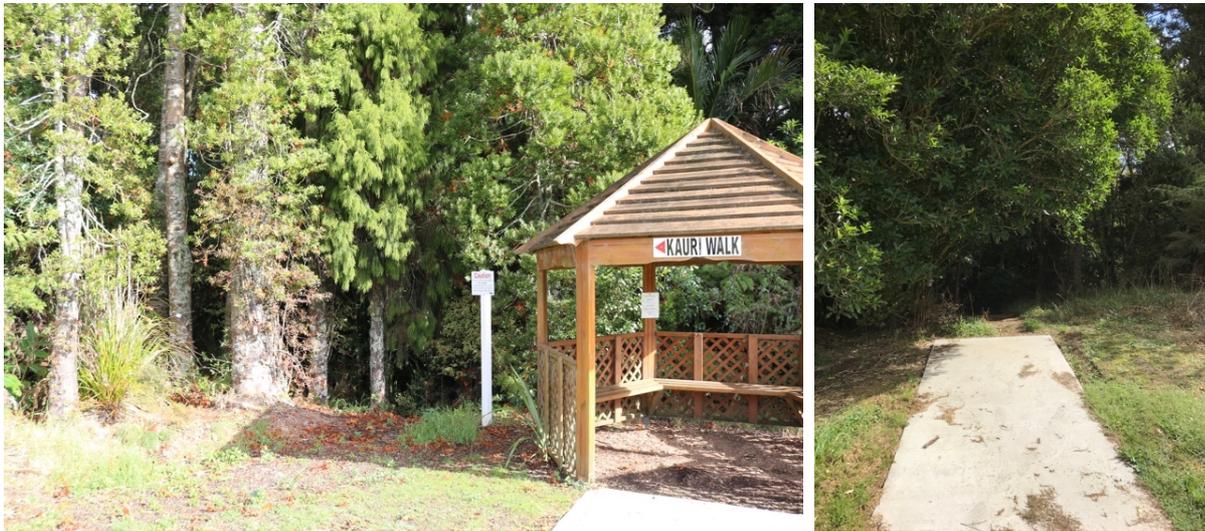
Figure 7 - Photos showing Kauri Walkway track and Gibbons Road track entries from the Domain.

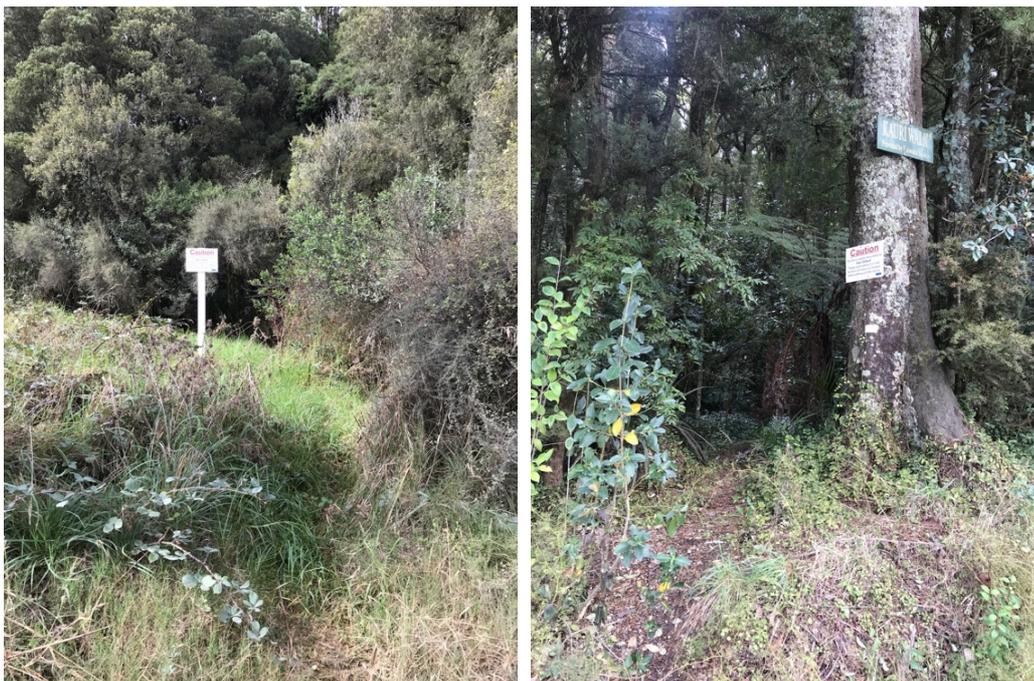
Figure 8 - Photos showing Gibbons road track and Scout track entries from Gibbons Road.

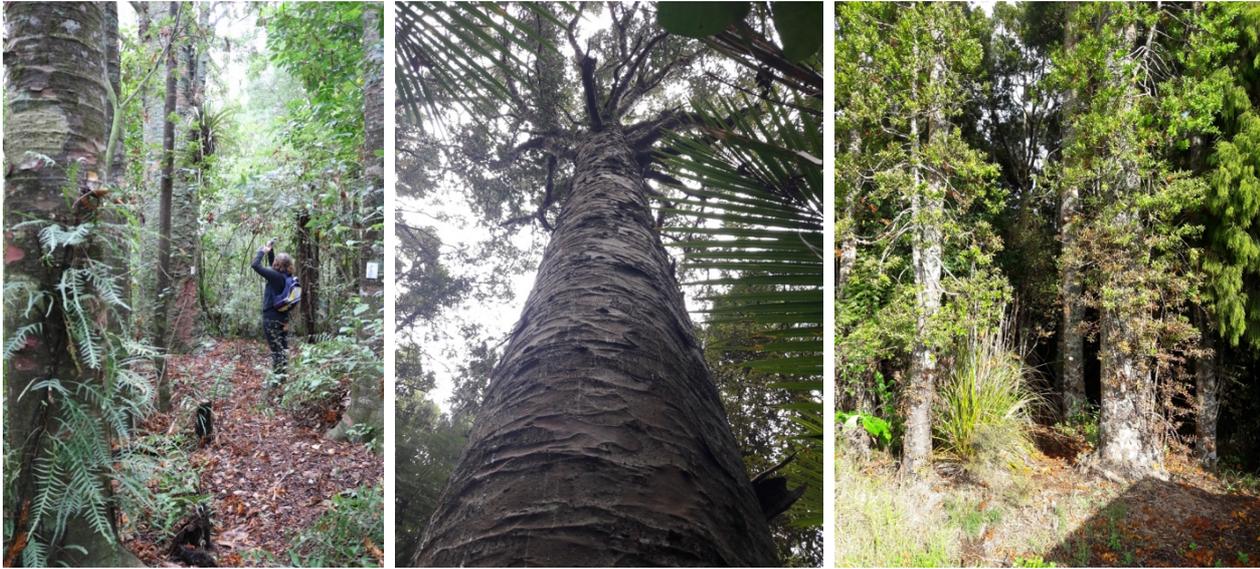
The kauri located within the forest of the Domain range in age from small rickers through to relatively mature trees. Seedlings and saplings are abundant. There are well-established native forest surrounds the walking tracks.

Figure 10 - Photos showing range of kauri sizes within the Domain forest.

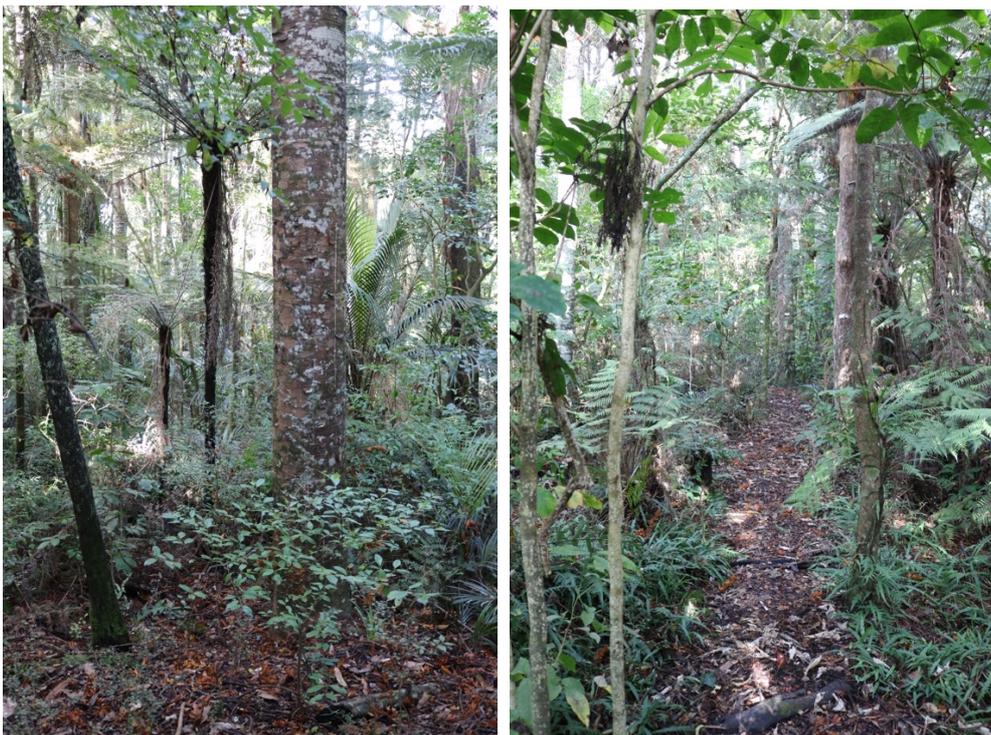
Groundcover species included a range of fern species, kie kie (*Freycinetia banksia*) and *Coprosma* species.

Figure 11 - Photographs showing general understorey vegetation within forest area of the Domain.

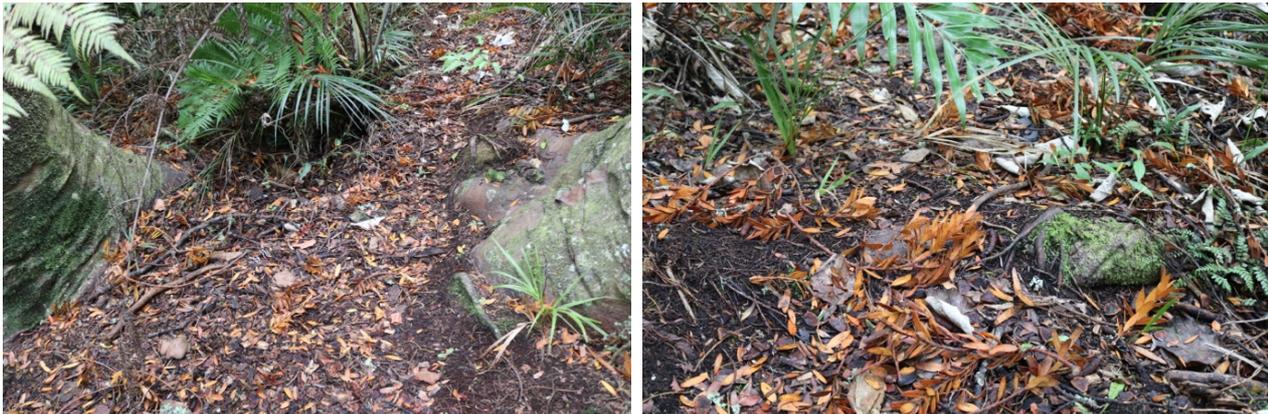
1. **Kauri root exposure** – in a number of locations the roots of kauri were visibly exposed within the track.

Figure 12 - Photos showing fine surface roots of kauri exposed within track alignment.

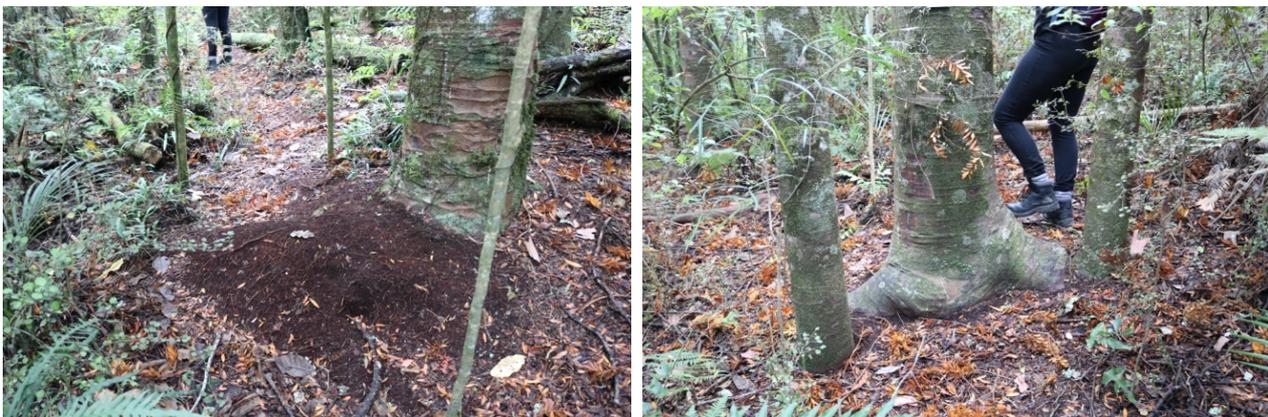
Figure 13 - Photos from Main kauri walk track showing exposed kauri roots and proximity of track.

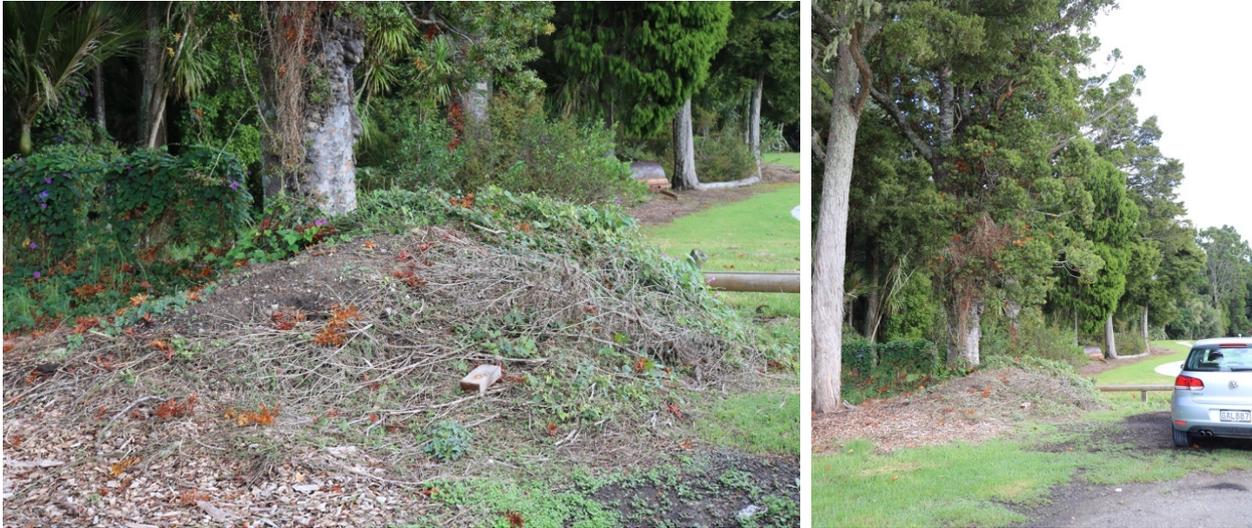
2. **Operational issues** - for kauri on the edge of the forest at the carpark. There are some isolated kauri that sit out from the forest edge and these have had rubbish piled up over their root zones with weed infestation and are in direct access of damage.

Figure 14 - Photos showing large kauri by carpark and mound of weed and rubbish laid over kauri root zone.

This would involve some post and rail fencing to be put in place in order to prevent public and dogs accessing key kauri that are located outside or at the edge of the forest area. This fencing could incorporate educational signage and would include appropriate underplanting to further assist in protection of the kauri specimens.

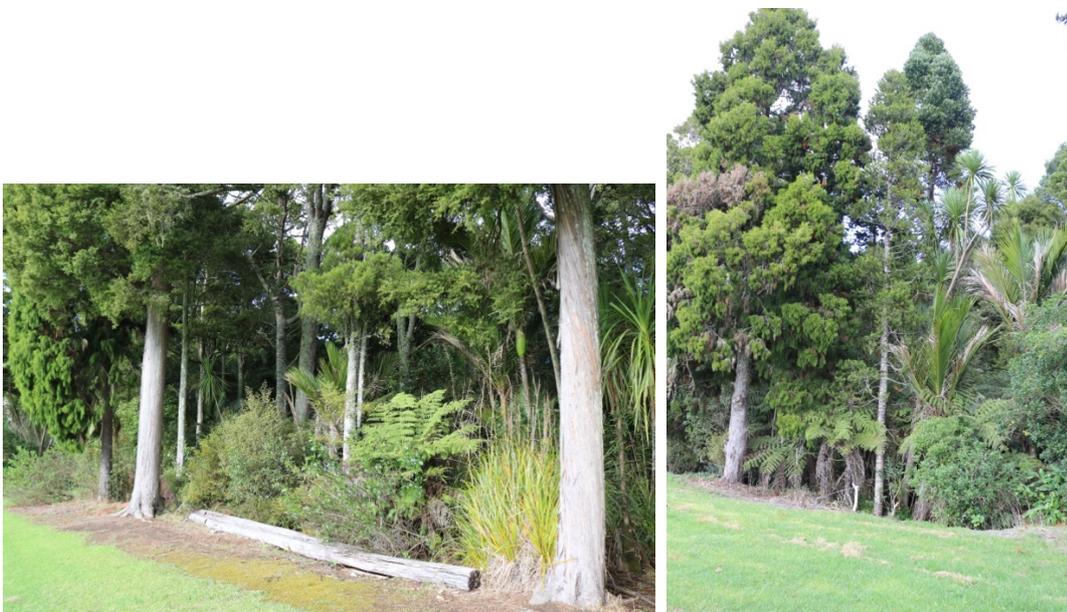
3. **Forest edge** – along the eastern edge of the forest area adjacent to the Domain sports field there are a number of kauri located at the forest edge with no buffer between mowing activity and with direct access from people using the sports fields. This edge also has some weed invasion.

Figure 15 - Photos showing edge condition of forest and kauri exposed to mowing and with direct access from fields.

Planting of a dense native buffer edge to the forest area to create a distance between public and operational activity within the Domain and the sensitive forest edge.

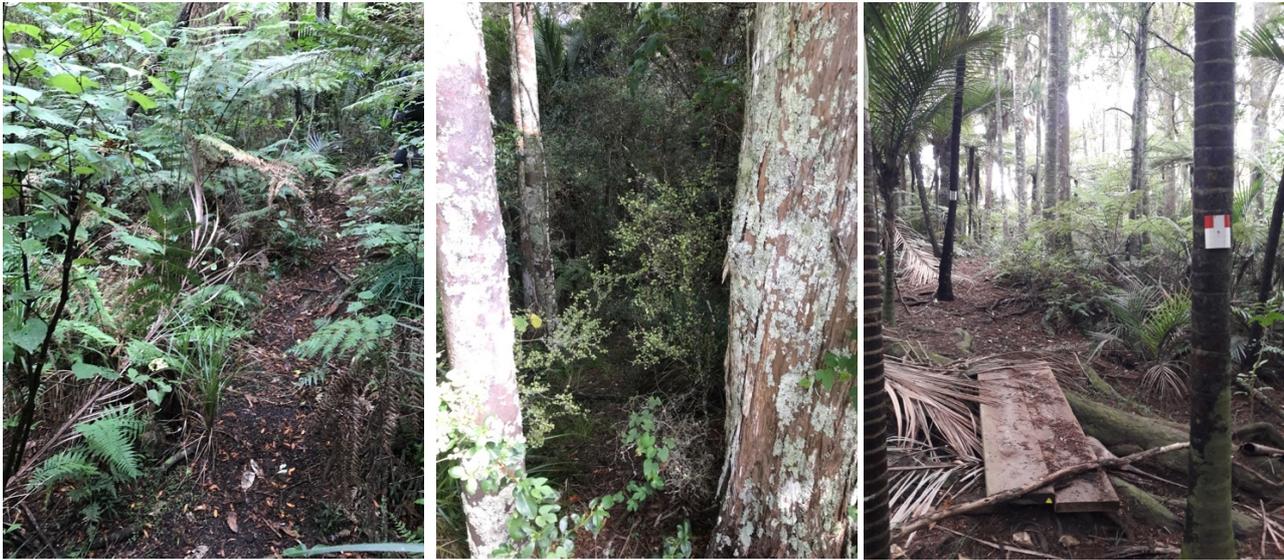
Scout track is accessed off the Main Kauri Walk track from the Domain and has an entrance at the Gibbons Road end of the main driveway entry to the Domain. The track is a forest experience short-cut up through to the Domain sports field area. This track has fewer kauri specimens within proximity to the track, with two key areas of kauri located close to the track along its length. As such this track has a lower risk than the Main Kauri Walk track in relation to potential effects on the kauri from walkers. The two sections where kauri are in close proximity to the track would be able to have short sections of boardwalks installed to reduce the risk to kauri roots. These sections would each be approximately 20m – 25m in length. The northern end of the Scout track links in with the existing Main Kauri Walk track and at this point kauri trees become more frequent. There is an existing informal track entry from the sports field down to Scout track that has no kauri on it and this offers potential to be developed as an alternative entry/exit point for Scout track.

Figure 17 - Photos showing examples of Scout track and vegetation with possible new entry in right hand photo.

One small relocation of entry point for Scout track was identified.

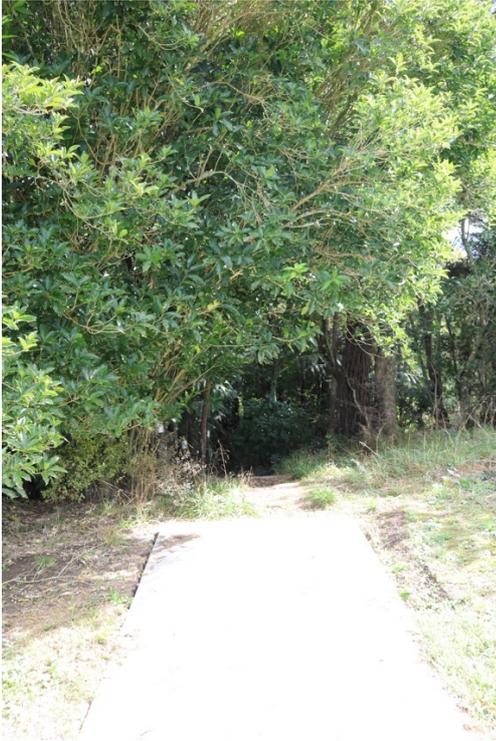
This is a track that connects the Domain to the northern end of the Main Kauri Walk track and then connects to Gibbons track. It is used by dog-walkers and walkers and runners as a connection through to Gibbons Road. This section of track does not have any kauri in close proximity to the track. Users might take a short cut through Scout track across the sports fields and connect to this track to get back to further north along Gibbons Road.

Figure 18 - Photo showing entry to Domain track from concrete path and sports-field area.

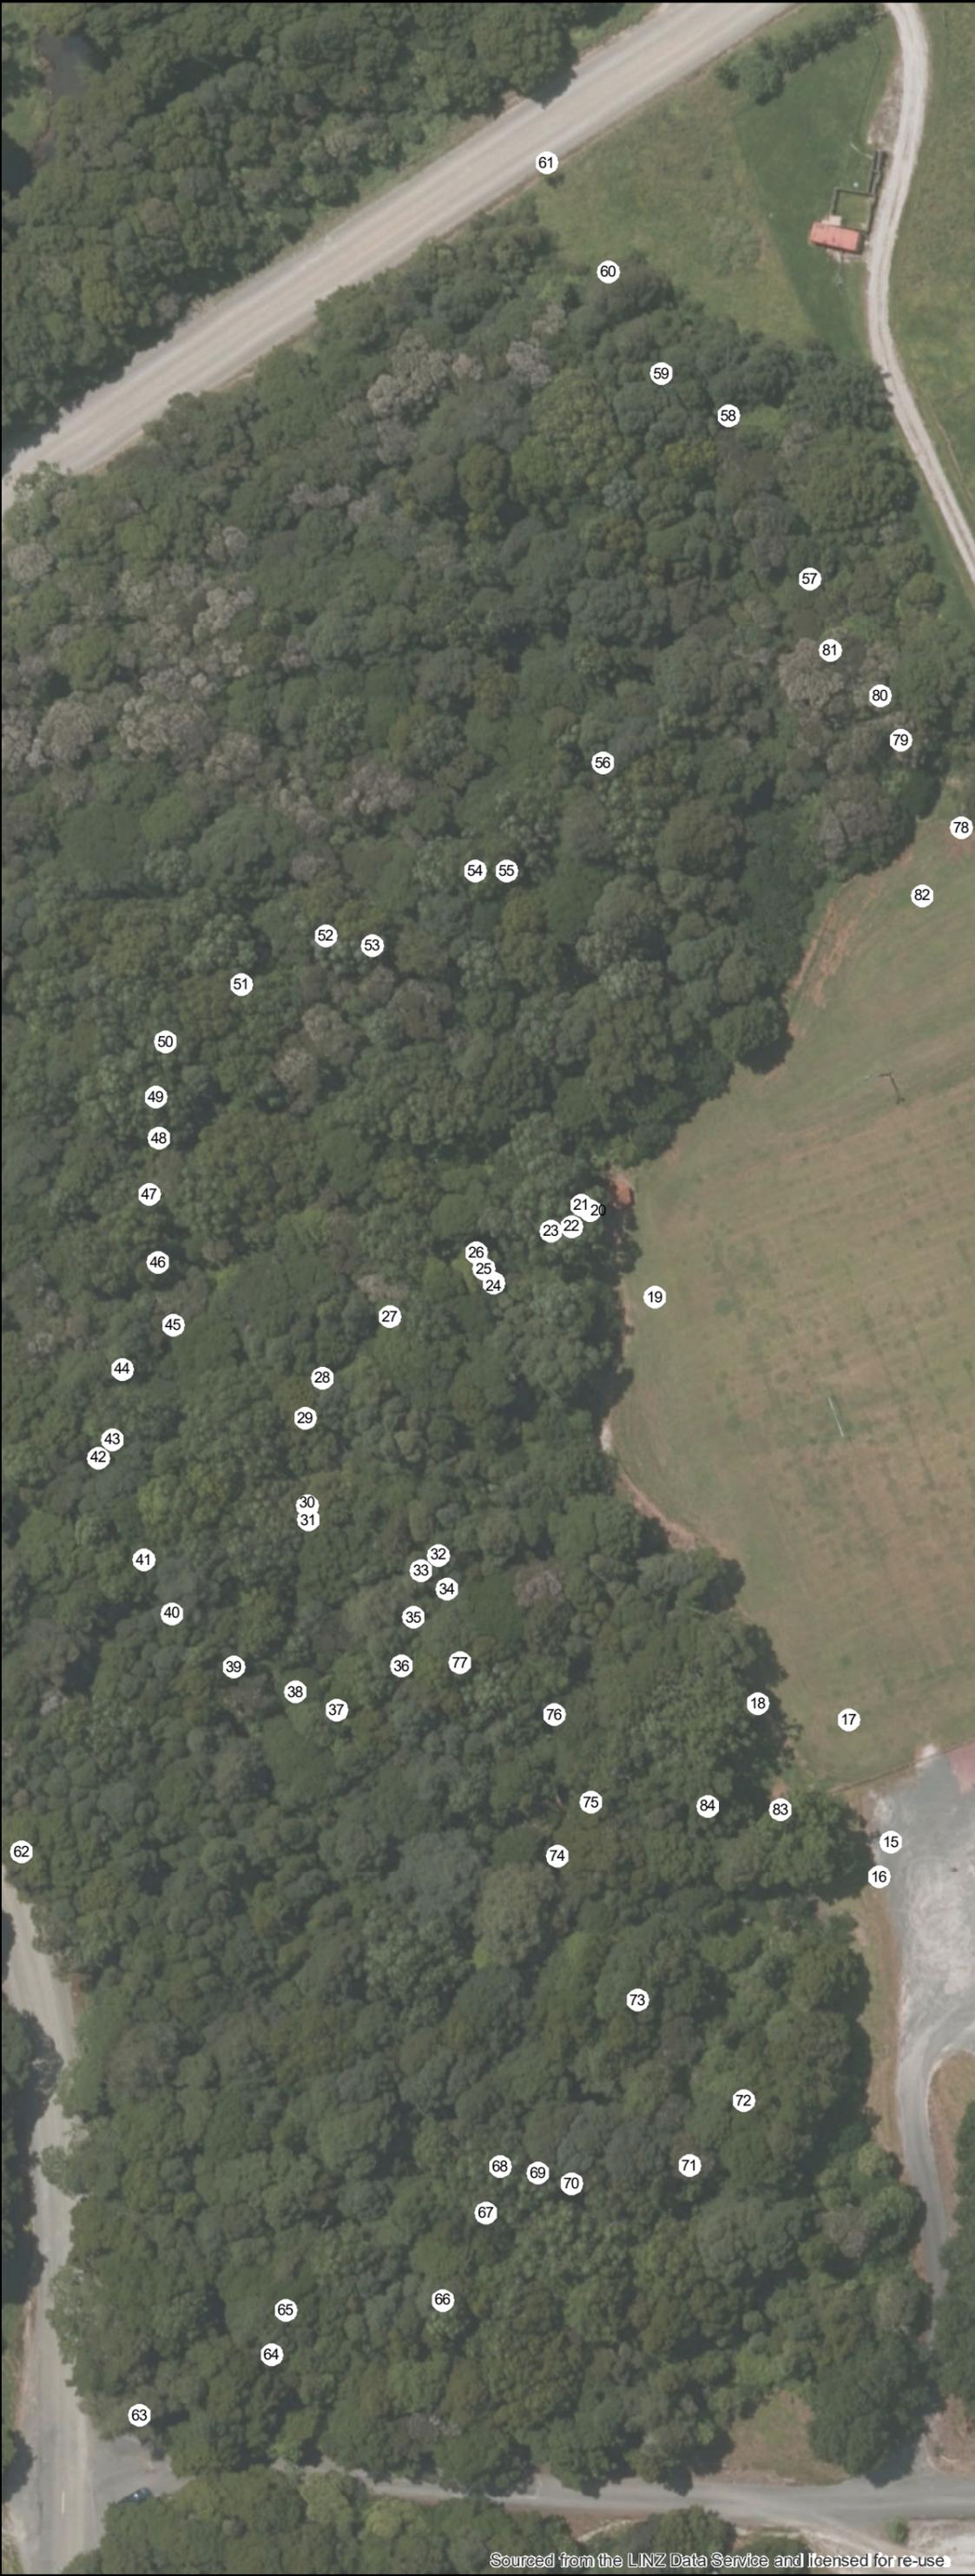
GPS Co-ordinates and Descriptions

- 15-Kauri 1 by car park and outside of main bush area
- 16-Kauri 2 ricker on edge of bush
- 17-Large kauri 3 at edge by concrete path
- 18-Kauri 4 by concrete path

- 19-View from concrete path to entry of kauri walk
- 20-Kauri 5
- 21-Kauri 6
- 22-Kauri 7
- 23-Kauri 8
- 24-Path with no kauri on edge
- 25-View from path to kauri approx 6m from path
