Report on Baylys Beach storm events

Meeting: Kaipara District Council
Date of meeting: 24 November 2021
Reporting officer: Sue Davidson, GM Sustainable Growth & Investment
Bernard Peterson, Maintenance Lead
Katy Simon, Climate Change Advisor
David Usmar, Infrastructure Officer

To update Council on the impact of the number of storm events over September and October at Baylys Beach.

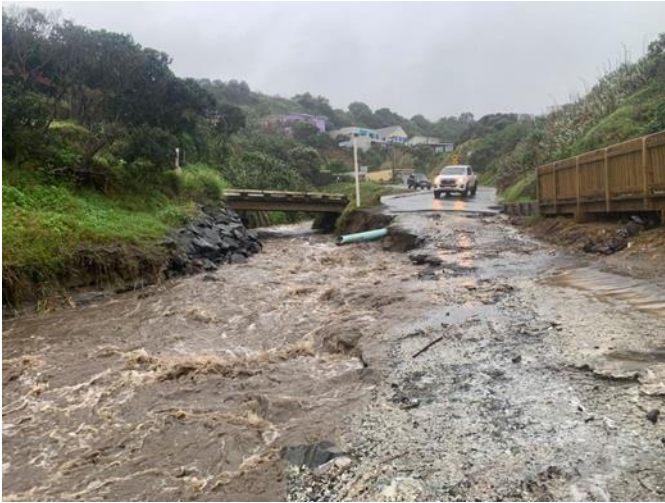
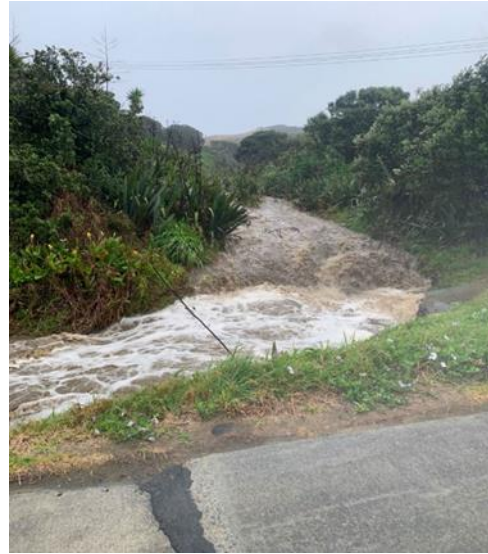
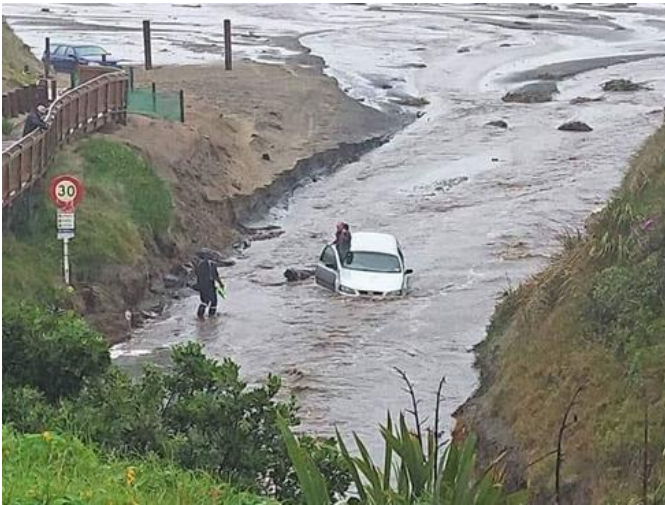
Baylys Beach has in the past had a number of storms that have affected both Council and private property. Most recently, one in mid-September and again in early October. In October, an extreme rain event in Baylys Beach, followed by immediate periods of further wet weather, saw significant damage wrought on the beach access at the bottom of the Baylys Beach catchment. This included major erosion to the stream and the resulting exposure of several retaining structures. The footpath was also damaged, as was the road leading to the beach access.

Images show damage at Baylys Beach due to heavy rain in October

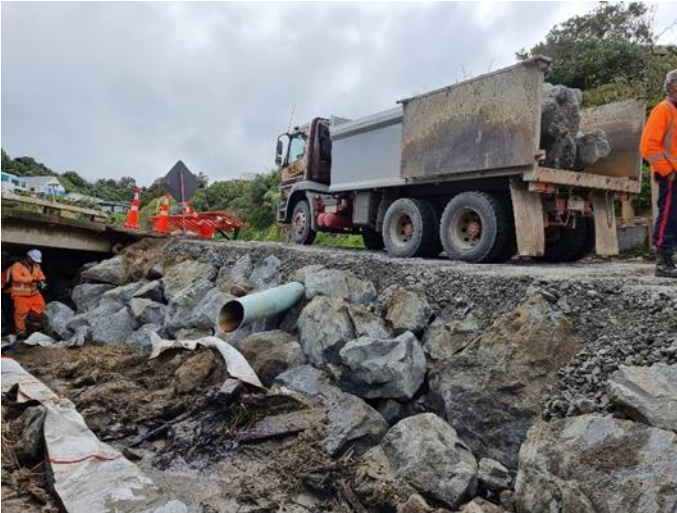
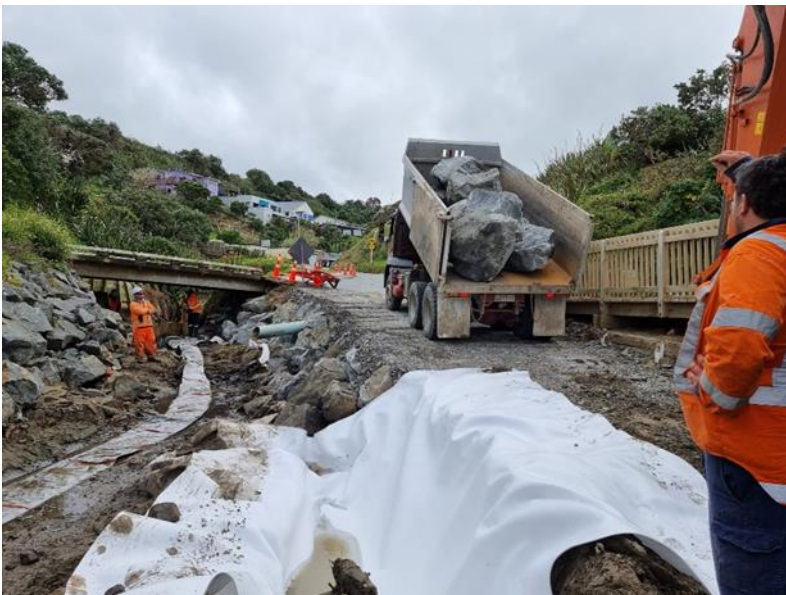
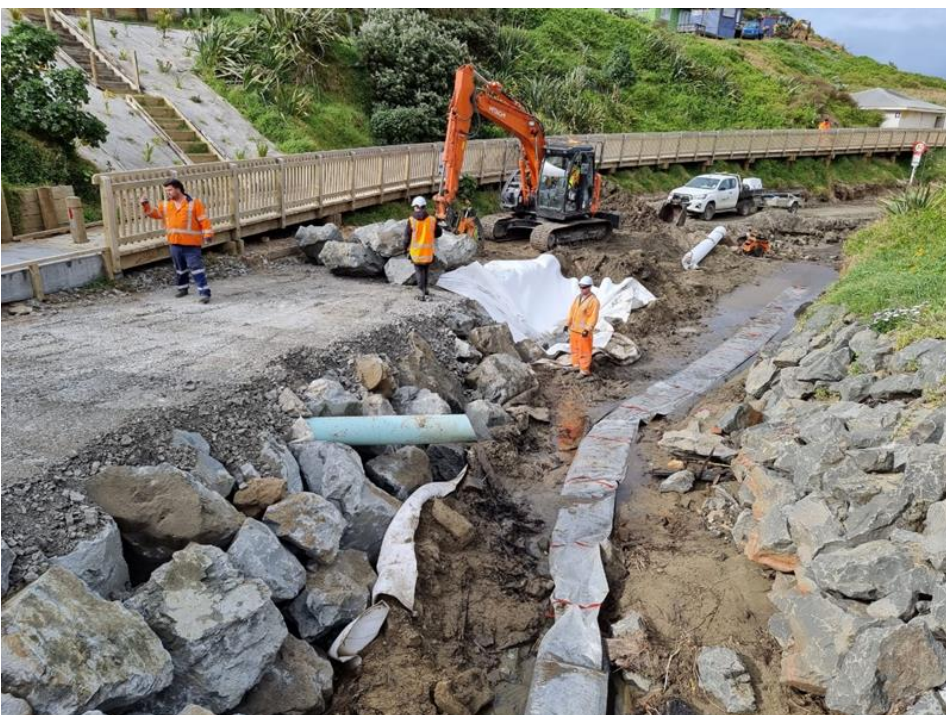
Images show repairs being undertaken at Bayllys Beach after October heavy rain event

On the 8th October engineers assessed the site and their initial report gave our maintenance team some immediate remedial options to implement. This includes installing rock spalls at the entrance, along the edge of the stream alignment. Contractors will then backfill the area with compacted limerock. Limerock is cohesive and will provide better resistance to any future weather impacts in the short to medium term.

The localised weather event in early October, caused more significant damages to the beach entrance than has been seen in recent years, lowering the overall level of the entranceway up to 1m in places. The immediate transition point from the end of Sea View Road onto the beach would not be able to be recovered through grading activity alone. Upon urgent investigation by WSP, on behalf of Council an immediate short to medium term solution was provided, to rock spall the southern stream alignment and backfill with compacted granular fill. Lime rock has been chosen for use as backfill material due to having a higher cohesion value and being a naturally sourced

material found within the west coast environment. Due to the urgency to reopen the access, works were undertaken under 'Section 330 – Emergency works and power to take preventive or remedial action, of the Resource Management Act 1991.' The recovery of sand as outlined, per standard routine grading practises can then be carried out upon completion to allow the reopening of the entrance.
