# Kai Iwi Lakes Security Review

## Kaipara District Council

**September 2020**

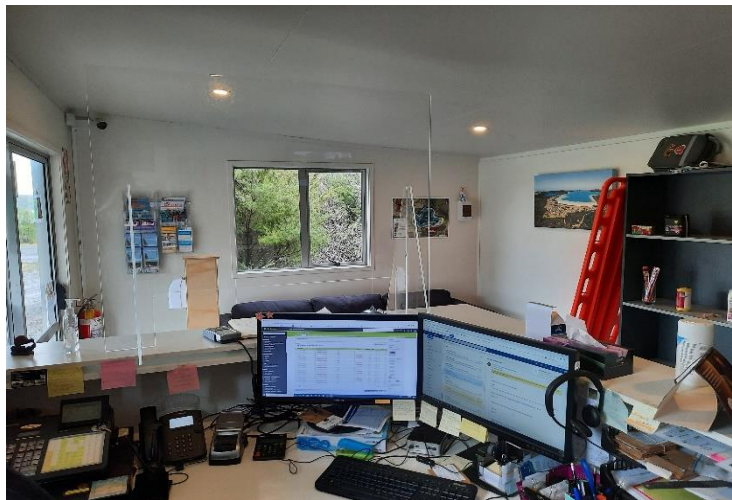
Staff desk space facing reception area

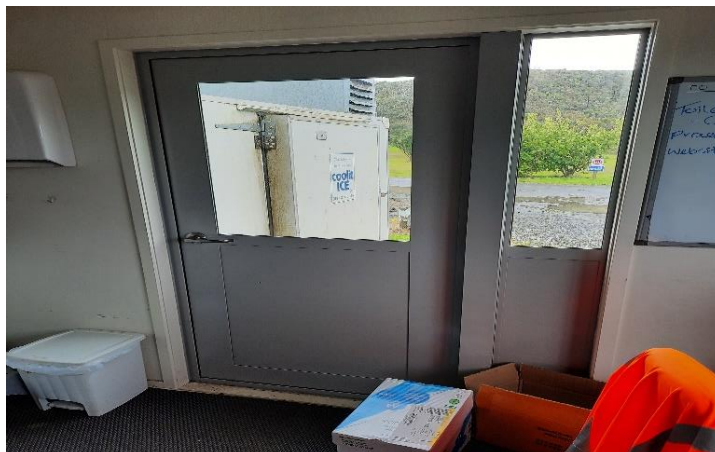
Rear office door

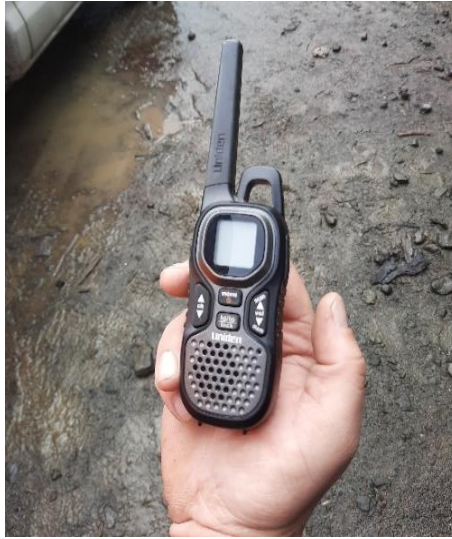
## Communications

| <b>Findings</b> | <p>There is unreliable or no cell phone coverage in areas of Taharoa Domain although Vodafone has better coverage than other providers.</p> <p>The current handheld radios only have basic line-of-site capabilities and are unreliable in bad weather or if obstructed by topography, trees and distance.</p> | <b>HIGH</b> |

| <b>Advice</b> | <p>Upgrade handheld radios to a VHF or similar system to improve reliability.</p> <p>All staff working in the Domain should be equipped with an upgraded radio.</p> | |

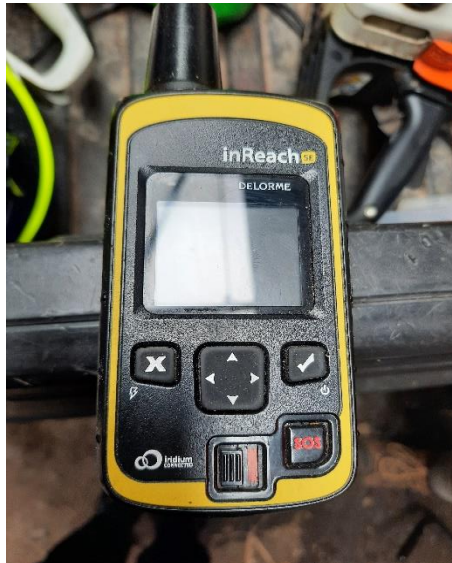
## Personal duress alert system

| <b>Findings</b> | <p>Due to limited cell network coverage, personal duress pendants are not suitable for staff use within the Taharoa Domain. The currently used GPS-Iridium based device with SOS function is deemed adequate and regularly successfully tested according to staff.</p> <p>The Parks Officers vehicle is fitted with a fleet management system duress alarm.</p> | <b>HIGH</b> |

| <b>Advice</b> | <p>Formalise guidelines on operational use, SOS/emergency activation and response, regular testing and limitations (GPS based systems do not work inside buildings or under thick tree foliage)</p> <p>Staff advised to keep the device with them at all times.</p> <p>Consider upgrading current devices to include more advanced communication capabilities including messaging.</p> | |

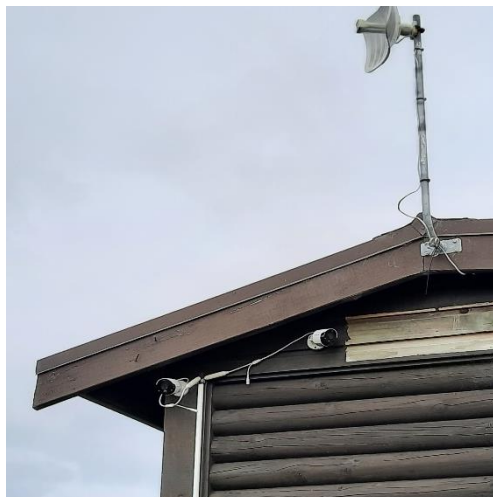
Arlo CCTV system (2 cameras only)

| <p><b>Findings</b></p> | <p>There are currently 14 CCTV cameras operating in the Domain although they are not connected by a common system.</p> <p>2 cameras are positioned inside the Pine Beach camp office reception area, 2 cover the exterior areas of the building including the entry area into the camping ground.</p> <p>1 solar powered camera covers the area in front of the Parks Officers utility shed with another solar powered camera covering the main entry into the Domain although only the Parks Officer can monitor the camera remotely on his smart phone with live imagery prone to freezing.</p> <p>Another 4 cameras cover the Promenade Point camping ground office including the building exterior and immediate surrounds.</p> <p>The final 4 cameras cover the exterior surrounds of the education building on the western shore of Lake Waikare although cameras are not set up to be monitored remotely.</p> <p>The hard drive for the CCTV is located under the reception office desk.</p> | <p><b>MEDIUM</b></p> |

| <p><b>Advice</b></p> | <p>Upgrade CCTV as the current system has noticeable limitations.</p> <p>CCTV should cover all areas of risk and entry/exit points. The quality should be confirmed to ensure that people are recognisable in all light conditions that will be present.</p> <p>An updated system should provide the ability for key staff and KDC Operations to monitor cameras remotely with motion activation capability.</p> <p>Footage should be kept for 30 days rather than the current 7-day capacity in case of enquires and investigations. This may also include COVID related investigations where a person/s movement and activity require verification.</p> <p>Due to reported incidents of vehicles being broken into with valuables been taken, advised to install 2 extra cameras covering the toilet block area on Kai Iwi Lakes road to detect/deter car break-ins, willful damage and disorderly related incidents. CCTV signage should also be in place.</p> | |

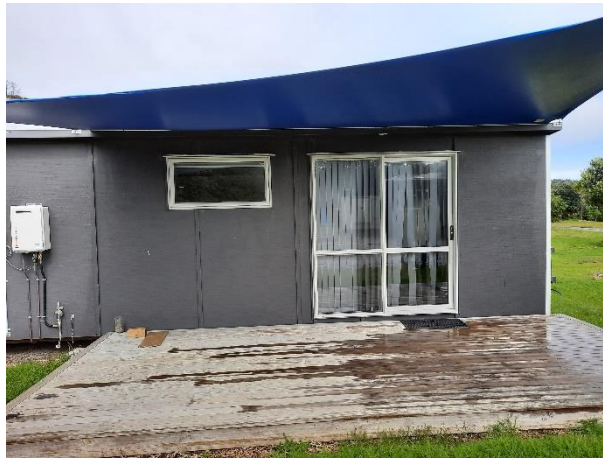
## Pine Beach camping ground staff accommodation

| <b>Findings</b> | <p>The Pine Beach camping ground staff accommodation is a prefab building consisting of a small living area with kitchenette and bedroom is located adjacent to the reception office.</p> <p>The building is primarily used to accommodate extra staff who are on duty during nighttime through the peak season.</p> <p>The building does not contain a television or other assets that maybe attractive to would be thieves and has a single-entry door with standard door lock.</p> | <b>LOW</b> |

| <b>Advice</b> | <p>We have no significant safety and security related concerns for this building although occupants should be reminded to keep the door locked if away, even for short periods.</p> <p>Windows should only be left open if fitted with security catches to prevent unlawful entry.</p> | |

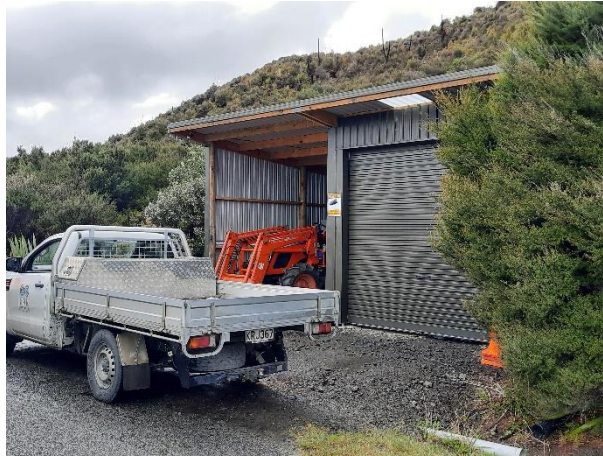
## Parks Officer Utility Shed

| <b>Findings</b> | <p>Parks Officer utility/maintenance shed located close to Pine Beach on the main entry road into the Domain. The shed is comprised of an open garage housing a tractor and an enclosed garage housing a range of equipment and off-road vehicle.</p> <p>The keys for the tractor and off-road vehicle are not kept on site and the entry door and garage door are fitted with standard locks.</p> <p>The area in front of the shed is covered by 2 CCTV cameras which are monitored by the Parks Officer via an App on his smart phone.</p> | <b>LOW</b> |

| <b>Advice</b> | Install dead locks on the entry and garage door to deter unlawful entry and theft. | |

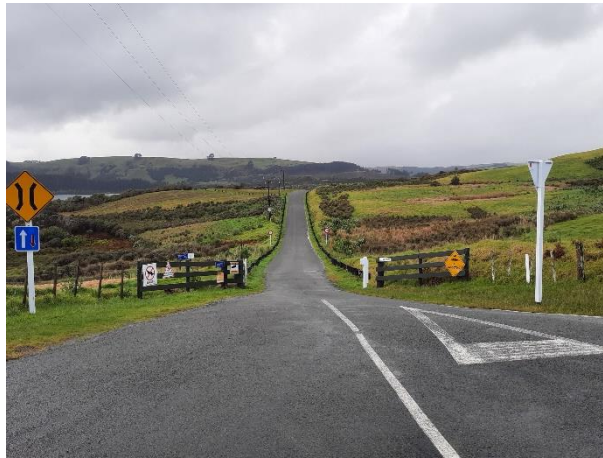
## Access Control – Main Entrance

| <p><b>Findings</b></p> | <p>Domain Road, off Kai Iwi Lakes Road, is the main entry into Taharoa Domain and leads to the Pine Beach Camping ground located approximately 2kms from the main road.</p> <p>The entrance has two metal gates that are manually closed together and padlocked from 21:30hrs until 07:00hrs during peak season although is left open during the off season.</p> <p>The entrance is covered by a single CCTV camera with signs advising of CCTV, no dogs and no hunting-shooting present.</p> <p>Parks Officer informed that local people expect to have access to the Domain 24/7 in the off season and when the gates have been locked during the off season, the gate padlock was cut, and the gates opened shortly after.</p> <p>On occasions vehicles has entered the domain and wilfully damaged grassed areas by performing 'donuts' including an incident involving a vehicle damaging campground equipment.</p> <p>During peak season, staff on duty overnight have to travel 2kms from the Pine Beach campground to unlock the gates in the event of an emergency or similar. Poor cell phone coverage can make this process more challenging.</p> | <p><b>MEDIUM</b></p> |

| <p><b>Advice</b></p> | <p>As is the practice at other large parks and domains, particularly if infrastructure and camping facilities are present, we advise an automated gate system is installed at the main entrance.</p> <p>An automated gate with CCTV can be opened and closed remotely, activated by road pad sensors (for exiting vehicles) or by keypad/key card.</p> | |

| | <p>An automated gate with compatible CCTV system would reduce unauthorized entry, willful damage and theft incidents while ensuring vehicles can enter and exit during emergencies.</p> <p>Besides KDC staff and regular contractors, keypad codes or key cards could be provided to police, fire and ambulance services in the event of an emergency.</p> | |

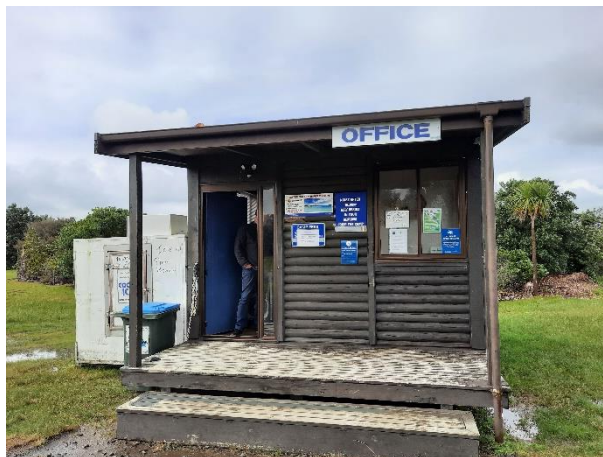
### Promenade Point campground reception office

| <b>Findings</b> | <p>The Promenade camping ground reception office is located close to the entrance with Kai Iwi Lakes road and consists of a small reception area and bedroom with cooking facilities.</p> <p>The office is only used during peak camping season with exterior area covered by 4 CCTV cameras although are not routinely monitored.</p> <p>During peak season, the camping ground is staffed by a couple who stay in a camper vehicle close to the office which appears to be an ideal arrangement.</p> | <b>LOW</b> |

| <b>Advice</b> | <p>The current safety and security arrangement for the Promenade camping ground office and surrounds seems adequate.</p> | |

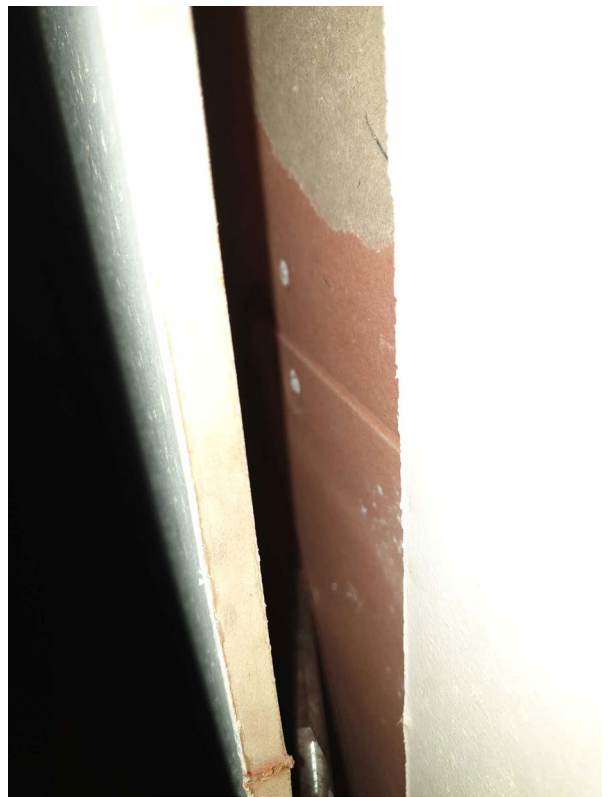
Figure 16 - Double lining appears to be standard with Plywood then Fireline being the 2nd layer

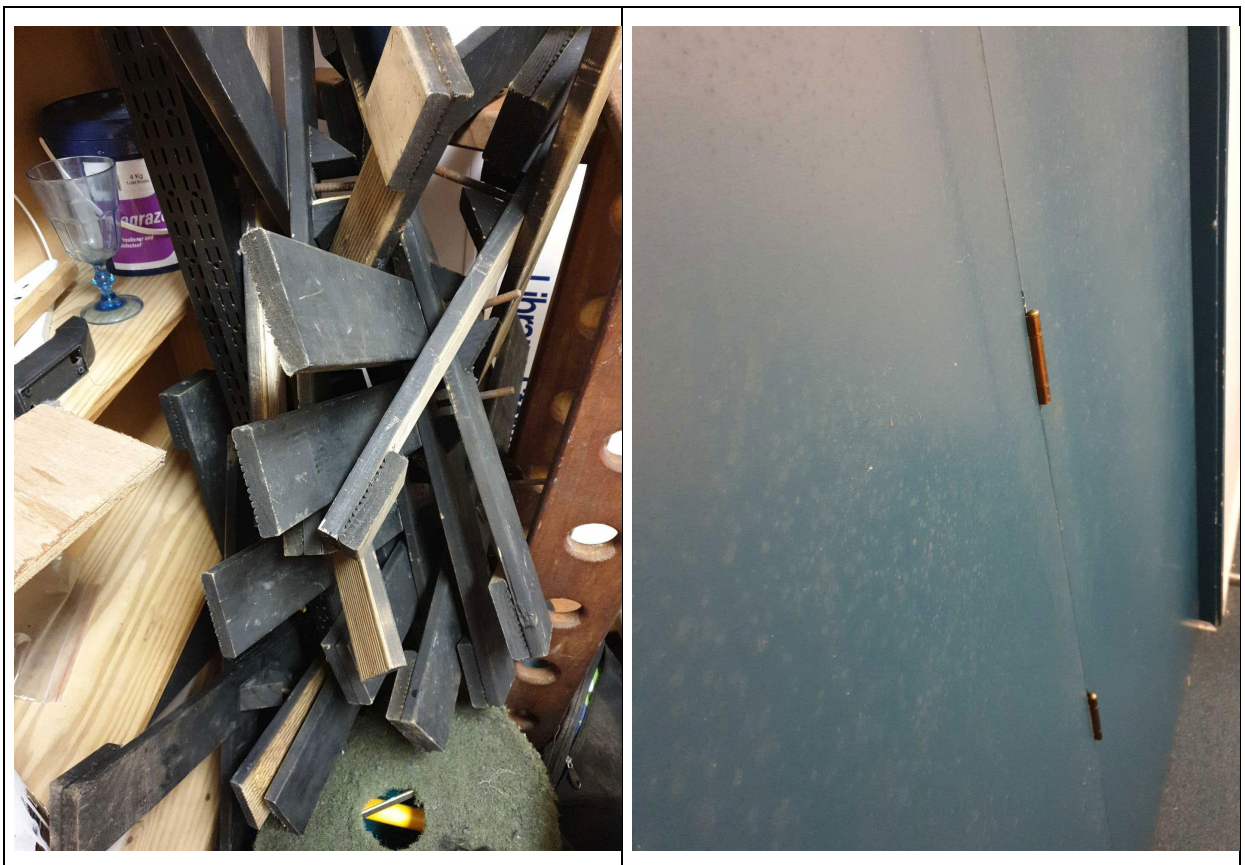
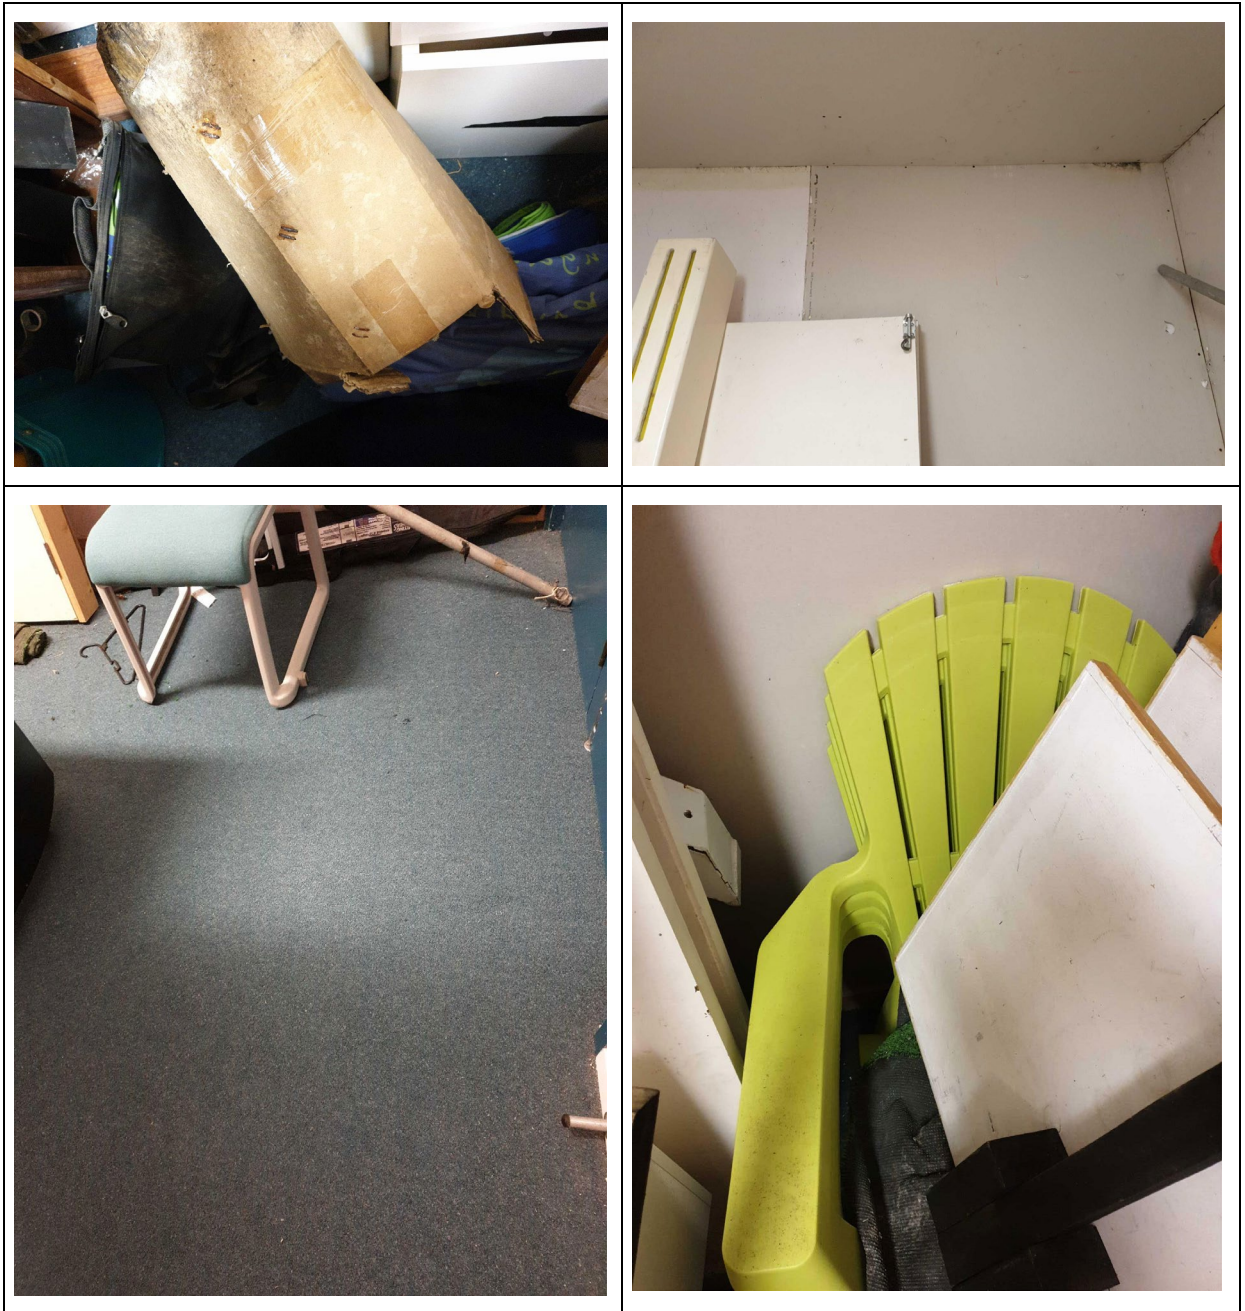
- 161. This room must be isolated immediately.
- 162. All items that were inspected in the storeroom had visible heavy contamination.
- 163. Wall linings, ceiling linings, doors all have active growth.

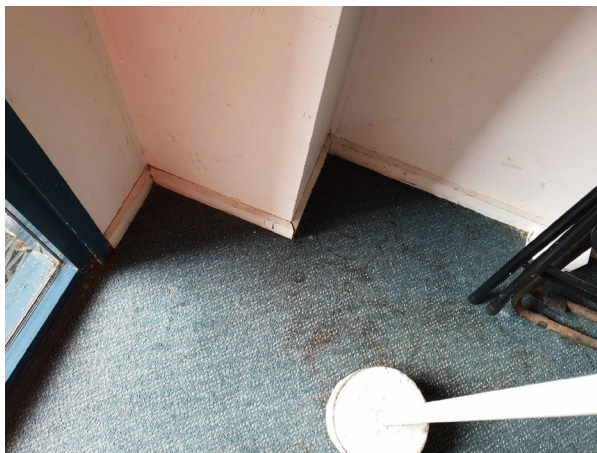
Figure 29 - Visible growth on the carpet

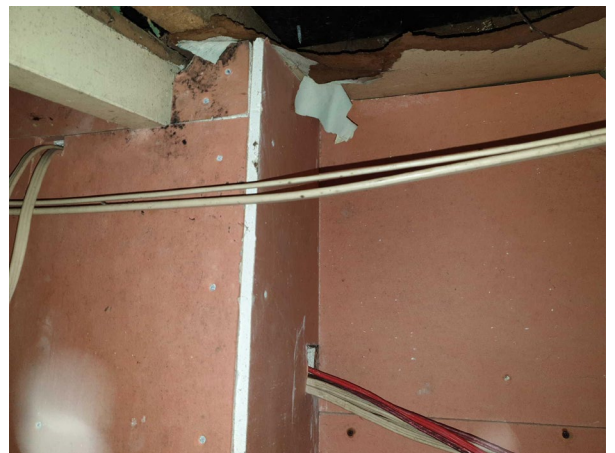
Figure 30 - There is visible growth on the Fireline in the ceiling cavity

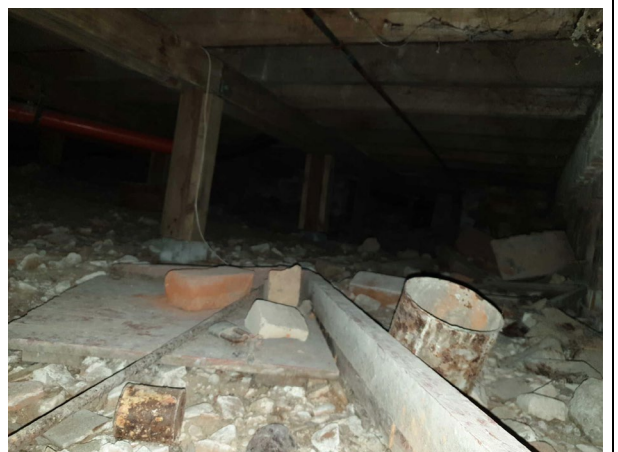
Figure 36 - Building rubble and debris is growing visible mould from the damp surroundings

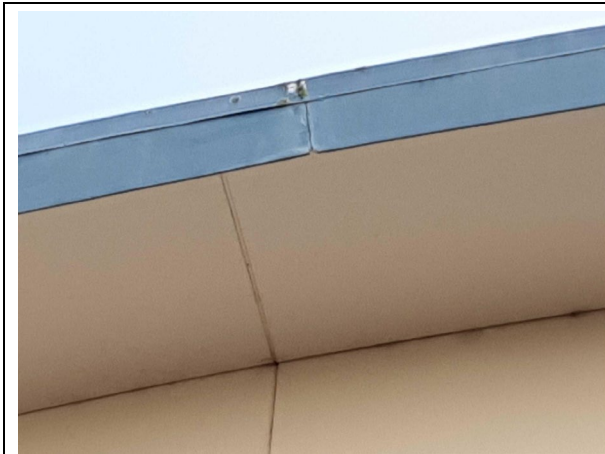
Figure 58 - unsealed connections in the barge to roof flashing
