## Review of Road Maintenance Delivery by NTA and Ventia for Kaipara District Council

### Part of Section 17A Review on Road Maintenance Delivery

*Prepared for:* Kaipara District Council

*Prepared by:* Kingston Infrastructure Ltd

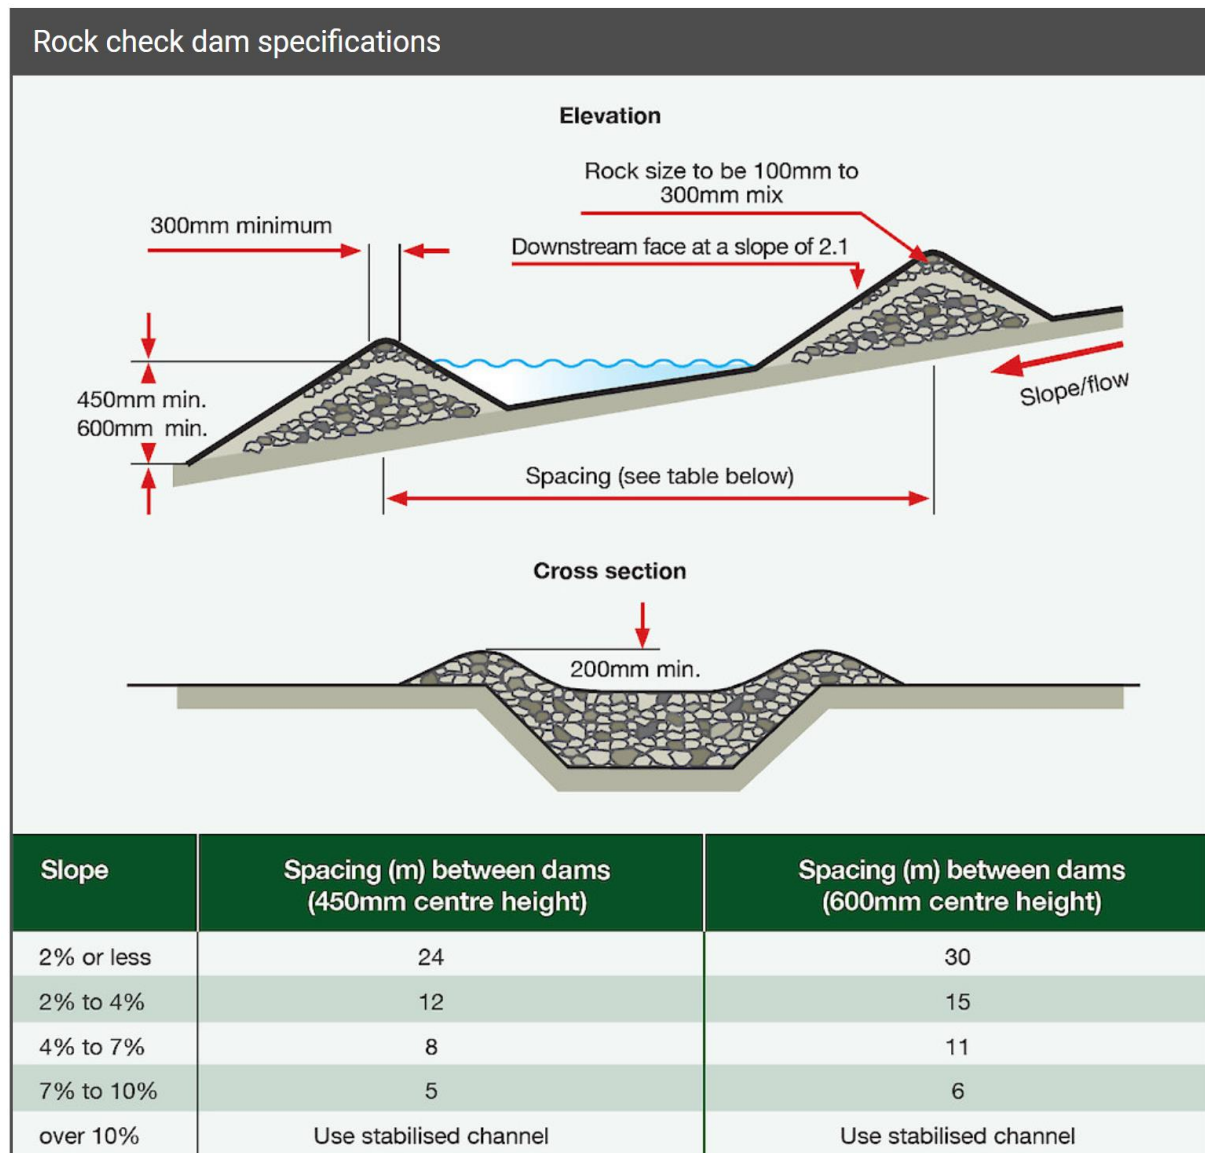
**Figure 1: Rock Check Dam Specification** (source NZ Forest Road Engineering)

Ventia staff advise there is no item within the schedule of rates for what would be known as 'Check Drains', which is a method of adding barriers across the drain to slow the water and lower scour potential. Where the water table has deeply scoured (near vertical sides greater than 0.5m), the pavement will "shove" laterally due to lack of side support, or overslips can occur (where the bank above the road slumps into water table and blocks it) due to the loss of toe support.

Information was sought from NTA and Ventia on what is the intervention level that would trigger "do minimum" to stop the pavement collapsing into the drain, and what method they have used to reinstate, or where they have reinstated, how did it occur. As no response has been received, it is recommended Council use accepted good practice, being cut the scour to shape, add bidum mat and infill with compacted gabion rock, and in long channel runs, use check drains (refer Figure 1 above).
