Mangawhai old fire station demolition

Meeting: Kaipara District Council
Date of meeting: 26 August 2020
Reporting officer: Matthew Williams, Infrastructure Projects Engineer
Tim Manning, Mangawhai Programme Delivery Manager

Title
A	Wood Street Revitalisation Project poster

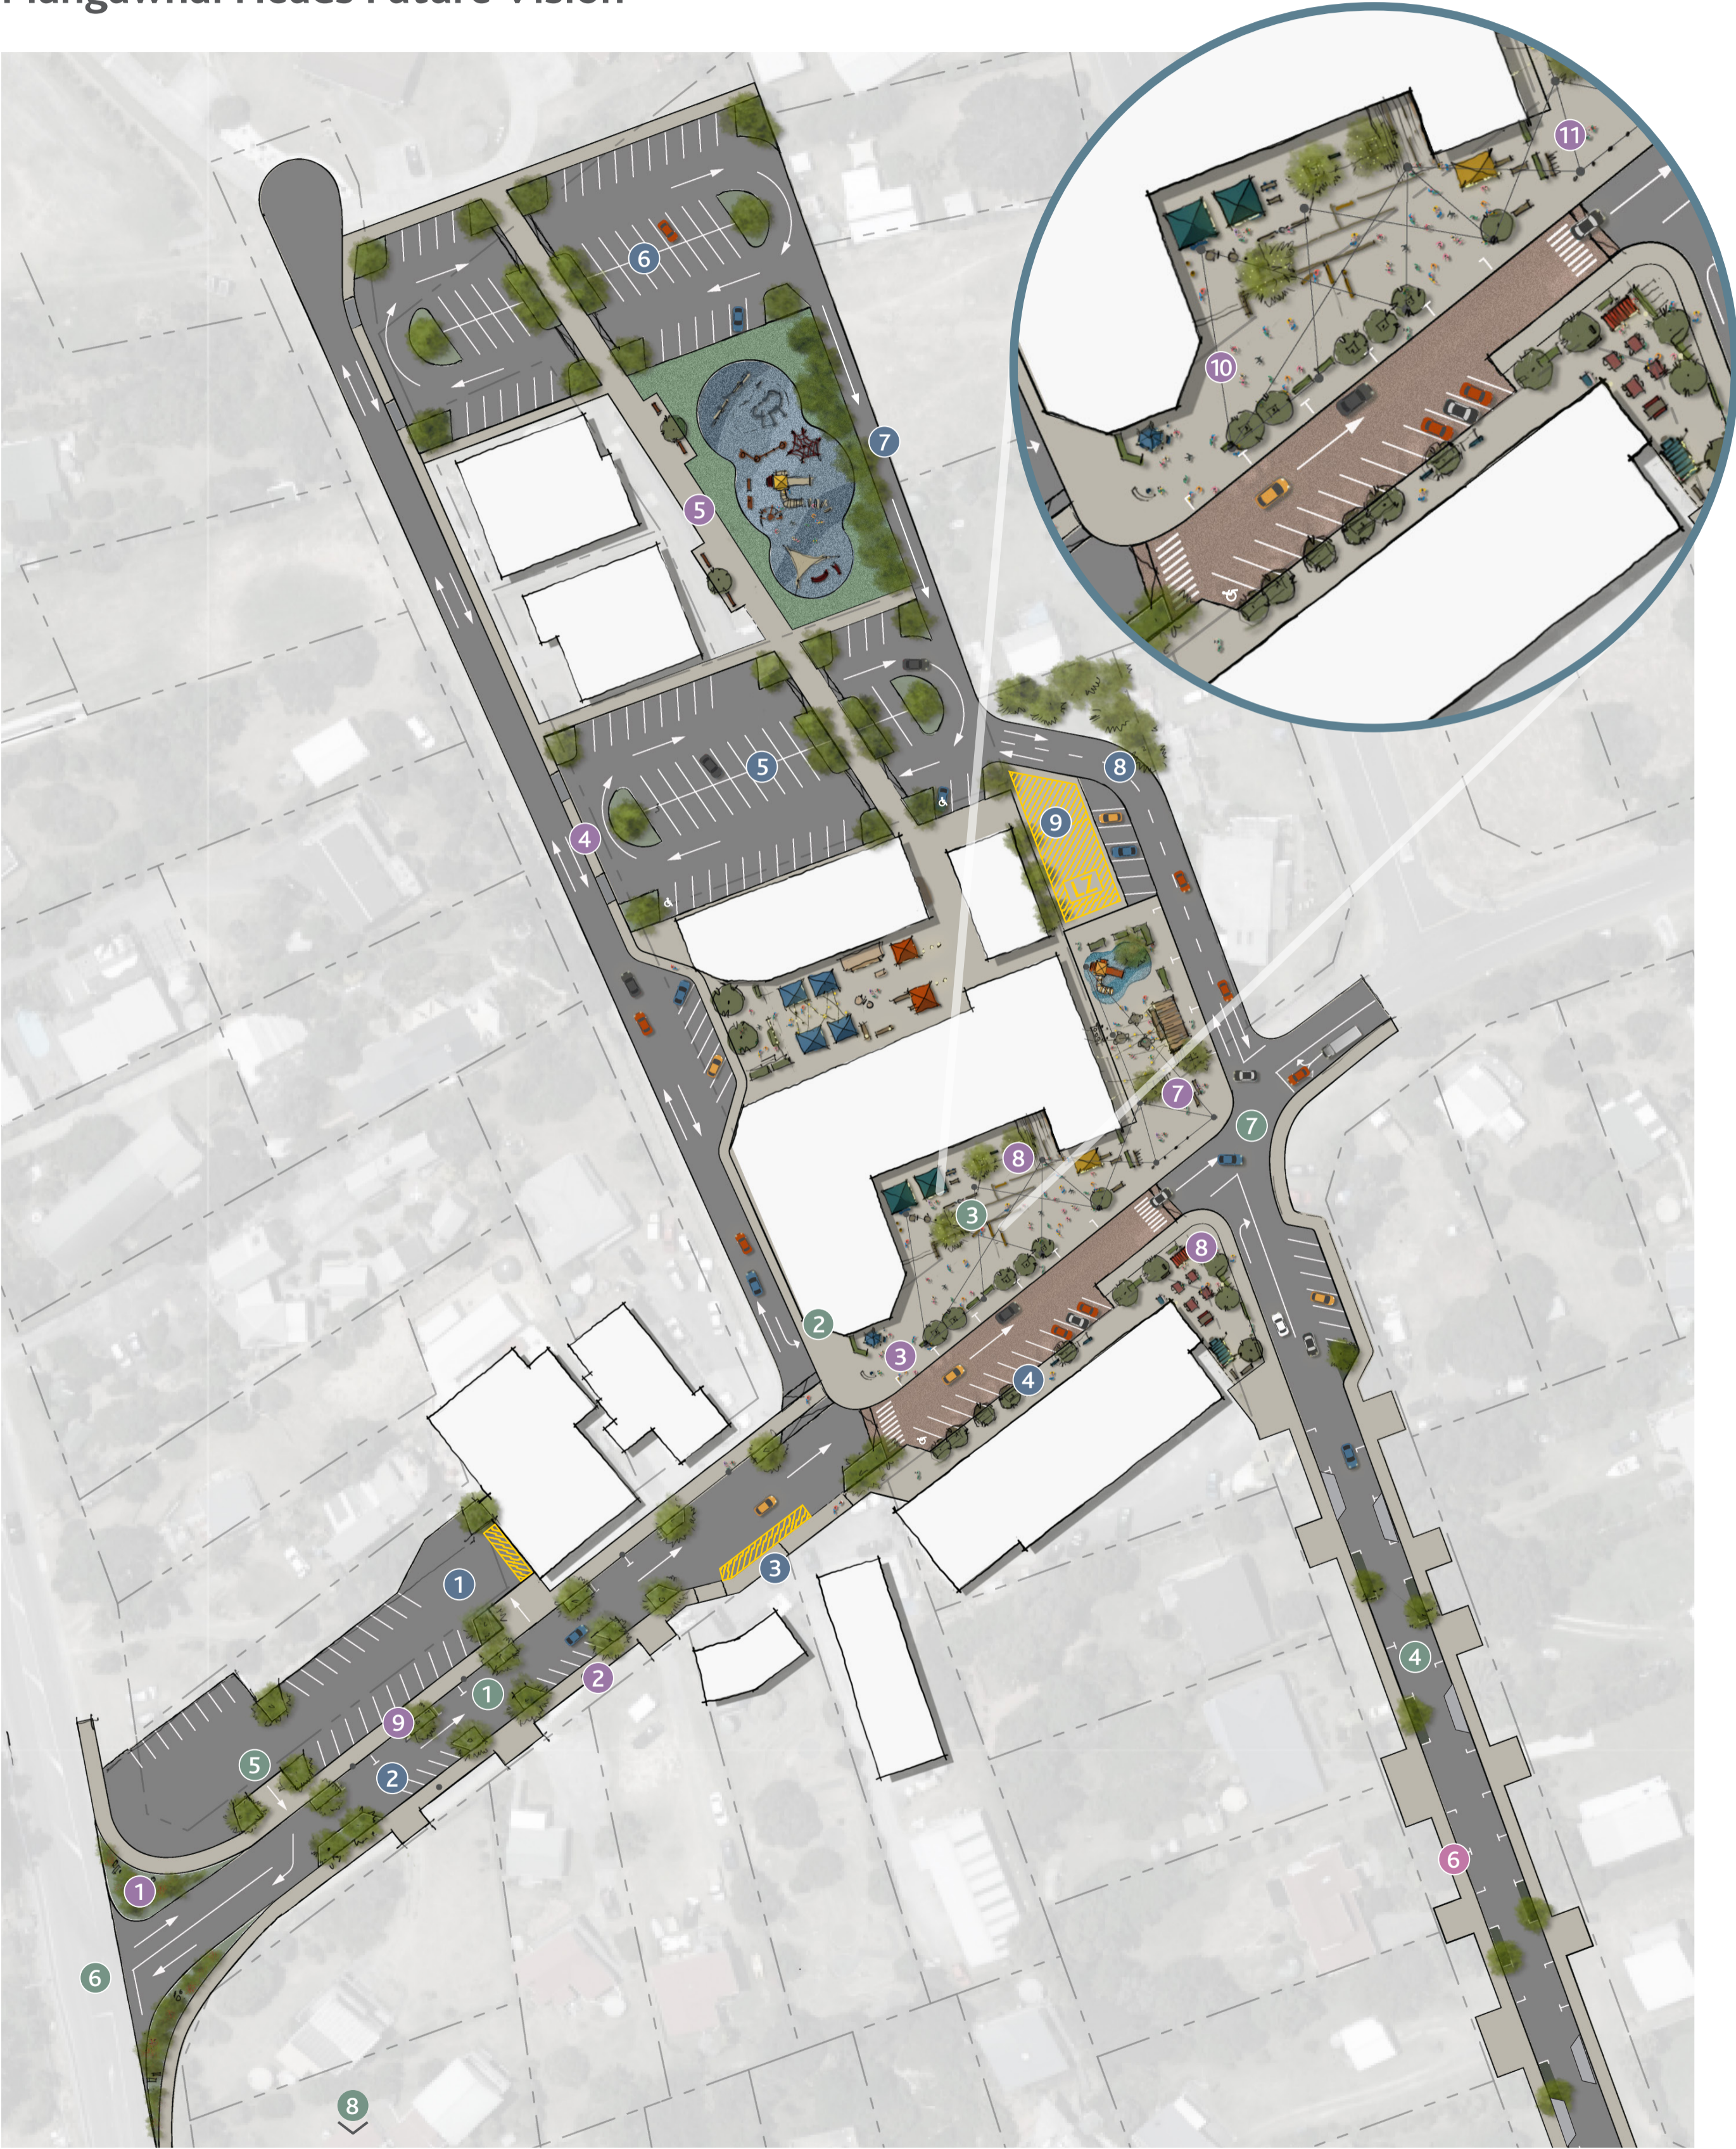
Wood Street 5-10 Year Vision

Key Components

- 1 One-way Wood Street
- 2 Left turn only on Fagan exit
- 3 'Shared Zone' in Wood Street shops
- 4 Traffic calming on Ellen, Findlay & Margaret Street
- 5 Four Square car park exit into Wood Street
- 6 Intersection tightening from Molesworth Drive into Wood Street
- 7 Wood & Ellen Street intersection improvements
- 8 Designated left turn lane on Findlay Street

- 1 Improved parking within Four Square
- 2 Mixed parking on Wood Street
- 3 Loading zone outside Top Catch & Liquor Store
- 4 Timed parking on Wood Street 'Shared Zone'
- 5 Improved parking flow within existing rear car park
- 6 New car park behind the community hall
- 7 Link lane behind playground to connect two carparks
- 8 Entry & exit lane through fire station site
- 9 Parking & loading zone in rear of fire station

- 1 Threshold treatment to Molesworth Drive & Wood Street intersection
- 2 Clear delineation of footpath on Wood Street
- 3 Wood Street: Shared street zone between Fagan Place & Ellen Street
- 4 Footpath improvements on Fagan Place
- 5 Pedestrian link through car parks & playground to Wood Street shops
- 6 Footpath on both sides of Ellen Street
- 7 Activation on old fire station site
- 8 Plaza spaces in Wood Street shops
- 9 Amenity and functional street planting
- 10 Street lighting for improved safety & amenity
- 11 Cycle parking & repair facilities

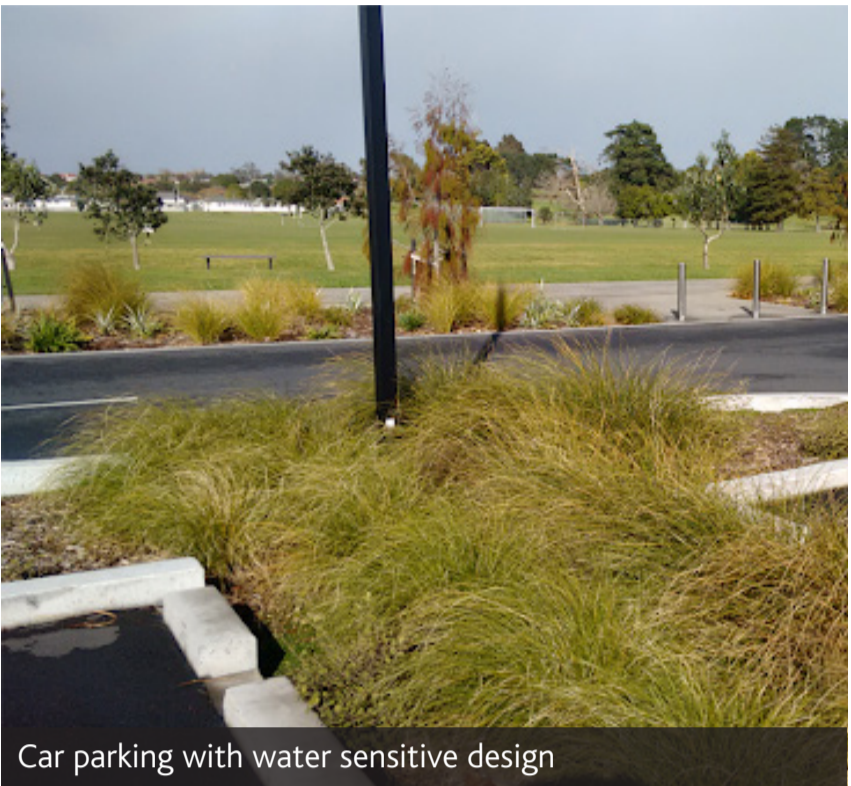
Car parking with water sensitive design

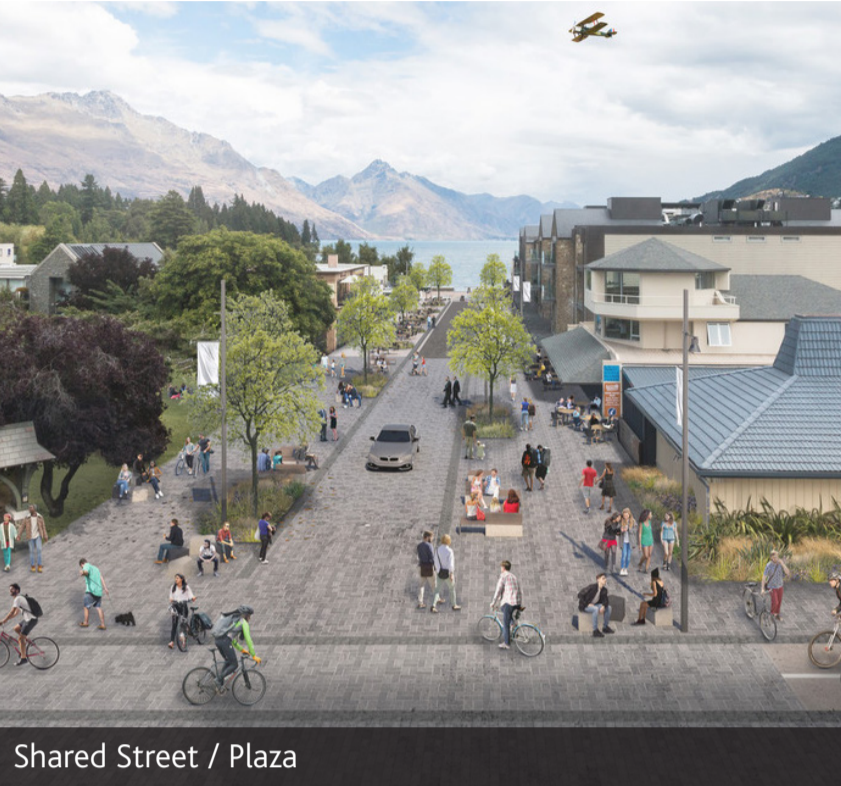
Shared Street / Plaza

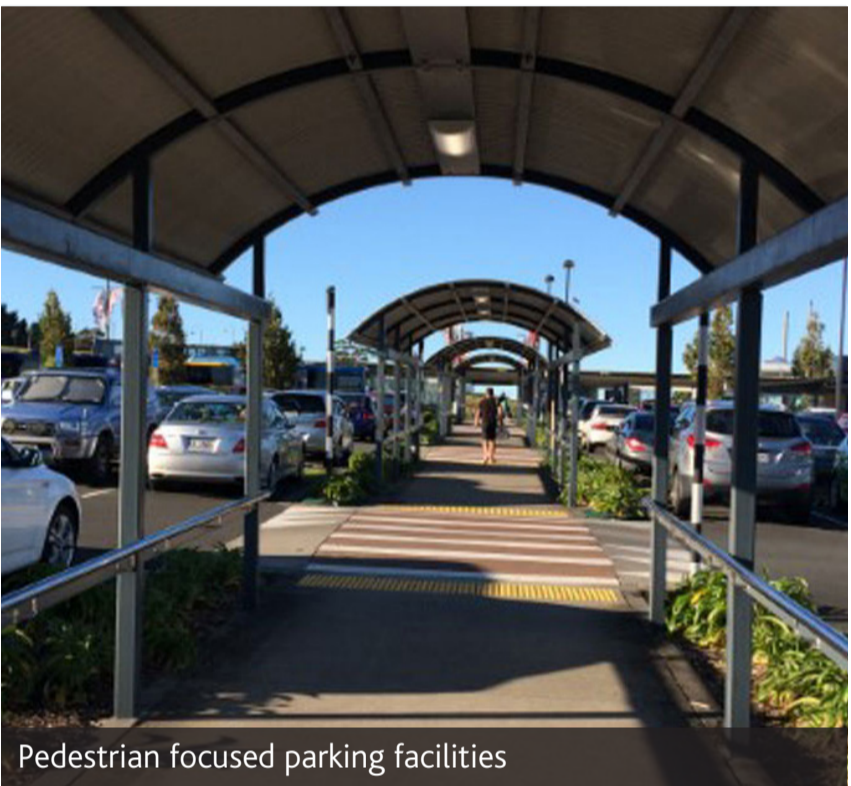
Pedestrian focused parking facilities

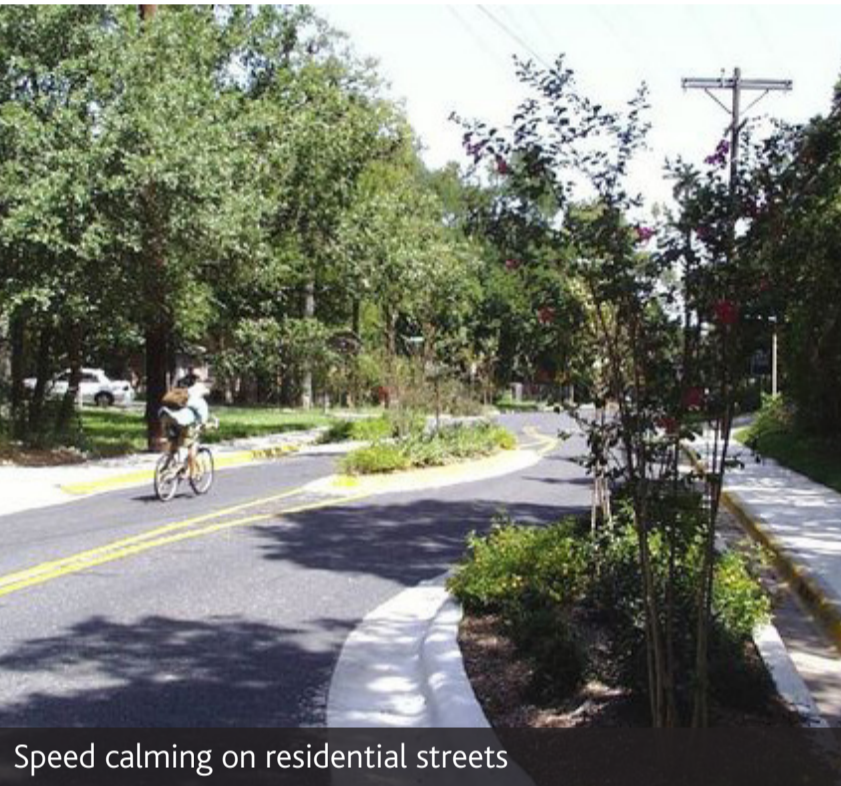
Speed calming on residential streets

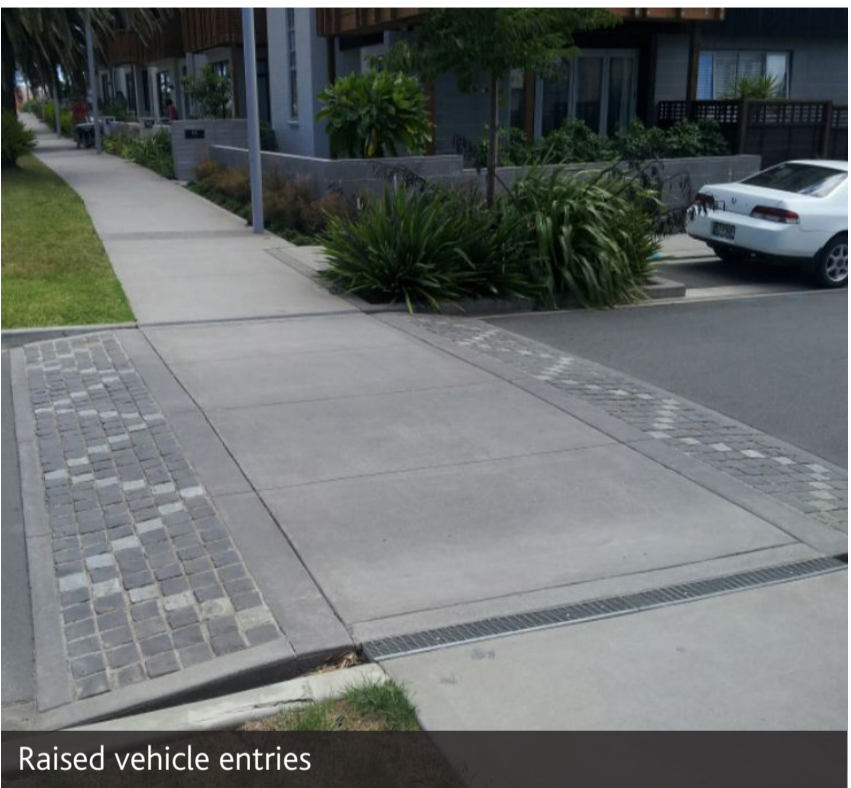
Raised vehicle entries

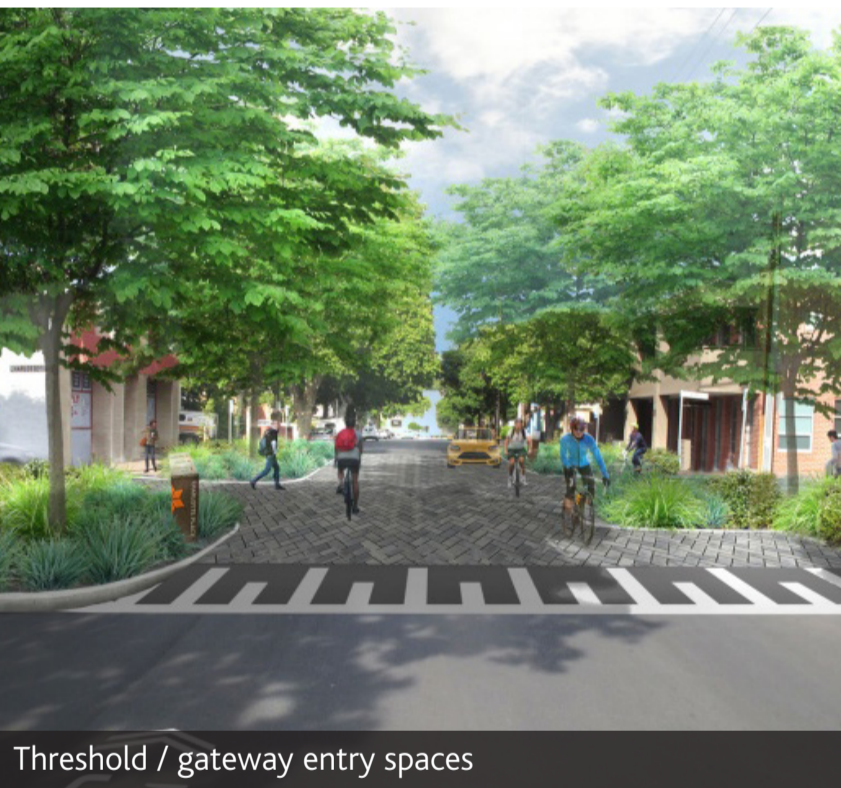
Threshold / gateway entry spaces

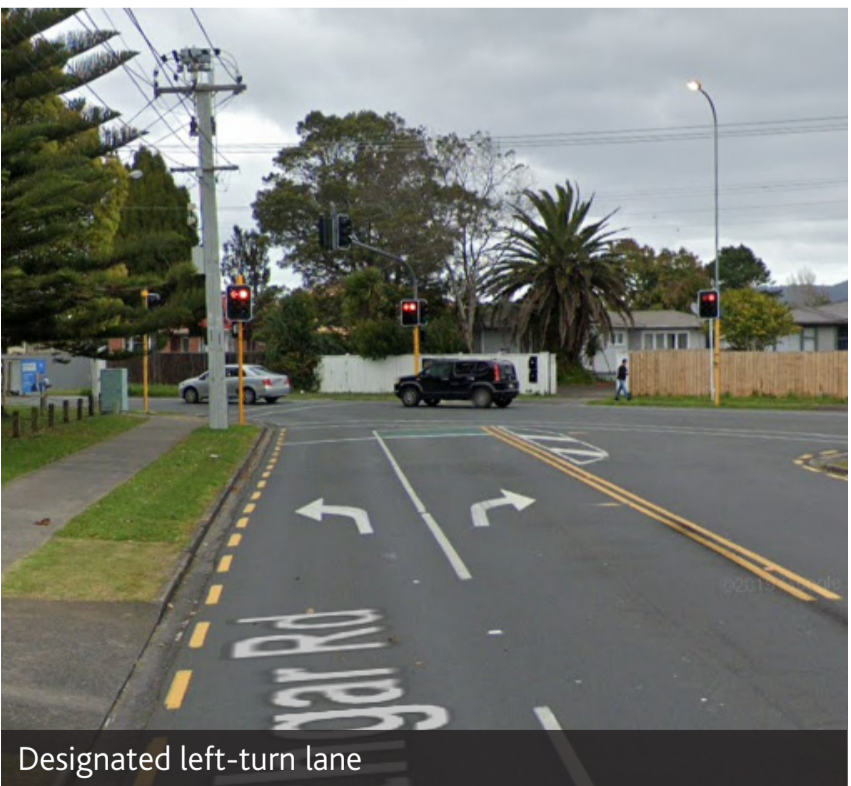
Designated left-turn lane

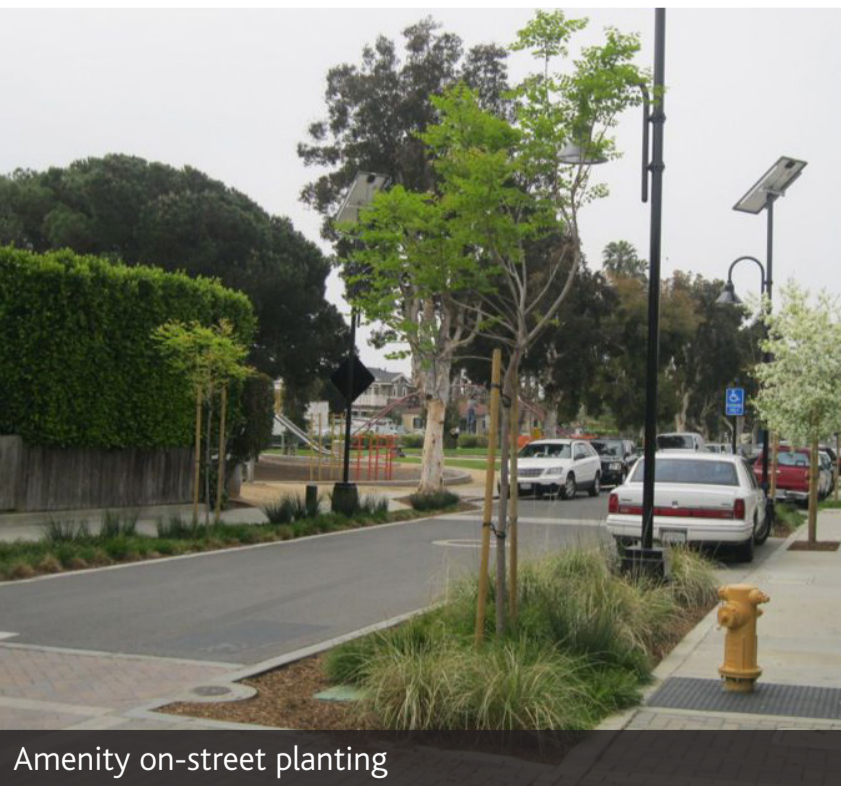
Amenity on-street planting
